UNIVERSITY OF MISSOURI-COLUMBIA

Research Reactor Center

REFERENCE: Docket No. 50-186
University of Missouri Research Reactor
License R-103

SUBJECT: Report as required by T.S. 6.1.h.(2) regarding reactor operation with the regulating blade in a degraded condition

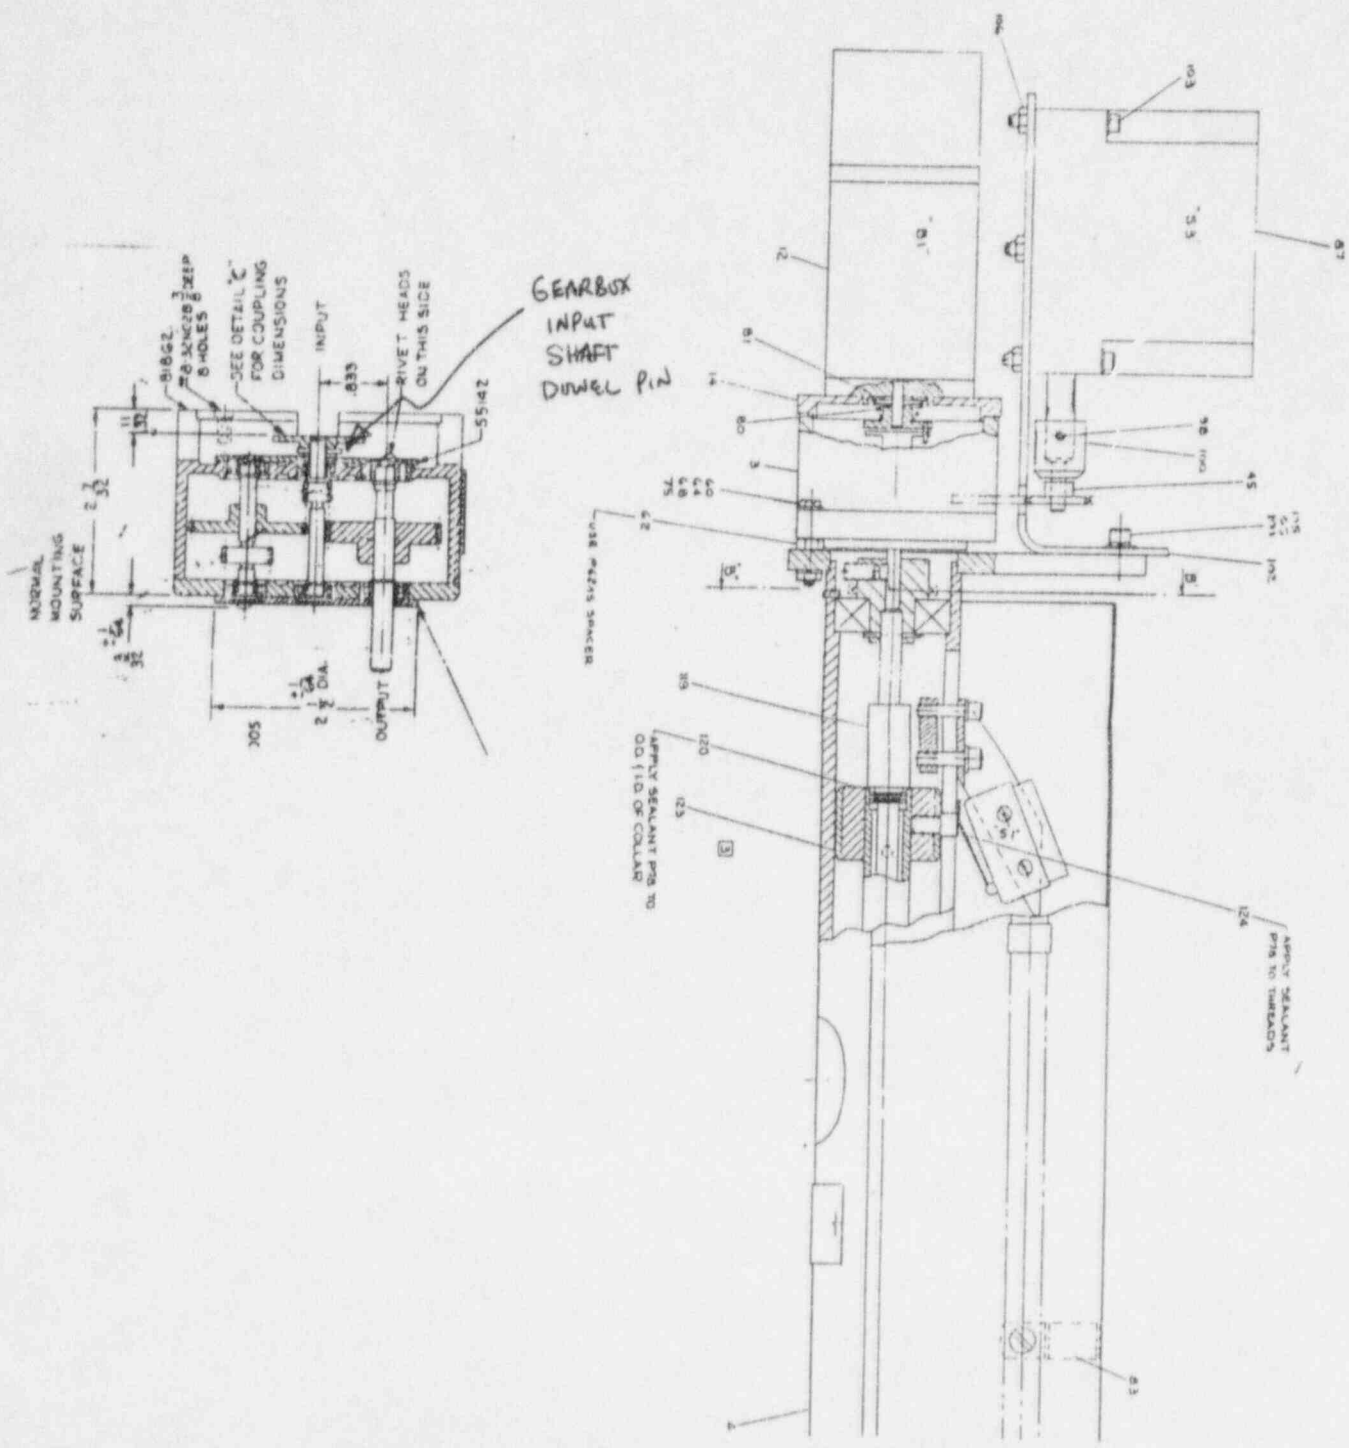
FIGURE 1

An electronics technician was called to investigate the problem with the regulating blade. After disassembly of the regulating blade drive motor and gearbox assembly, the electronics technician found that the dowel pin had failed in the gearbox coupling to the drive motor. This resulted in a friction fit between the gearbox input shaft and the gearbox coupling that allowed the shaft to slip in the coupling when the regulating blade was driven out.

The regulating blade system is used to automatically control reactor power at a desired power level (normally 10 MW). The blade is constructed of stainless steel and is driven at 40 inches per minute by the regulating drive mechanism. The regulating drive mechanism consists of a drive servomotor, gearbox assembly, and a ball/lead screw arrangement to translate the rotary motion of the motor and gearbox to the linear motion of the regulating blade.

Subsequent investigation by the Electronics Shop indicated that the dowel pin for the gearbox input coupling was missing and had presumably broken shortly before the operator detected an audible difference in the regulating blade drive. The dowel pin and input shaft bearing were replaced, the mechanism tested, and compliance checks relevant to the regulating blade rod run-ins were completed. Review of Electronics Shop maintenance logs indicate no previous failure of this coupling pin which was part of original design.

The dowel pin was replaced in the gearbox coupling and the gearbox input shaft bearing was replaced. The regulating blade drive was installed and the compliance check (CP-14) was completed to demonstrate its operability. This check included drive speed in both "in" and "out" direction and assured that alarms and rod run-ins associated with the regulating blade were actuating at the expected rod height.

A failure of this dowel pin in the gearbox coupling was the first in twenty-seven years of operation. The pin was replaced by an equivalent dowel pin. No additional long-term corrective action specific to this failure is planned. The regulating blade drive motor and gearbox are already on a six month preventive maintenance schedule which includes an inspection of all set screws and pins.
