FACILITY: South Texas Project, Units 1 and 2 (STP)

SUBJECT: SUMMARY OF JANUARY 18, 1996, MEETING ON THE RESIDUAL HEAT REMOVAL (RHR) PUMP IMPELLER CRACKING

RESIDUAL HEAT REMOVAL PUMP IMPELLER CRACKING

January 18, 1996

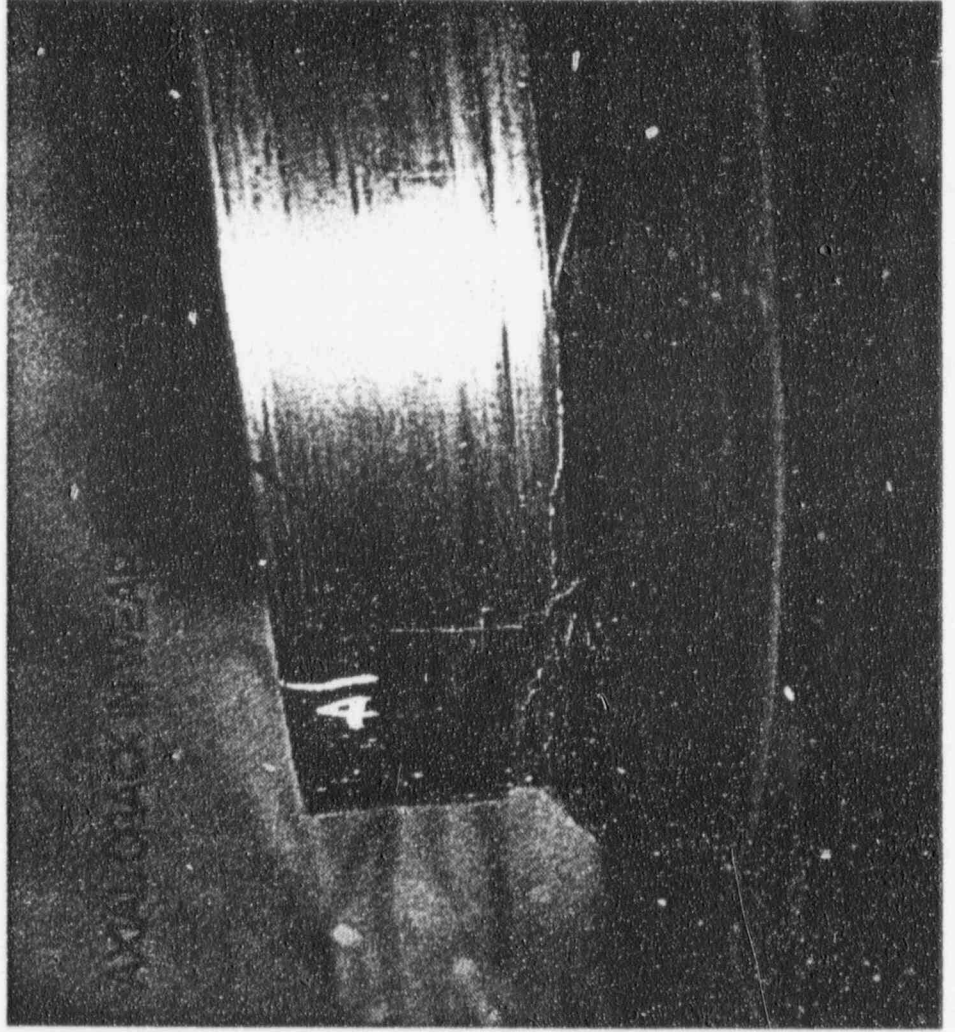
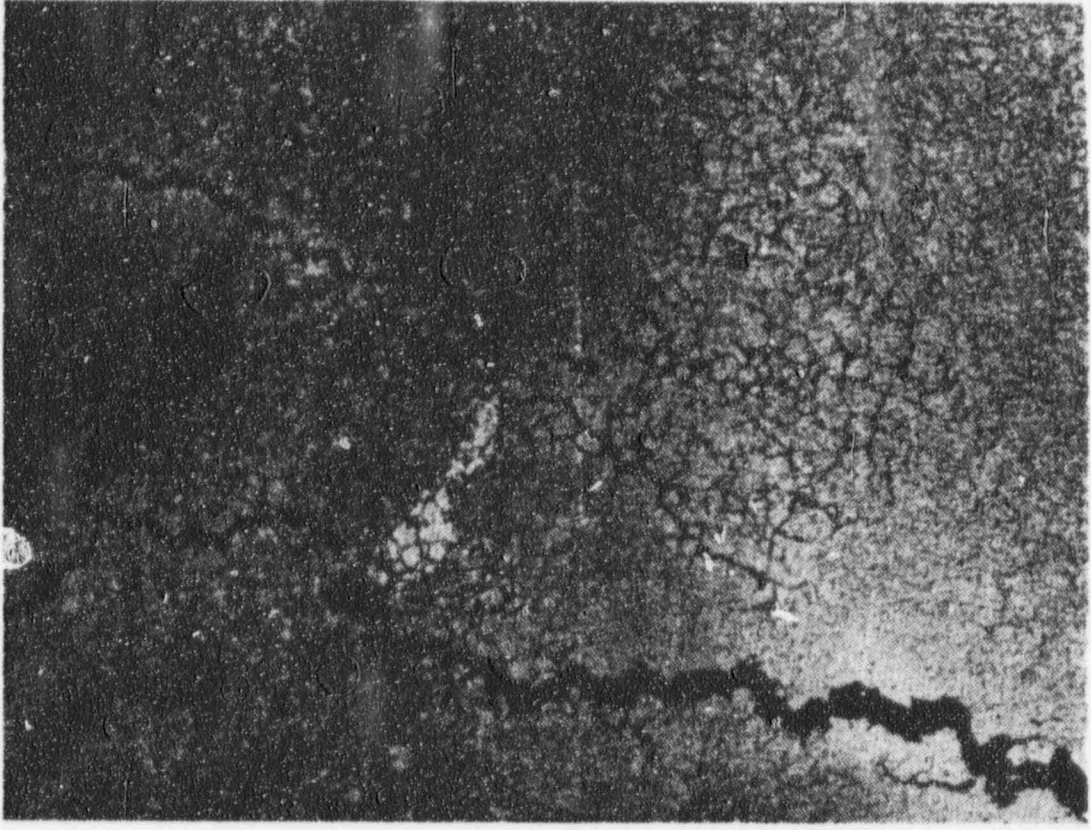
SUCTION SIDE WEAR RING AXIAL CRACKING ON 1C RHR IMPELLER

The wear ring axial cracking was due to improper flame hardening which made the wear ring susceptible to stress corrosion cracking. The proper flame hardening depth was not achieved on the suction ring wear side. However, the licensee verified that the proper flame hardening depth was achieved for the 1C backside wear ring and 4 additional wear rings.

- Axial Cracking Initiated and Propagated by SCC
- Proper Flame Hardened Depth not Achieved on Suction Wear Ring
- Shallow Flame Hardening Increases Susceptibility to SCC
- No Cracking on 1C Backside Wear Ring
- Verified Proper Flame Hardened Depth for 1C Backside Wear Ring (and 4 additional wear rings)
- Proper Flame Hardening Produces Residual Compressive Stresses

- The axial cracks were primarily intergranular in nature.

150X
PHOTOMICROGRAPH OF THE INTERGRANULAR
PATTERN OF THE AXIAL CRACK

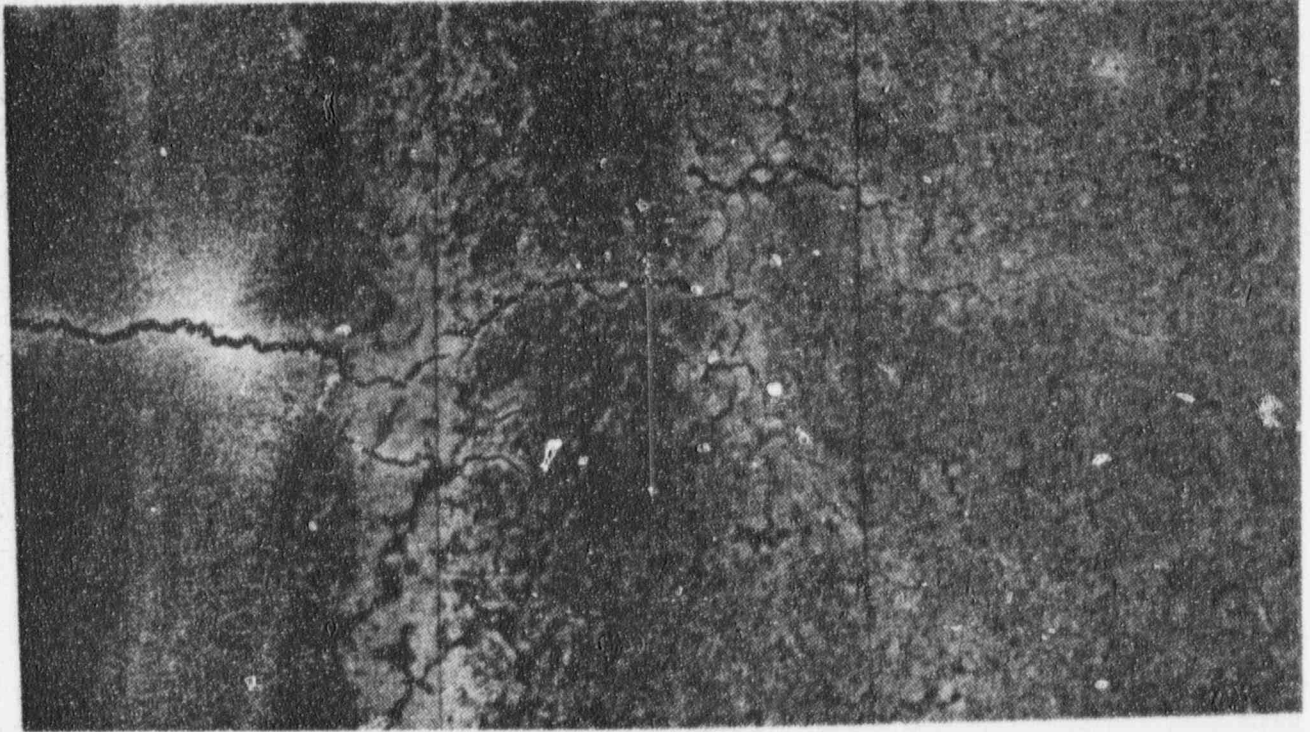
SUCTION SIDE WEAR RING AXIAL CRACKING

FLAME HARDENING DEPTH WAS LESS THAN NORMAL AND APPEARS TO HAVE OVERLAPPED A PREVIOUS FLAME HARDENED LAYER OF GREATER DEPTH. THIS IS BELIEVED TO HAVE SET UP RESIDUAL TENSILE STRESSES AT THE SURFACE.

FLAME HARDENED REGION

DEPTH 0.055"

HARDNESS HRC 52.1

HAZ DEPTH 0.010" HRC 42

SOFT INTERMEDIATE LAYER

HARDNESS HRC 27

SECOND HARDENED ZONE

DEPTH 0.050"

HARDNESS HRC 42

NOTE: ASM METAL HANDBOOK VOLUME 4, STATES THAT SURFACE HARDENING DEPTHS LESS THAN 0.075" ARE COMMONLY RESIDUALLY STRESSED IN TENSION, WHILE HARDENING TO A DEPTH OF 0.105" ENSURES THAT RESIDUAL STRESSES ARE COMPRESSIVE.

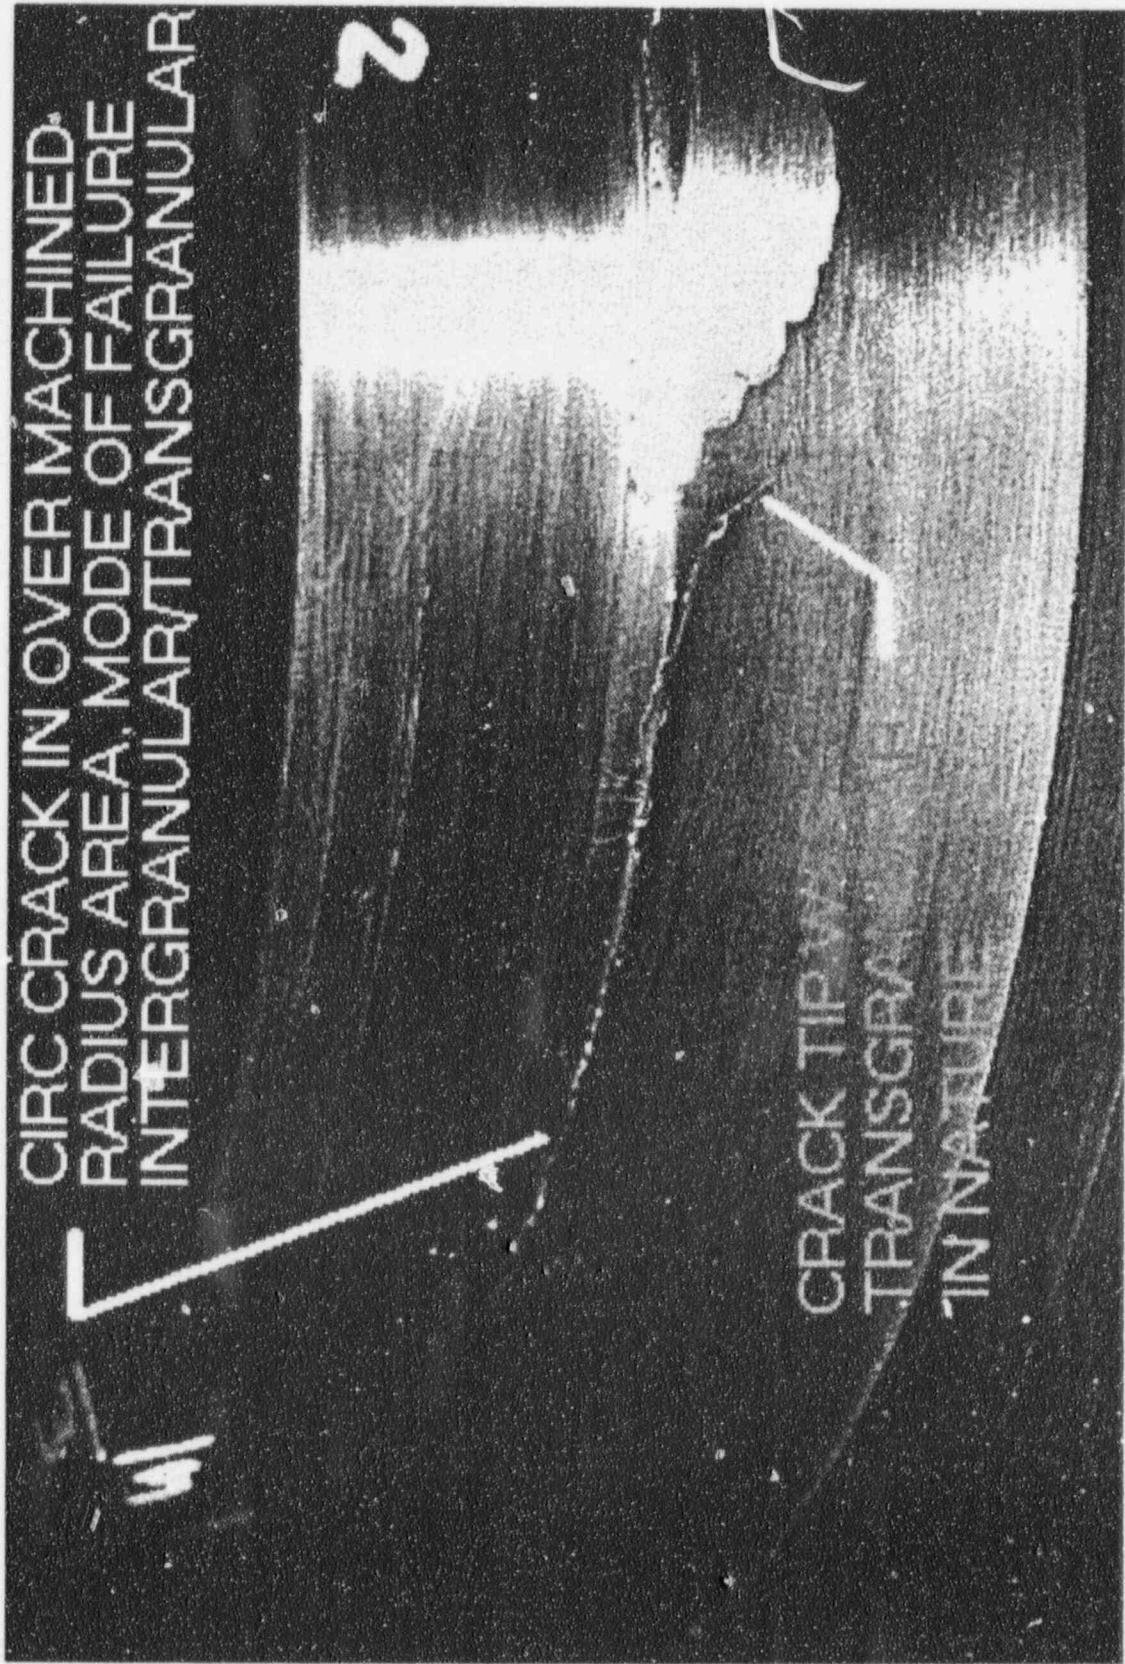
CIRCUMFERENTIAL CRACKING IN SHROUD AREA OF 1C RHR IMPELLER

The circumferential cracking in the shroud radius region was a result of overmachining of the impeller shroud radius. The design nominal thickness is 0.325 inch and the minimum 1C shroud thickness was 0.015 inch. However, the licensee verified proper thickness of the 2B impeller and two spare impellers.

- Circumferential Cracks Initiated and Propagated by SCC
- Minimum 1C Shroud Radius Thickness was 0.015"
(Design Nominal Thickness = 0.3125")
- Overmachining of the Shroud Radius Coupled with Wear Ring Flame Hardening Produced Residual Tensile Stresses
- Verified Proper Thicknesses of 2B and Two Spare RHR Impellers

CIRC CRACK IN OVER MACHINED RADIUS AREA. MODE OF FAILURE INTERGRANULAR/TRANSGRANULAR

CRACK TIP WITH TRANSGRANULAR IN NATURE

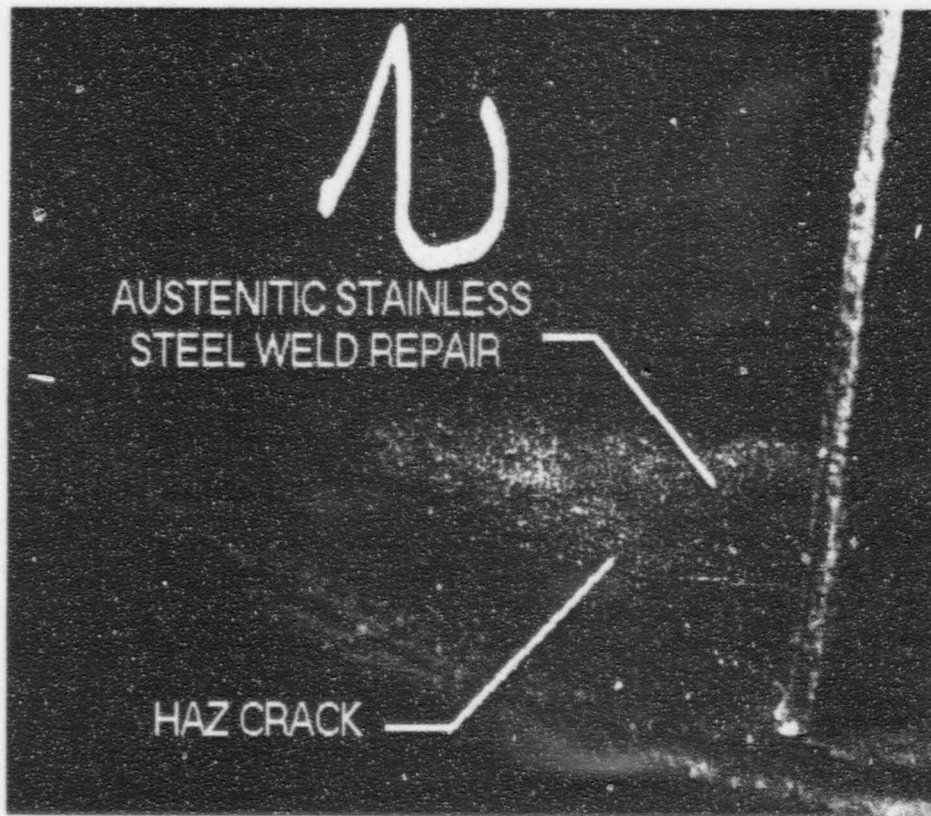
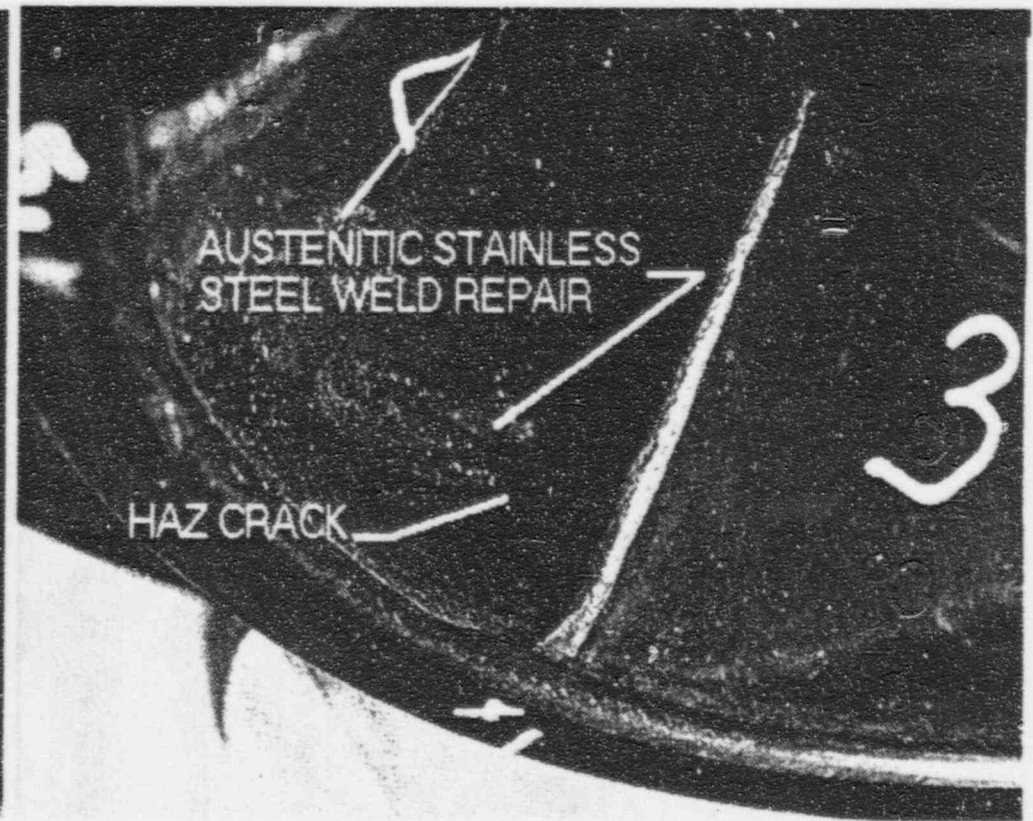
WELD REPAIR HAZ CRACKING ON 1C RHR IMPELLER

The cracking in the heat affected zones of vane weld repairs was caused by improper weld filler material. Austenitic weld filler material was used to make repairs in the martensitic material, producing residual tensile stresses. However, the licensee observed that weld repairs with the proper (martensitic) weld material did not crack because the use of martensitic weld material produced residual compressive stresses.

- Heat Affected Zone (HAZ) Cracking Initiated by SCC
- Chemical Composition Testing Confirmed that AUSTENITIC Weld Filler Material was used on the Cracked Repairs
- Austenitic Weld Repairs in Martensitic Material Produce Residual Tensile Stresses
- Martensitic Weld Repairs did not crack
- Martensitic Weld Repairs Produced Residual Compressive Stresses
