UNITED STATES
NUCLEAR REGULATORY COMMISSION
WASHINGTON, D. C. 20555

MEMORANDUM FOR: Tom Rehm, Assistant to the Executive Director for Operations
FROM: Carlton Kammerer, Director, Office of Congressional Affairs
SUBJECT: . . . REQUEST FOR INFORMATION ON GRAND GULF

SUBJECT: REPORT NOS. 50-416/83-55 AND 50-417/83-09

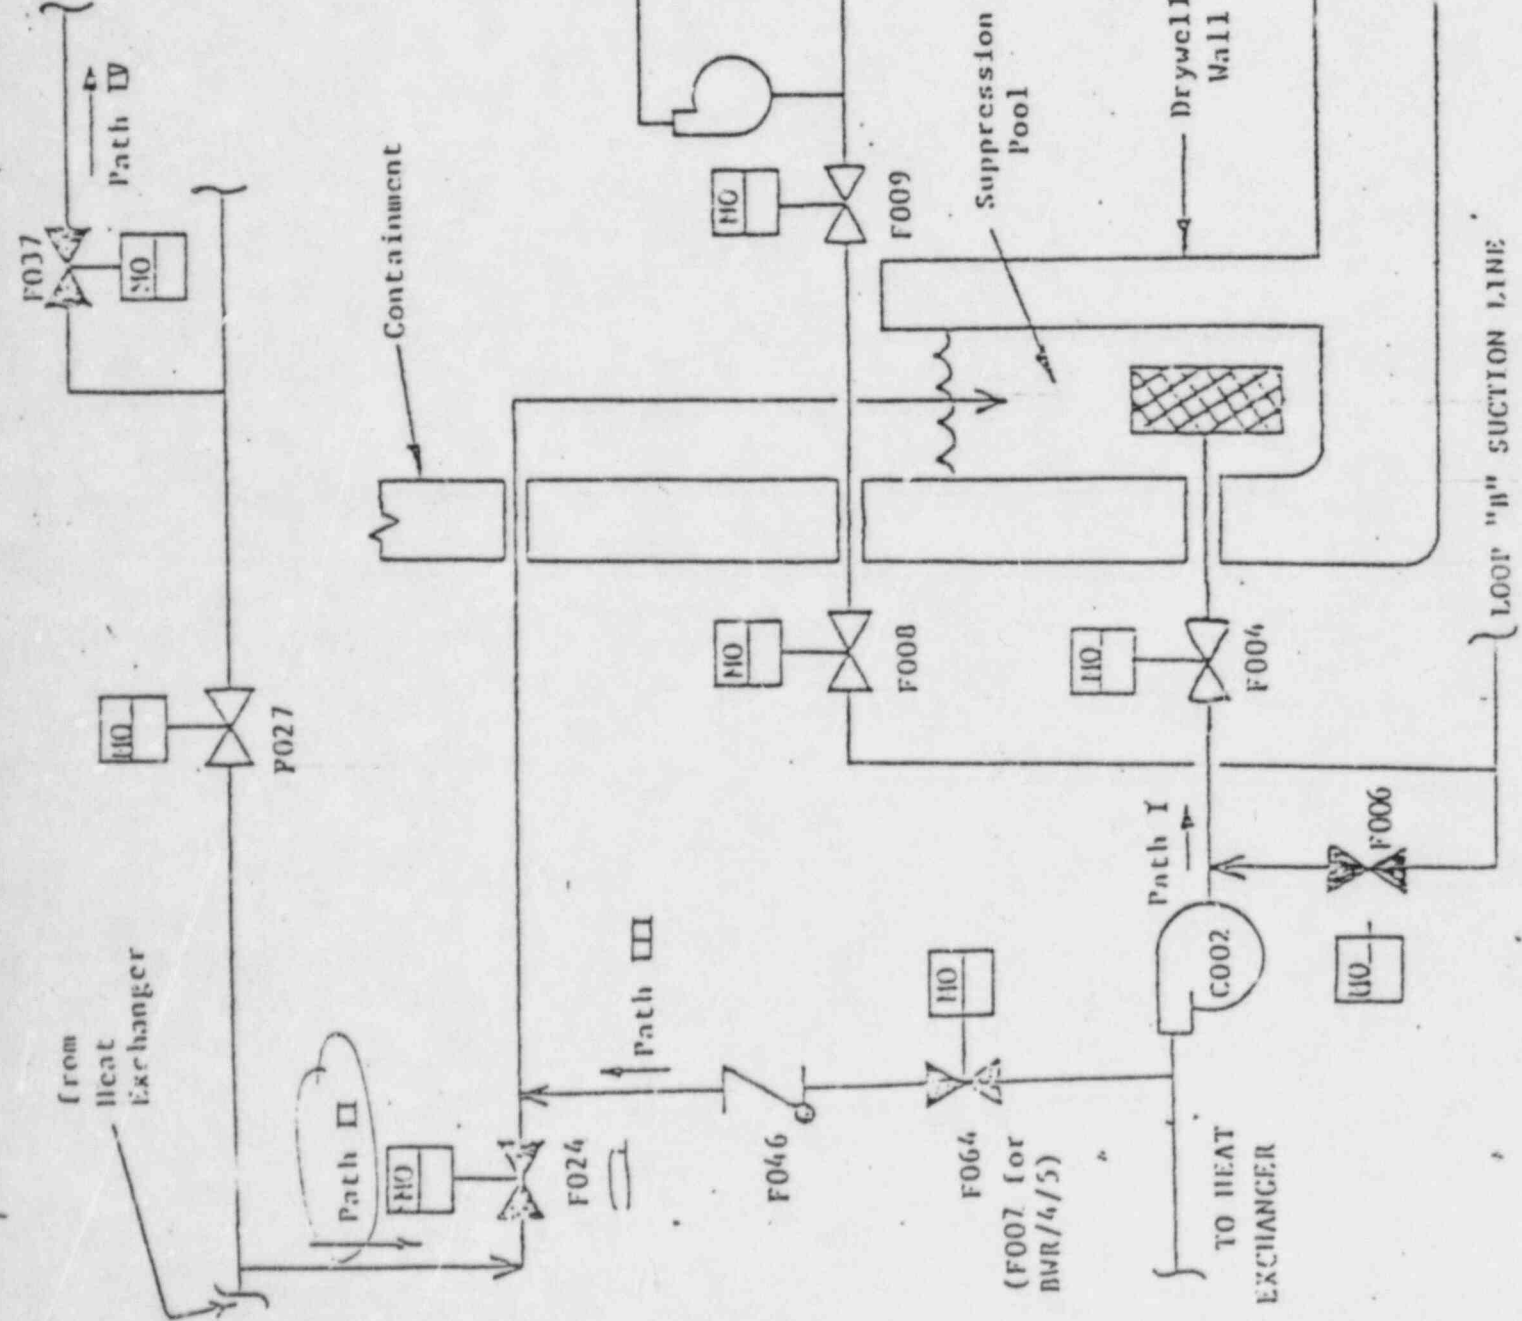
UPPER
CONTAINMENT POOL (UCP)
(BWR/6 ONLY)

There was no danger of core uncovering at any time. This is due to the fact that the LPCI line comes into the reactor vessel above the top of the active core.
