GENE-523-A092-0995  
DRF 137-0010-8

## Evaluation of the Peach Bottom Unit 3 Core Spray Line

September 1995

GE Nuclear Energy  
175 Curtner Ave  
San Jose, CA 95125

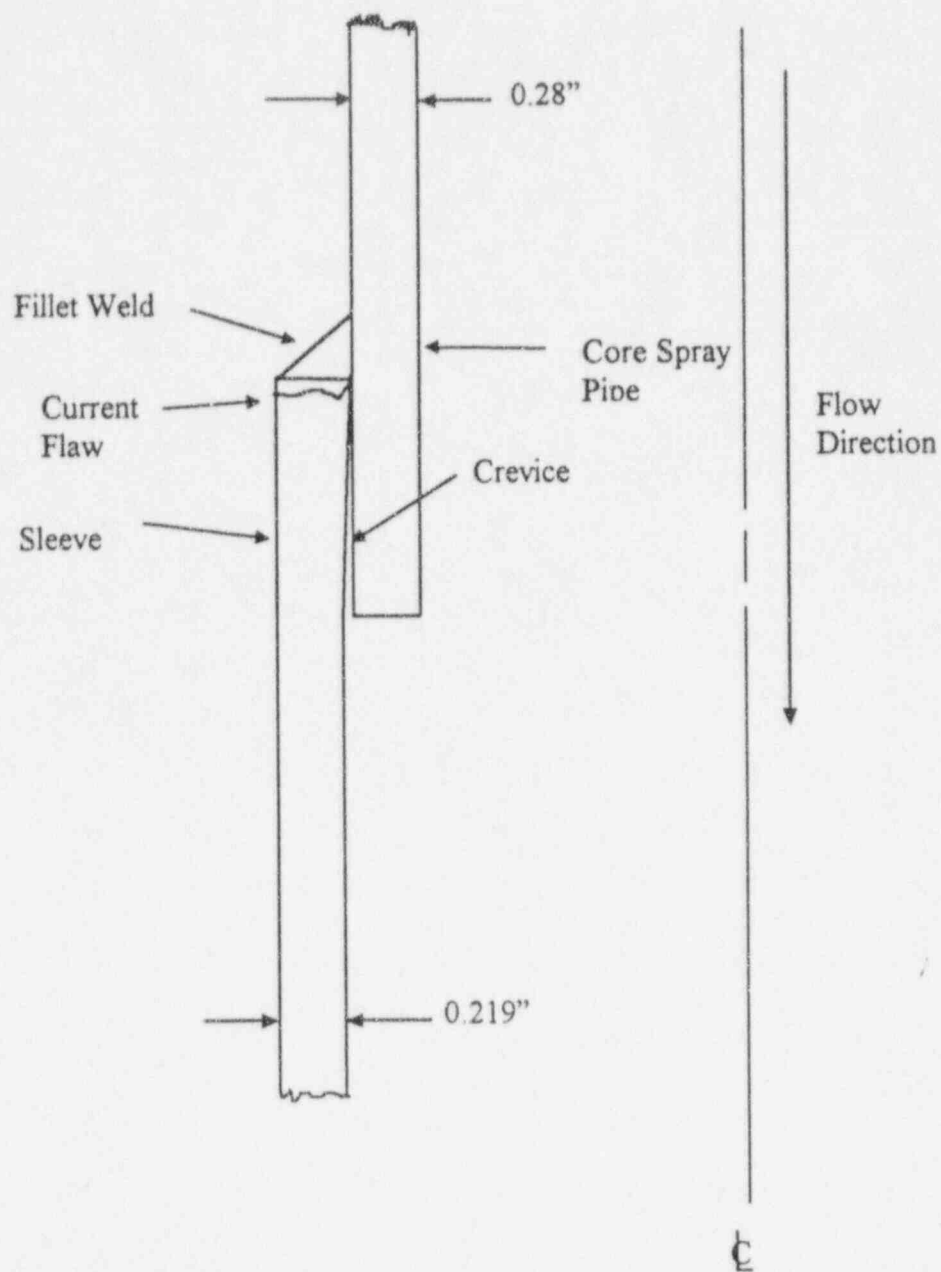
Figure 1-2 - Schematic of Core Spray Line in Vicinity of Observed Cracking

An indication was found in one of the vertical portions of the core spray pipe (there are a total of four vertical downcomers, two per core spray loop) on the outside diameter of the sleeve near the fillet weld (See Figure 1-2). Since the indication was seen on the outside surface, and considering that a crevice exists on the inner surface of the sleeve, it is assumed that the cracking initiated on the inner diameter of the sleeve. The cracking is likely intergranular stress corrosion cracking (IGSCC) due to the effects of the fillet weld induced heat affected zone (HAZ), residual stress, crevice condition, and aggressive core spray pipe environment.

The indication has been observed to be approximately three inches long on the outside surface of the sleeve. Thus, assuming initiation on the inside surface of the sleeve, it then follows that there is at least three inches of through-wall cracking. Since visual inspection has been performed, part through-wall cracking from the inside surface of the remaining circumference cannot be ruled out. It has been demonstrated that even if the sleeve were to be totally severed at the current flaw location, the pipe would not disengage from the sleeve and thus the core spray delivery would not be disrupted. Since some of the factors which contribute to stress corrosion cracking may be present on the core spray pipe (inner cylinder) at this location, the possibility of crack initiation in the pipe is examined further in this report.

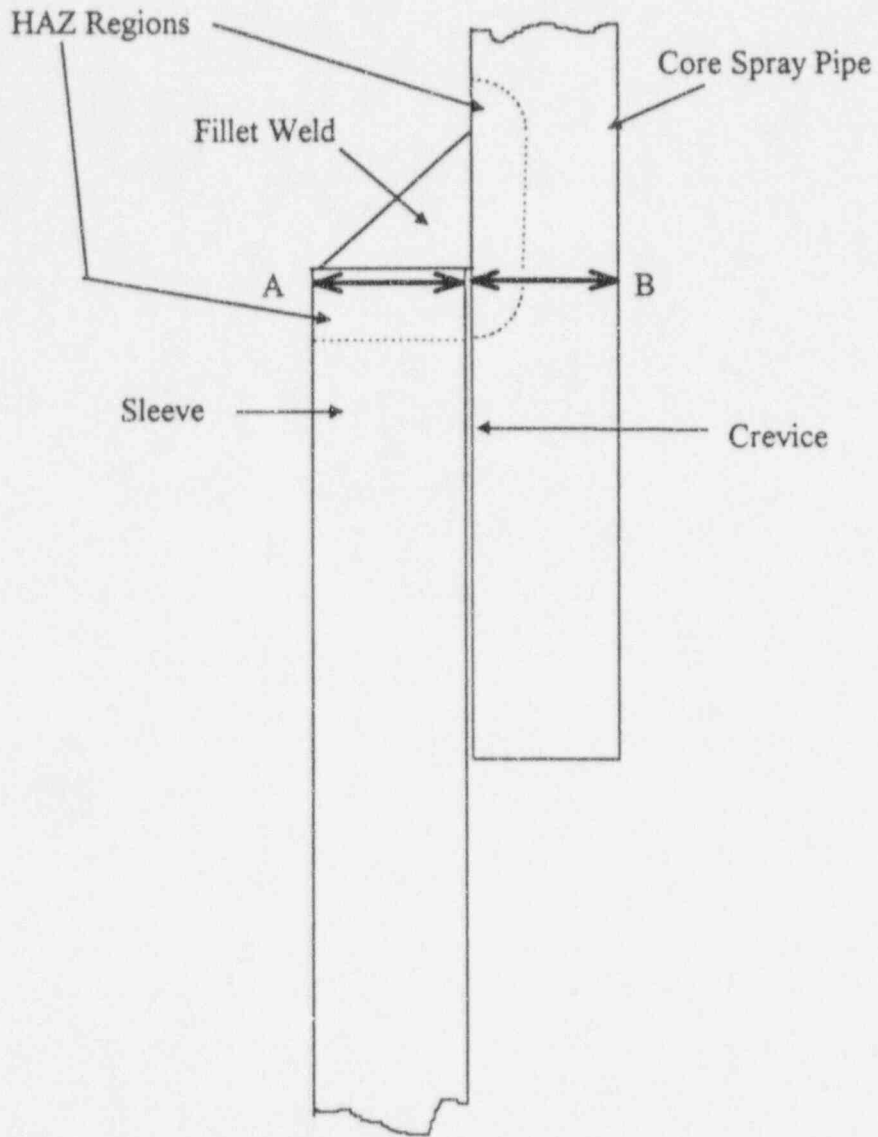
Figure 2-1 - Schematic of Cracked Region in Core Spray Line

The fillet weld between the core spray pipe and sleeve will induce weld residual stress and an area of sensitized material. Figure 2-1 shows the geometry of the sleeve to piping junction. Also shown (by the dotted line) is the expected behavior of the HAZ due to the fillet weld. In the sleeve itself (where a crack has been observed) the heat affected zone penetrates through the entire cross-section of the sleeve. Thus, there is a path of susceptible material where a crack could propagate through-wall. However, for the core spray pipe, the HAZ will not penetrate through the entire thickness. Depending on the heat input and other welding parameters, the HAZ depth will vary, but the penetration will likely not be through-wall and is expected to be half the wall thickness. This is illustrated in Figure 2-1.

The indication appears to be in the sleeve HAZ as designated by Section A in Figure 2-1. Based on consideration of the environmental, geometric and stress factors at this location,

it is likely that the cracking initiated from the inside surface of the sleeve at or near the crevice tip.

Combining these arguments concerning residual stress, applied stress and HAZ characteristics, it is believed that the potential for initiation and propagation of cracking along section B in the core spray pipe is not likely. Also, the integrity of the pipe is maintained even with a through-wall flaw of 270° of the circumference. It should also be noted that due to the low stresses in the pipe, the allowable 360° part through-wall flaw could have a depth of more than 95% of the pipe wall and still maintain structural integrity.

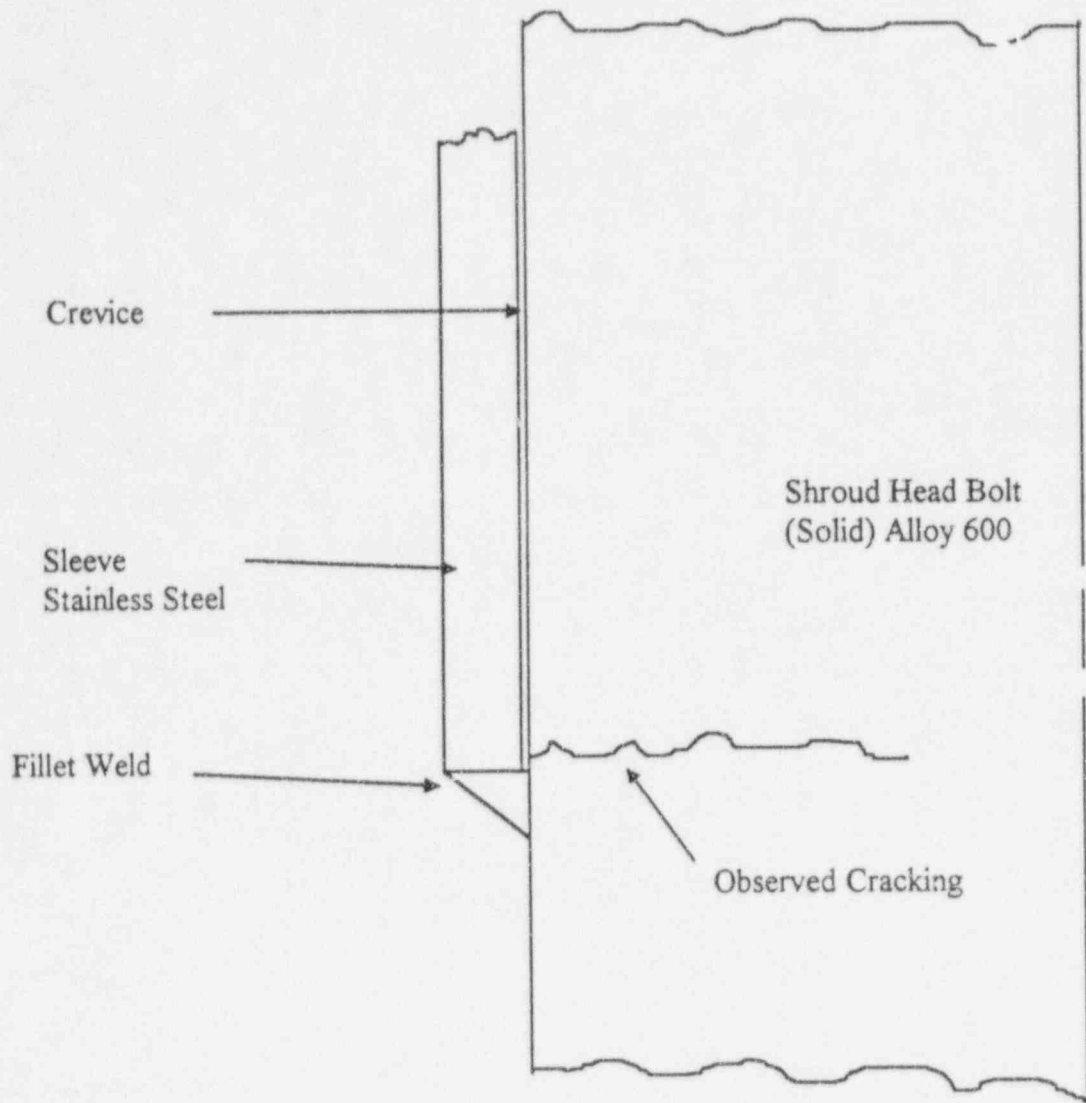
Figure 2-2 - Schematic of Shroud Head Bolt Cracking

Cracking was observed in the SHB's in the vicinity of the crevice formed by the connection of a sleeve to the bolt with a fillet weld. In this case, the sleeve is on the outside and the bolt on the inside. The bolt in this case was solid. The sleeve was then fillet welded to the outside surface of the bolt. The bolt was fabricated from Alloy 600 and the sleeve from stainless steel. Figure 2-2 shows a schematic of the SHB geometry in the vicinity of the observed cracking.

Figure 2-2 shows that the cracking in the SHB's was observed in the inner component. However, the inner component is the load carrying component for the shroud head bolt configuration. No cracking has ever been observed in the non-load carrying SHB sleeve. For the core spray pipe case, the load carrying component is the outer sleeve, and the non-load carrying component is the core spray pipe. Based on field experience, it is reasonable to expect any crack initiation to occur in the outer sleeve (consistent with the observed crack). Conversely, field experience suggests that crack initiation in the piping is not expected.
