Duane Arnold Energy Center
3277 DAEC Road
Palo, IA 52324
Telephone 319 851 7611
Fax 319 851 7611

September 22, 1995
NG-95-2906

Subject: Duane Arnold Energy Center
Docket No: 50-331
Op. License No: DPR-49
Licensee Event Report #95-009.
File: A-118a

TITLE (4)
PCIS Groups 2 through 5 Isolations Due to EPA Breaker Trip on "Undervoltage"

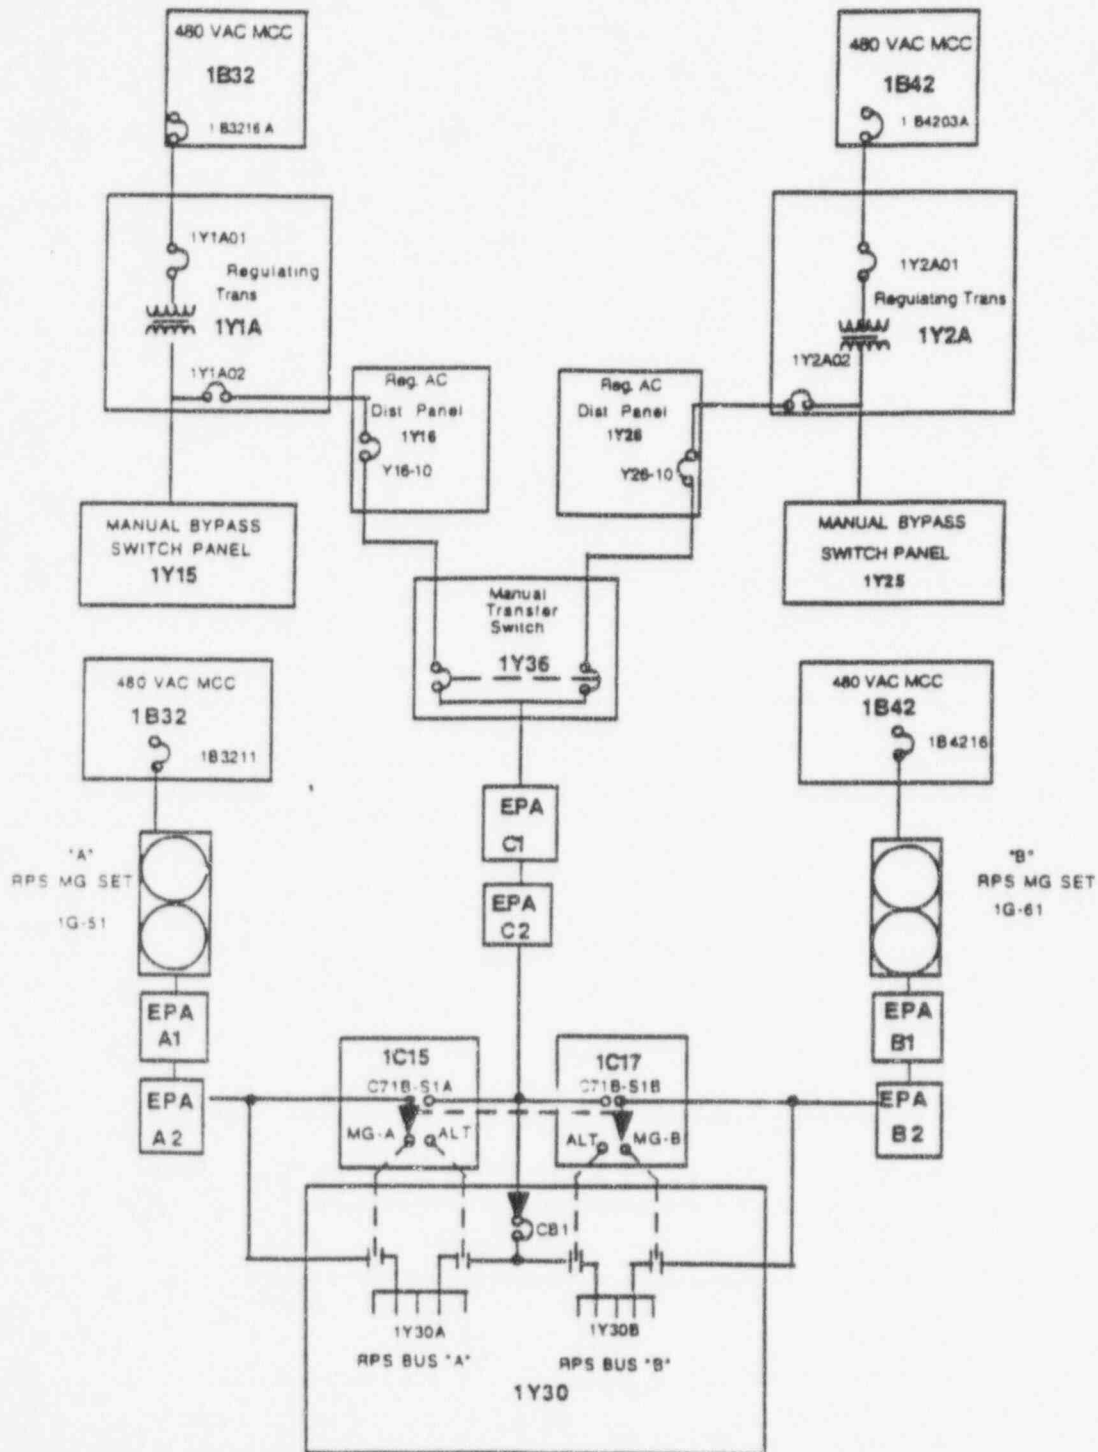
Figure 1

II. CAUSE OF EVENT (See Fig. 1 on Page 4)

The immediate cause of the Groups 2 through 5 PCIS Isolations and the "B" side RPS 1/2 SCRAM was the loss of power to the "B" RPS bus. The loss of power to the bus was caused by EPA breaker EPA-B2 tripping on undervoltage. A conclusive reason for the undervoltage trip was not determined.
