ENGINE REBUILD REPORT

Motor Vessel Columbia

State of Alaska  
Division of Marine Transportation  
Department of Public Works

March 31, 1981

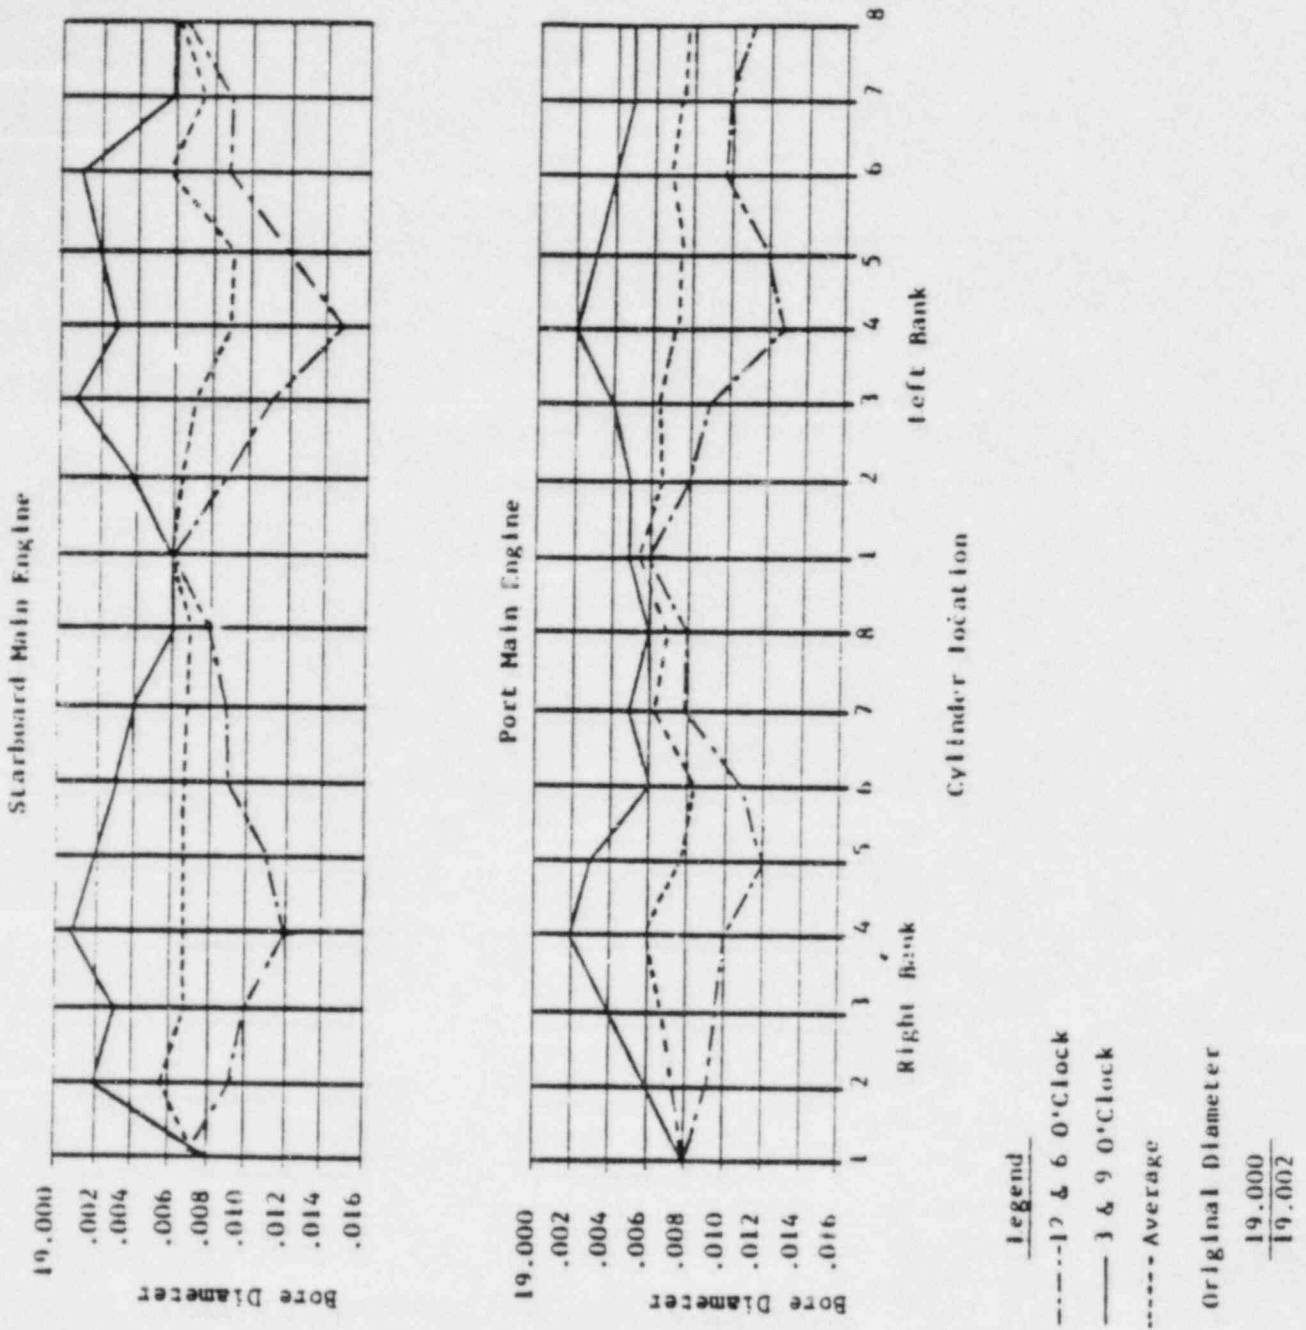
Figure 3. Bore Diameter, Engine Blocks, M/V Columbia, December 19, 1980

Figure 3 data show a gradual increase in all cylinder diameters and a pattern of non-symmetrical change similar for all four blocks. All the bore diameters have grown uniformly between .006 and .007 inch over the lifetime of the engine. This increase indicates an interstitial flow within the metallic structure of the block that has allowed a permanent change in dimensions.

In addition to the uniform increase in all bore diameters, there is a pattern of non-uniform deformation. While the cylinders at the ends of the blocks remain essentially circular the cylinders at the center show a gradual change to a maximum ovalness of .012 to .015 inch. This ovalness is a result of dimensional changes beyond the uniform increase in diameter to which all the cylinders are subject. It indicates that the structural webs between the cylinders are subject to the effects of creep.

Both uniform diameter increase and ovalness have resulted from metallic creep. Because the combined stresses (41,000 psi) are well above design limits for cast iron, metallic failure was expected in the intercylinder web areas and around the cylinder circumferences where the proximity of holes for cooling water and studs produce stress concentrations. Metallic failure was found and is discussed in Section V, Nondestructive Testing. T-4

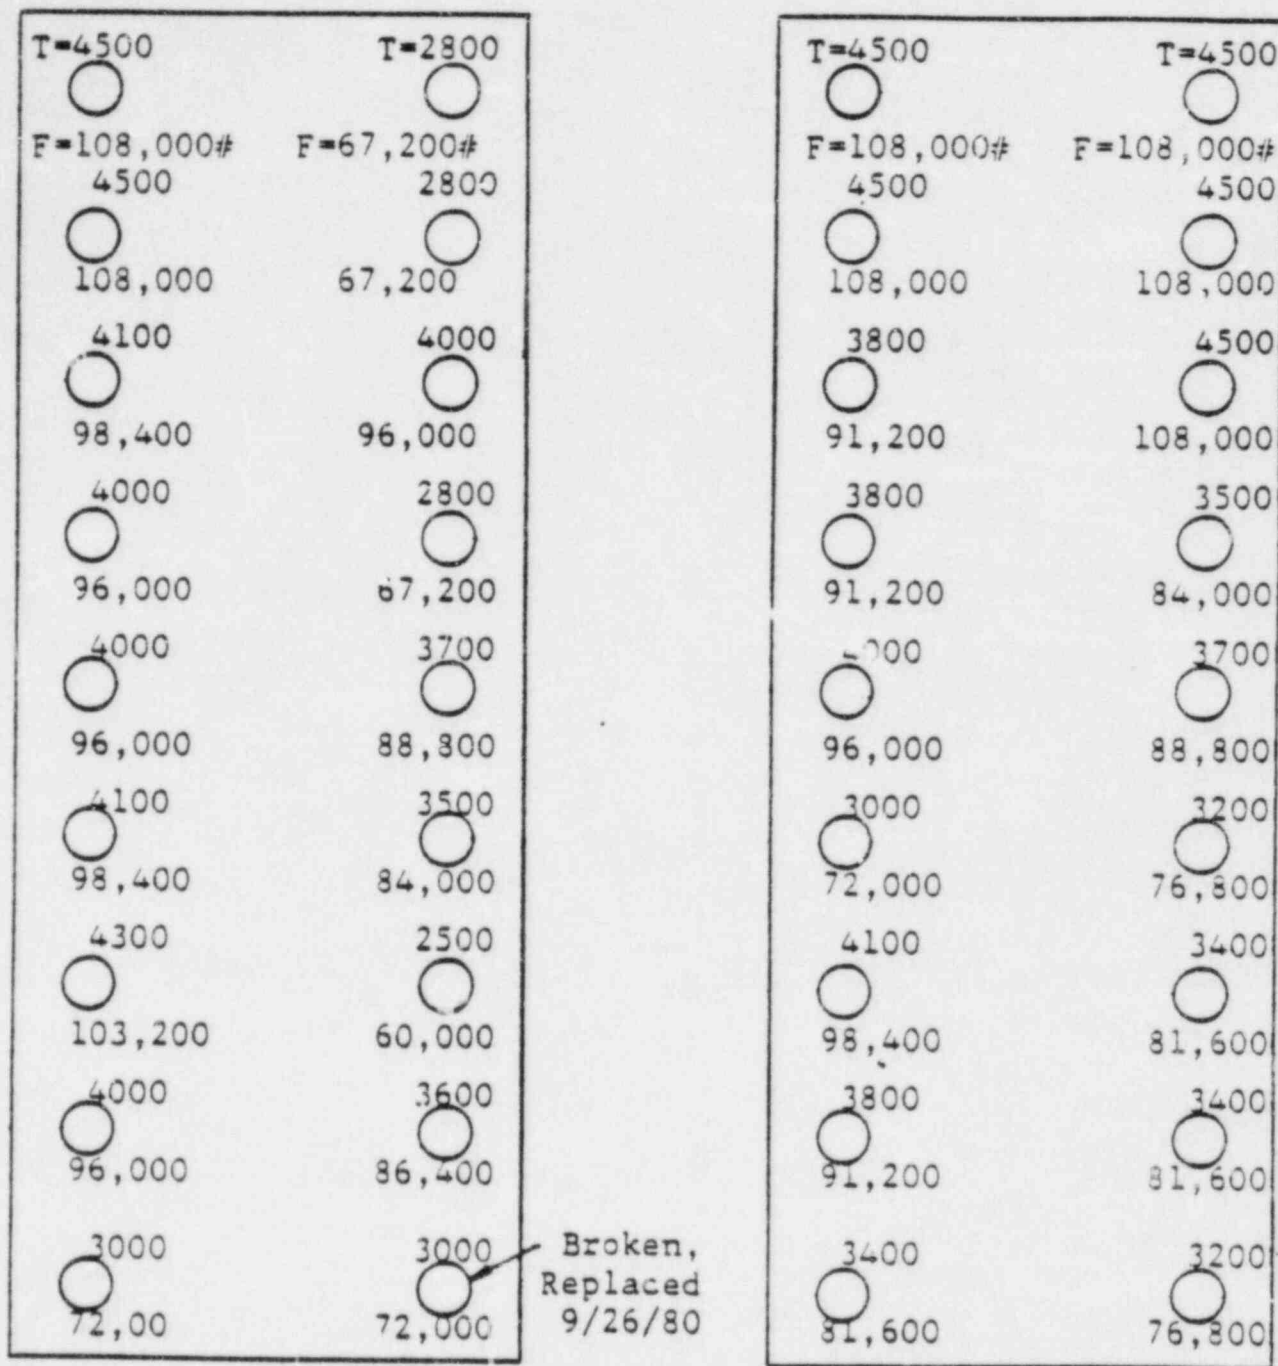
Figure 5. Block to Crankcase Bolts, Starboard Main Engine, December 31, 1980

On September 26, 1980, a bolt broke on the left rear block of the starboard main engine. Temporary repairs were made and the bolt was replaced on return to Seattle. During installation of the new bolt, the torque levels of all block bolts were checked by noting when the nuts moved during a retorquing procedure. The procedure used was to begin at one corner of the block and proceed down one side and back up the other. Figures 5 and 6 (pp. I-13 and I-14) show the recorded break-loose torque levels observed during this procedure and the force levels of preload in the bolts. (3)

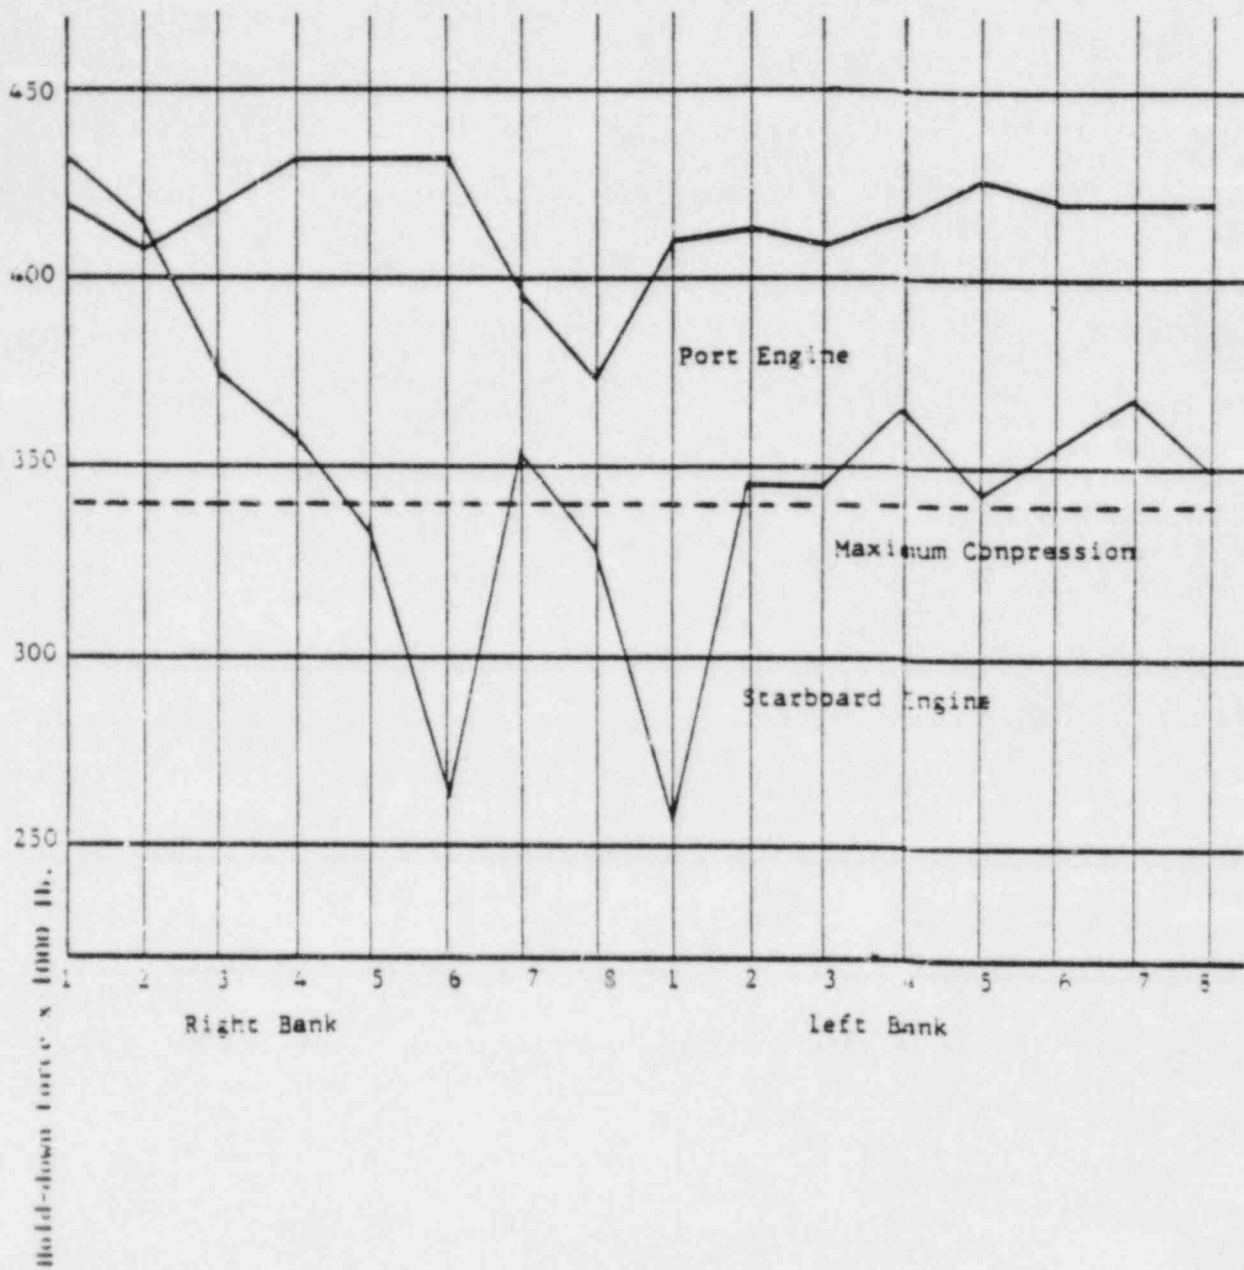
Figure 7. Engine Block to Base Hold-down Force

In Figure 7 (p. I-15), the force from the calculated preload by the four bolts surrounding each cylinder is compared to the maximum force generated by the firing pressure. The question is whether or not, in the partially torqued condition observed, there was sufficient structural integrity in the preload forces to keep the engine properly together. The data show that for several cylinders on the starboard engine, preload force was inadequate, while on the port engine preload force was sufficient but not optimum.

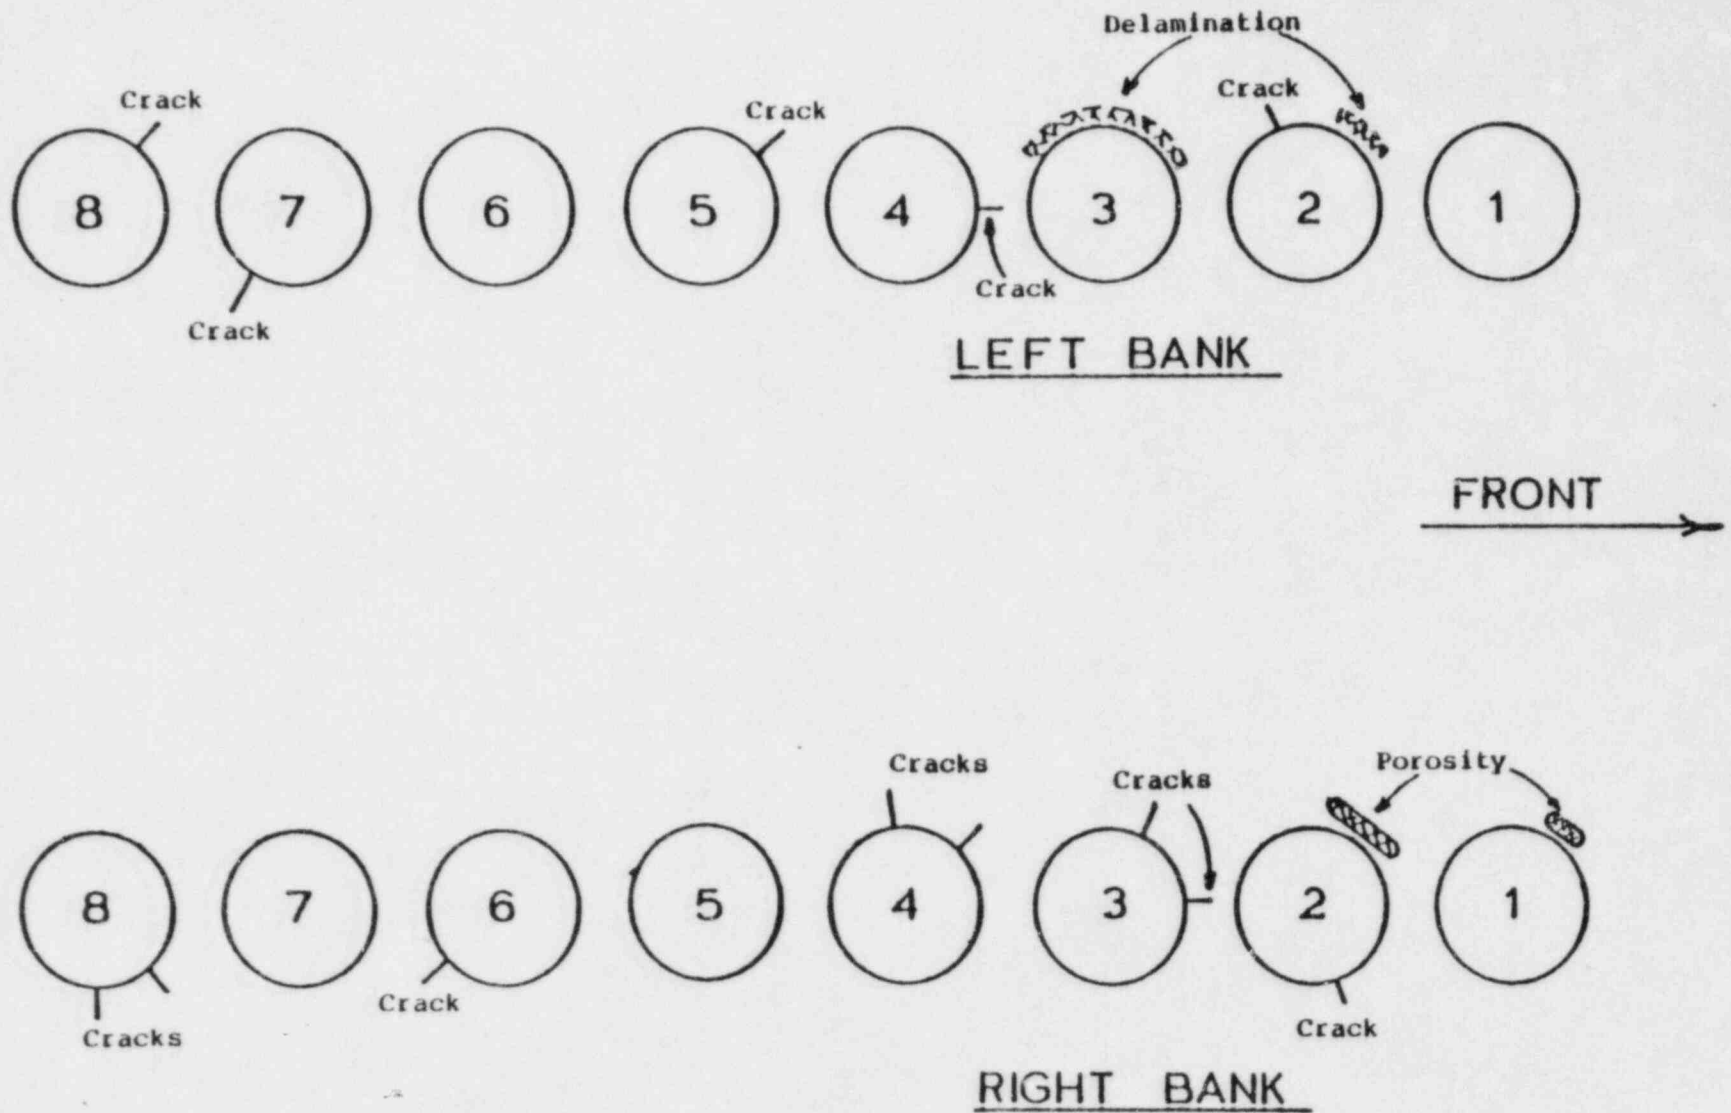
Figure 12. Nondestructive Testing, Starboard Main Engine

The top surface of the blocks for both engines was tested. Data from ultrasound examination of the blocks are presented in Figures 12 and 13 (pp. IV-2 and IV-3) with details in Figures 14 and 15 (pp. IV-4 and IV-5).

Fractures seen most frequently were radial cracks extending out from the cylinder counterbore. The radial cracks were either in areas of stress concentrations caused by holes for cooling water passage or stud drillings, or in the inter-web area between cylinders in the center of the block. The most destructive type of fracture was seen in cylinders 2 and 3 of the left bank of the starboard engine. Figure 14 shows the form of the delamination crack where the cylinder liner lip was separating from the block structure. This fracture prevented the liner from being properly installed and could have led to a catastrophic engine failure.

1. high compressive stresses on the counterbore lip,
2. localized stress condition from the combinations of sharp internal corner for lip (1/32 inch radius),
3. nearby drilling for waterjacket or stud,
4. termination of stud threading at the same level,
5. creep deformation, and
6. fatigue.

Because of the delamination cracks, one block was not serviceable, and so both blocks for the starboard engine were renewed.

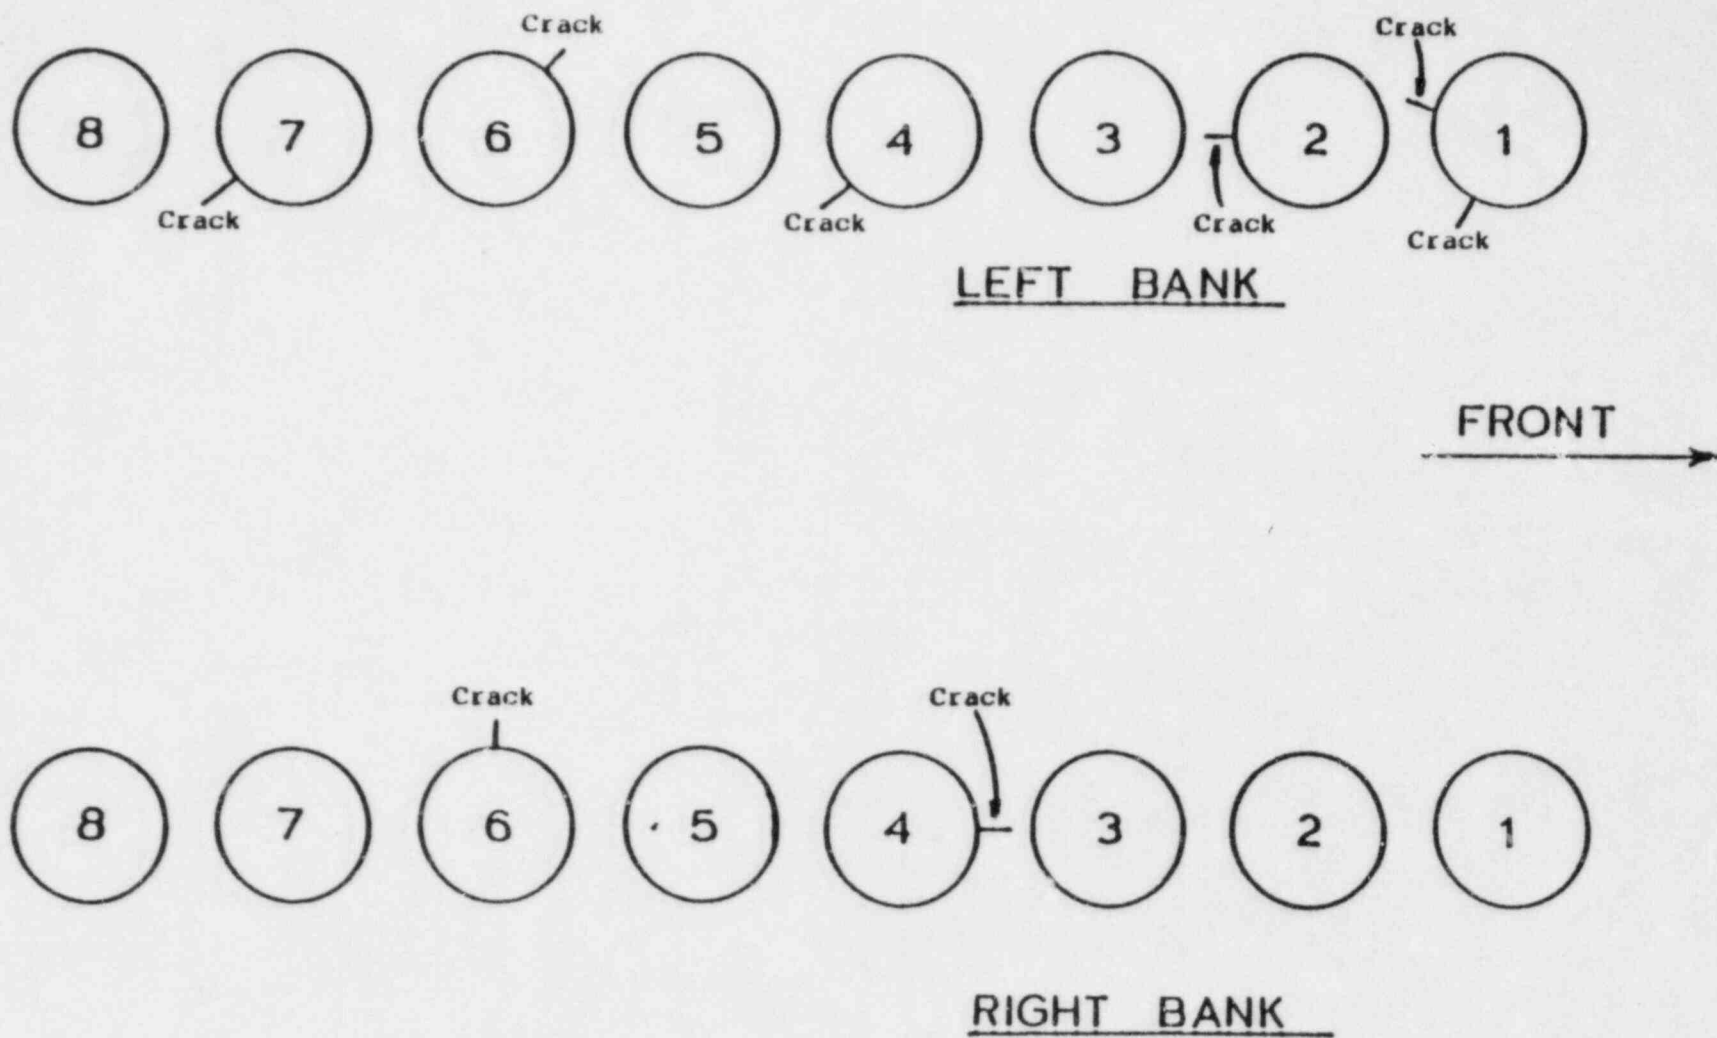
Figure 13. Nondestructive Testing, Port Main Engine

The port engine, although showing radial cracks, did not have the delamination failure seen in the starboard engine. The port engine was renovated by boring the block to a larger diameter and resurfacing the counterbore lip to a consistent depth for all cylinders. When the first cuts were made on the counterbore lip, the exposed surface showed shear fractures extending downward in the counterbore lip. Specific ultrasound probes for curved surfaces confirmed the shear fractures in cylinder 3 of the port engine. Cylinder 14 also had a shear fracture at the counterbore lip.

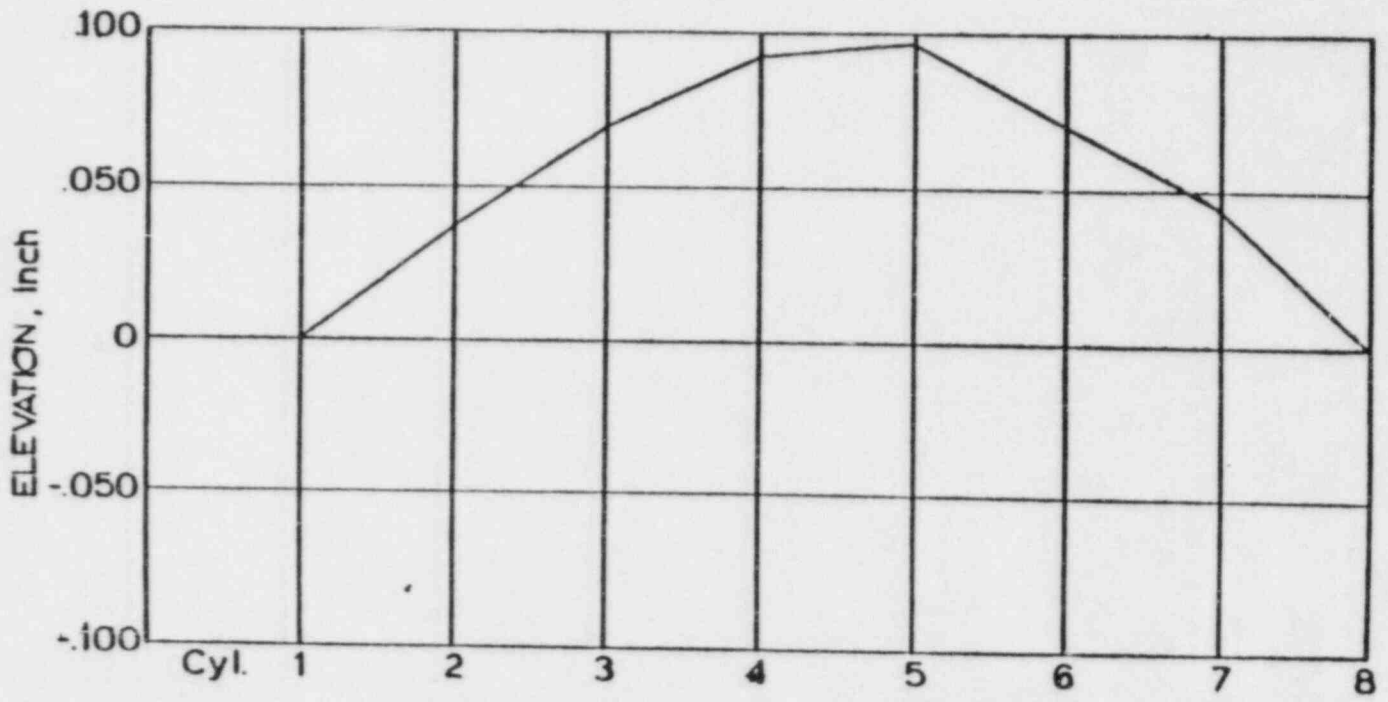
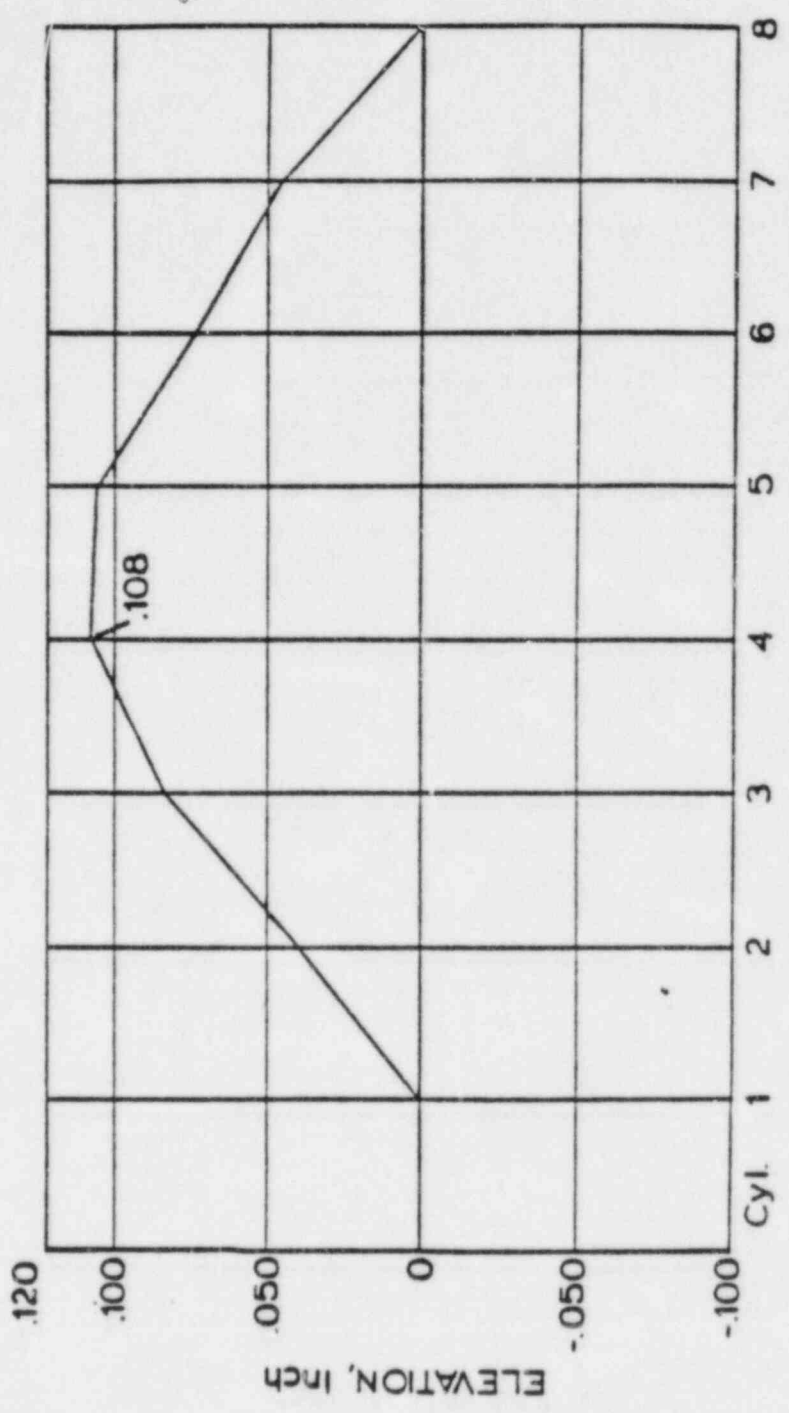
The elevations are shown in Figures 18 and 19 (pp. V-4 and V-5). The surface elevation shows the block surface was bowed upward and twisted in the center. Cylinder 4 rose .108 inch and twisted .018 inch downward in the center. Cylinder 5 showed values nearly identical to those of cylinder 4. Cylinders on either side of the center taper to a uniform elevation at each end. All curves

return to zero at the ends because the measurements were taken using the ends as reference points. This bowing upward was a concern in the rebuilding. Upward bowing was removed in the preliminary alignment procedure and it must be remembered for future maintenance procedures.

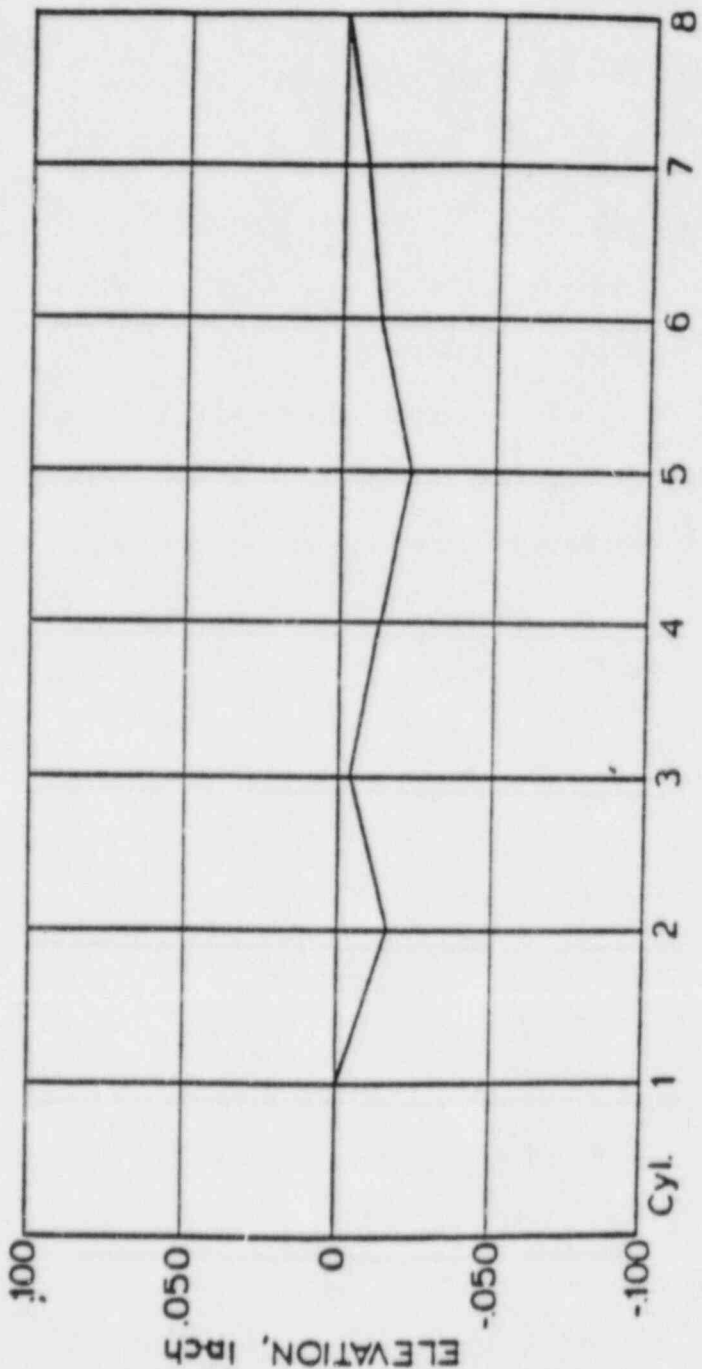
The left bank drops in the center and is similar to the right bank for the rear half of the engine. See Figures 22 and 23 (pp. V-8 and V-9). The front half of the engine is significantly different from the front half of the right bank. It warped severely where the surface had some s-twists. Severe delamination of the counterbore lip occurred in this region. The combination of metal failure, loosened tie rods, and warped surfaces may be interrelated.

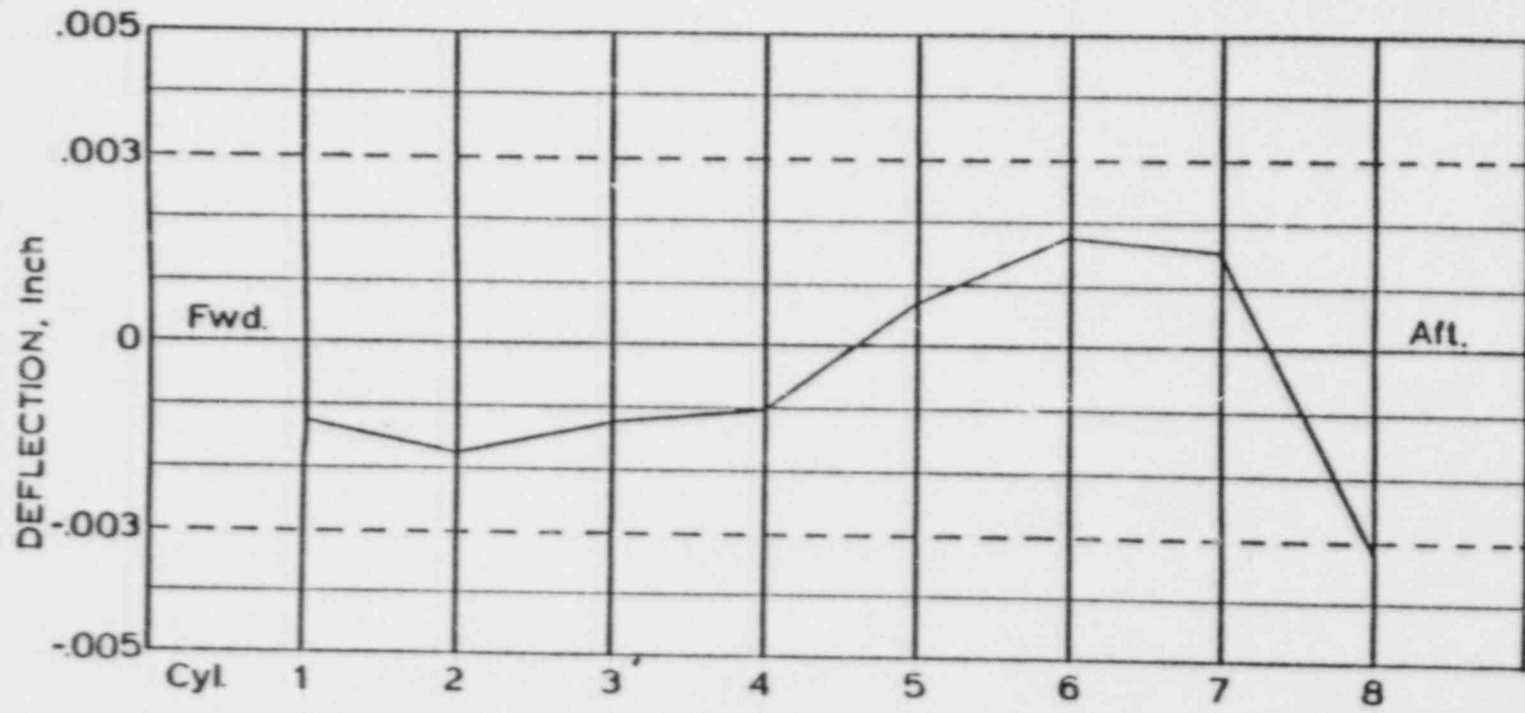
Figure 25. Crank Deflection of the Port Main Engine, Hot

Figure 25 shows historical data when the engine was hot and Figure 26 during rebuilding when the engine was cold. Deflection tolerance of .003 inch is allowed. The forward end of the engine, although changing sign (+ or -), is within acceptable limits. The aft end of the engine, however, is outside acceptable limits in both hot and cold conditions. Figure 27 shows the comparison between hot and cold. The front end of the engine is within acceptable limits. At the rear, both readings are similar and thermal changes do not alter the out-of-tolerance readings. Cold readings at the rear of the engine accurately represent hot reading for operating conditions.

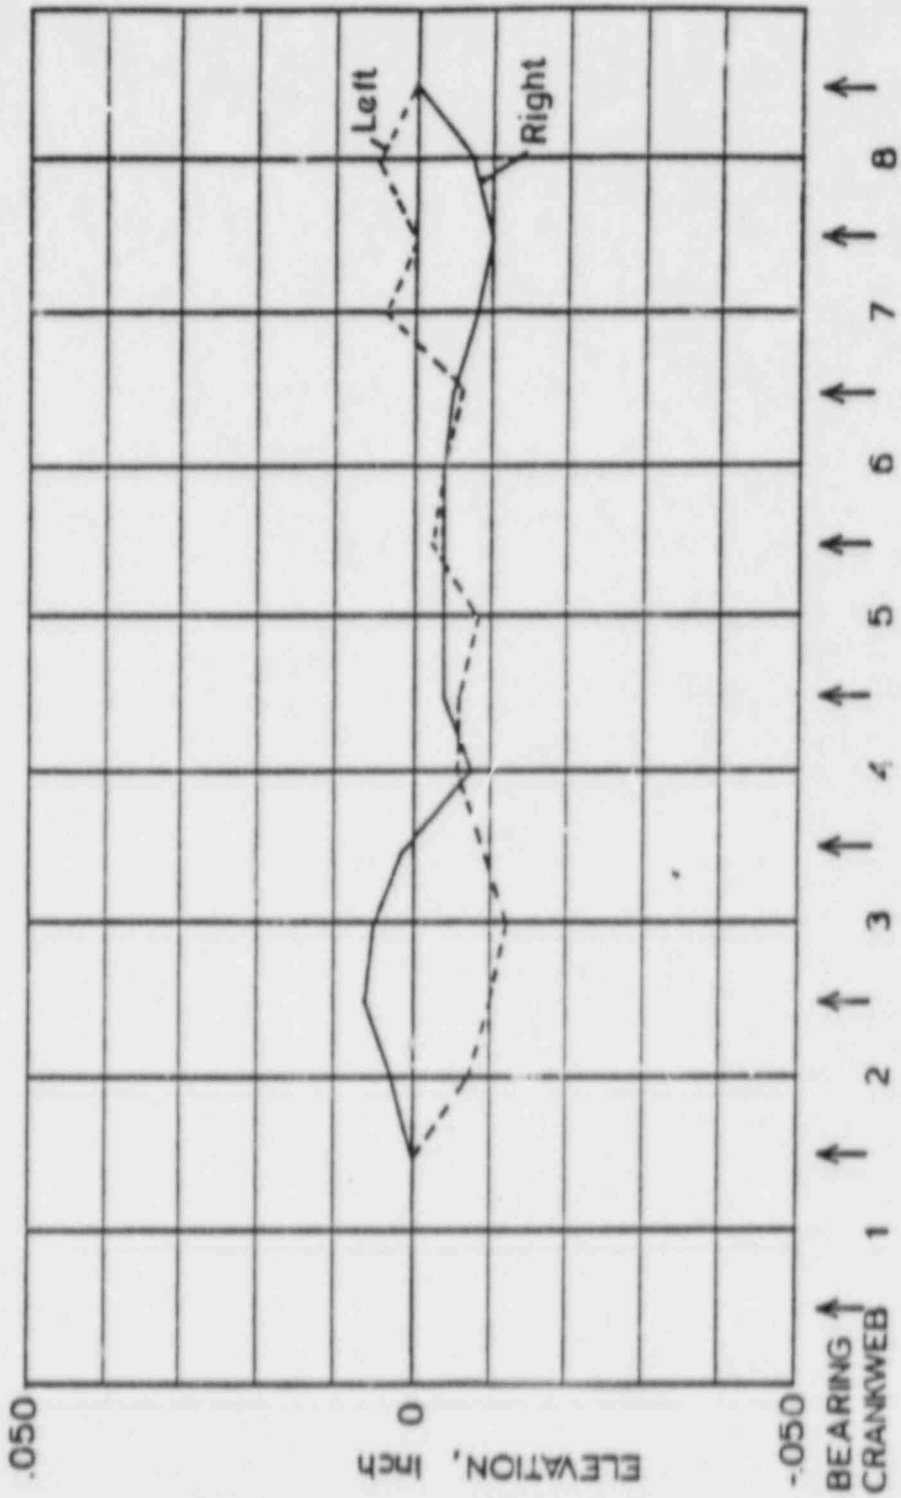
Figure 28. Elevation of Cylinder Blocks for Port Main Engine After Relaxing and Retorquing All Structural Bolts

Figure 28 (p. V-16) shows the optical sighting of the port main engine blocks after relaxing and properly retorquing all the base and block bolts. Both block surfaces have a maximum of .010 inch of deflection and the previous bowing, sagging and warping had been removed.

A major portion of the misalignment was due to inaccurate prestress within the engines resulting from a relaxation of torque in the nuts and an improper retorquing procedure during repair operations. The critical effect of proper torque on all structural bolts mandates that proper torque be maintained in the future.

The preliminary report (Appendix) recommended properly retorquing the block bolts of the engines during rebuilding. While the engines were accessible, the base bolts were checked for proper torque and were found to be below acceptable limits. All structural bolts in the port engine were relaxed and retorqued according to the procedure recommended by the Enterprise Company. Retorquing was done in a proper criss-cross pattern from the center outward in three graduated steps of increasing torque. The surfaces of the blocks were checked again.
