Fermi 2
6400 North Dixie Hwy
Newport, Michigan 48166
(313) 586-5249

October 2, 1995
NRC-95-0105

Subject: Revision to Request for Discretionary Enforcement

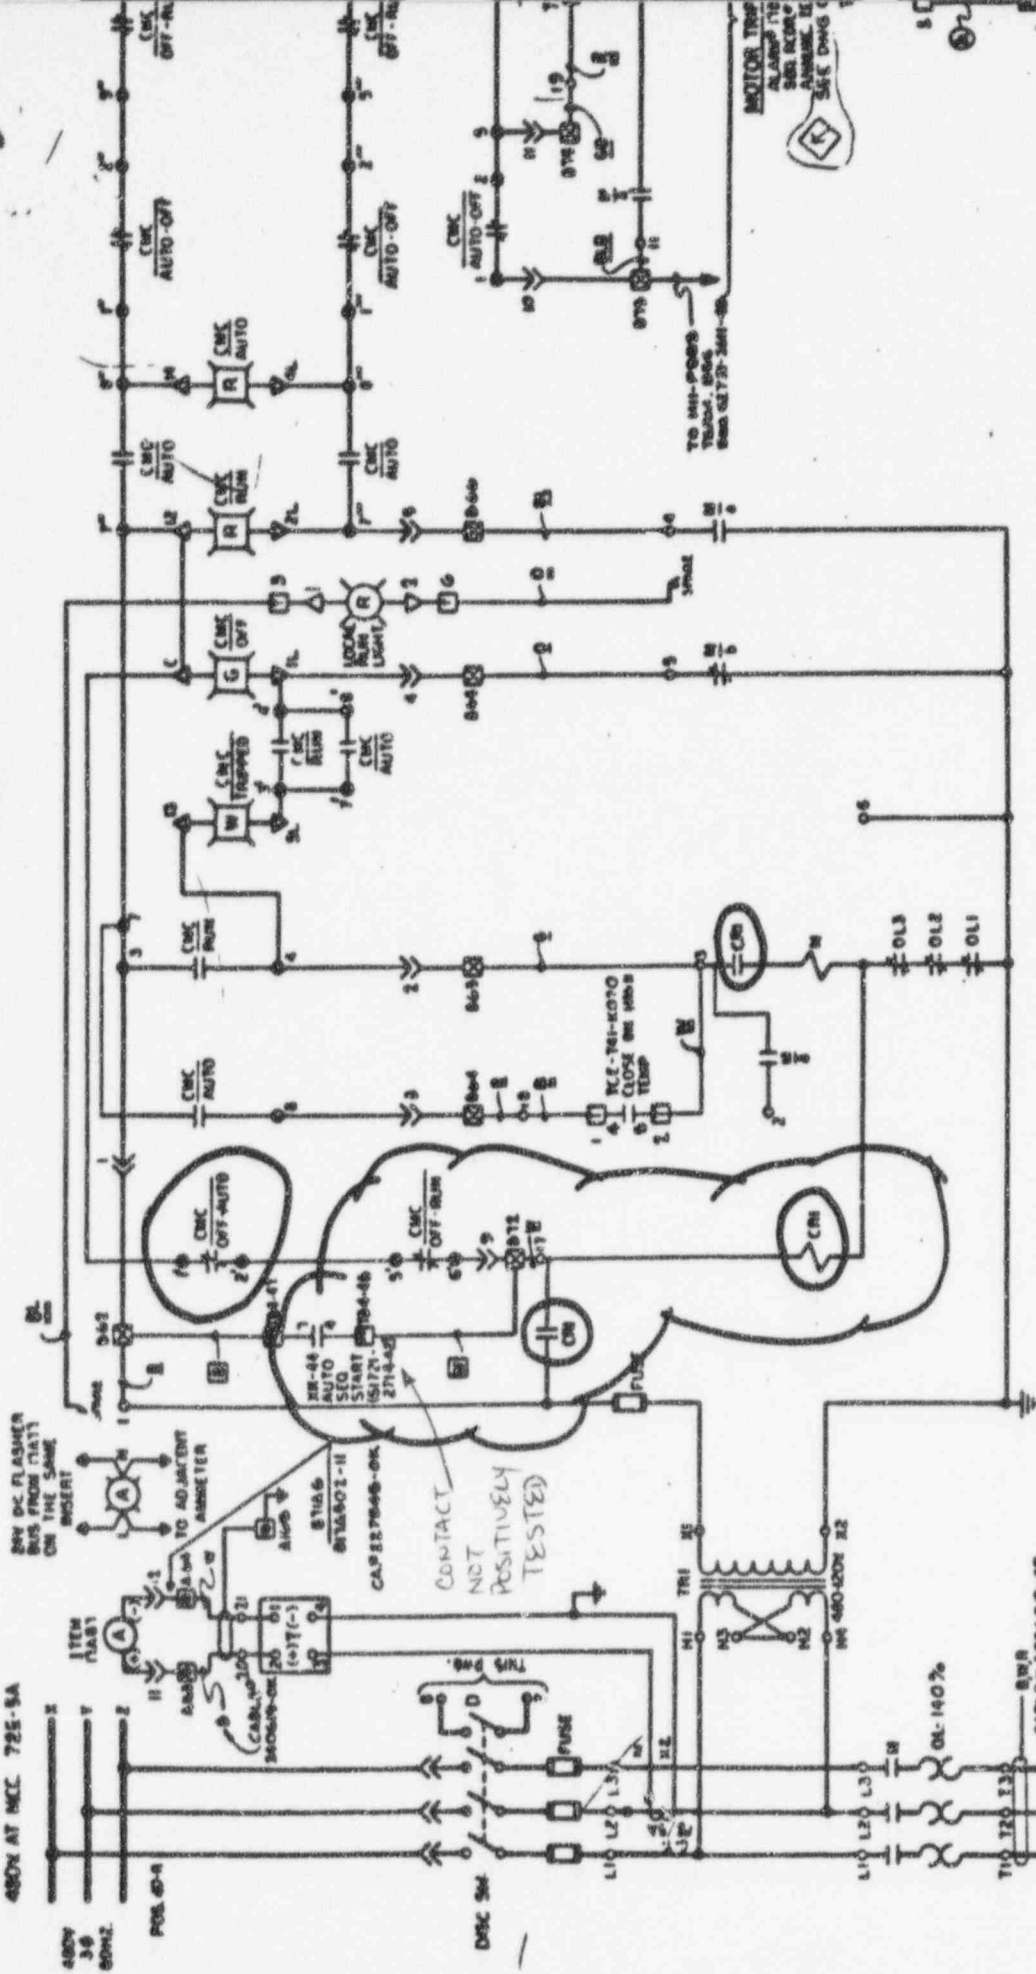
480V LOAD SEQUENCER (TYPICAL)

verification that the auto-connected loads are running on the 480-volt emergency busses after the diesels automatically start. However, this testing does not verify that the automatic digital load sequencer system sequencing relays are responsible for actually closing the associated loads. There are parallel control switch contacts and control relay contacts that could provide for immediate connection of the loads to the 480-volt emergency bus after diesel generator starting without a closure signal from the load sequencer system. The sequence of surveillance testing establishes the conditions to open these parallel contacts, but does not include positive verification that the parallel contacts are actually open. Refer to the attached sketch for a sample schematic representation.

For the inadequately tested load sequencer contacts, any hypothetical failure of the subject contacts could have gone undetected during the surveillance testing only if a parallel contact in the associated CMC control switch or control relay contact had failed closed. If this had occurred, the associated load would still function as needed because the logic would be completed via the failed closed parallel contact(s) and the 480-volt emergency bus loads would load onto the bus when the diesel breaker closes. In addition, since the surveillance testing did verify that the diesels were able to respond adequately to the connection of all loads,
