NOTICE OF VIOLATION

Georgia Power Company
Hatch Nuclear Plant

Docket Nos. 50-321 and 50-366
License Nos. DPR-57 and NPF-7
EA 95-167

LPCI INJECTION VALVE ISSUES

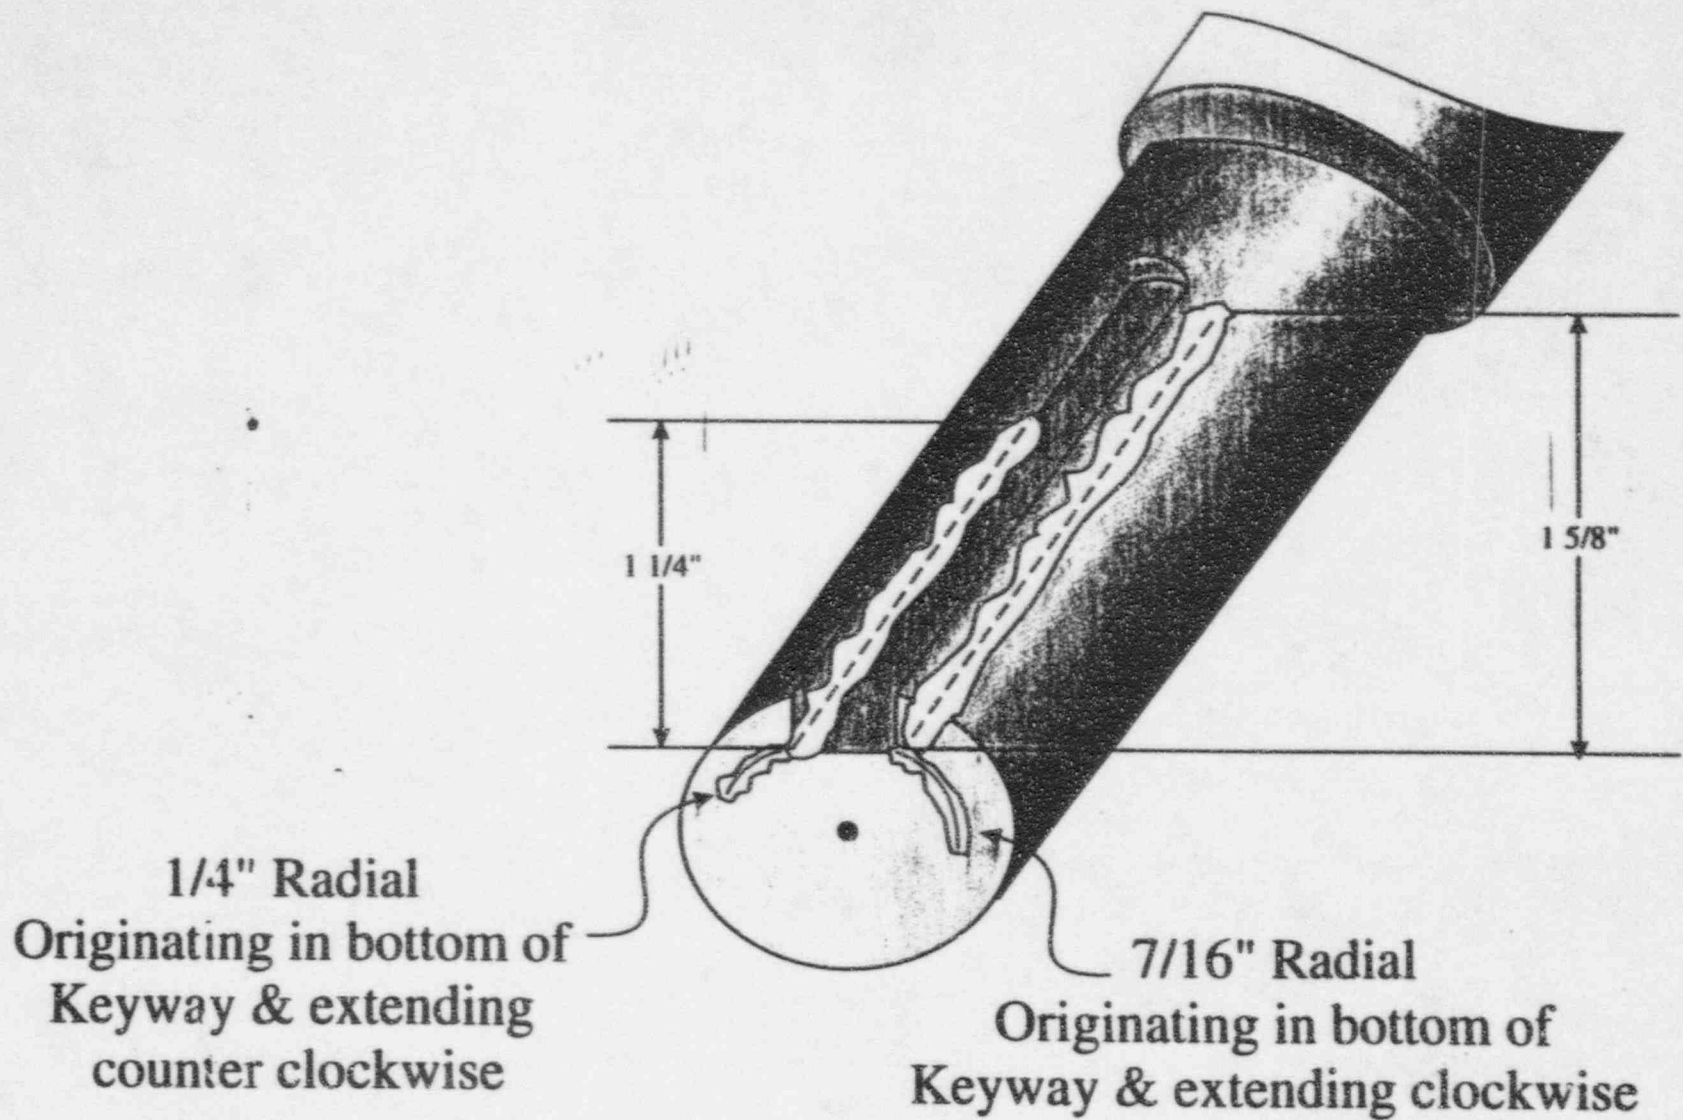
<u>VALVE</u>	<u>INSPECTION/ANALYSIS RESULTS</u>
1E11-F015A	Motor pinion key was sheared. No cracks in shaft. Key was made of 1018 steel.
1E11-F015B	Motor shaft was broken at the keyway. Shaft had cracks emanating from <u>both edges</u> of the keyway as a result of fatigue. Final failure was result of torsional overload. Shaft material was 1144 carbon steel. Key material was 4140.
2E11-F015A	Shaft was cracked. Key was half way out of keyway, had a small crack, and was 4140.
2E11-F015B	Shaft from motor which failed on 5/19/95 was cracked. Had been in service ~9 years with a 4140 key, 1144 shaft .

Cracked Shaft (2E11-F015B)

- **Inspect other motor shafts for cracking during upcoming refueling outages.**
- **Continue to pursue solutions to motor shaft cracking with industry experts.**
- **If warranted, advise BWROG and others of potential generic nature of shaft cracking issue.**

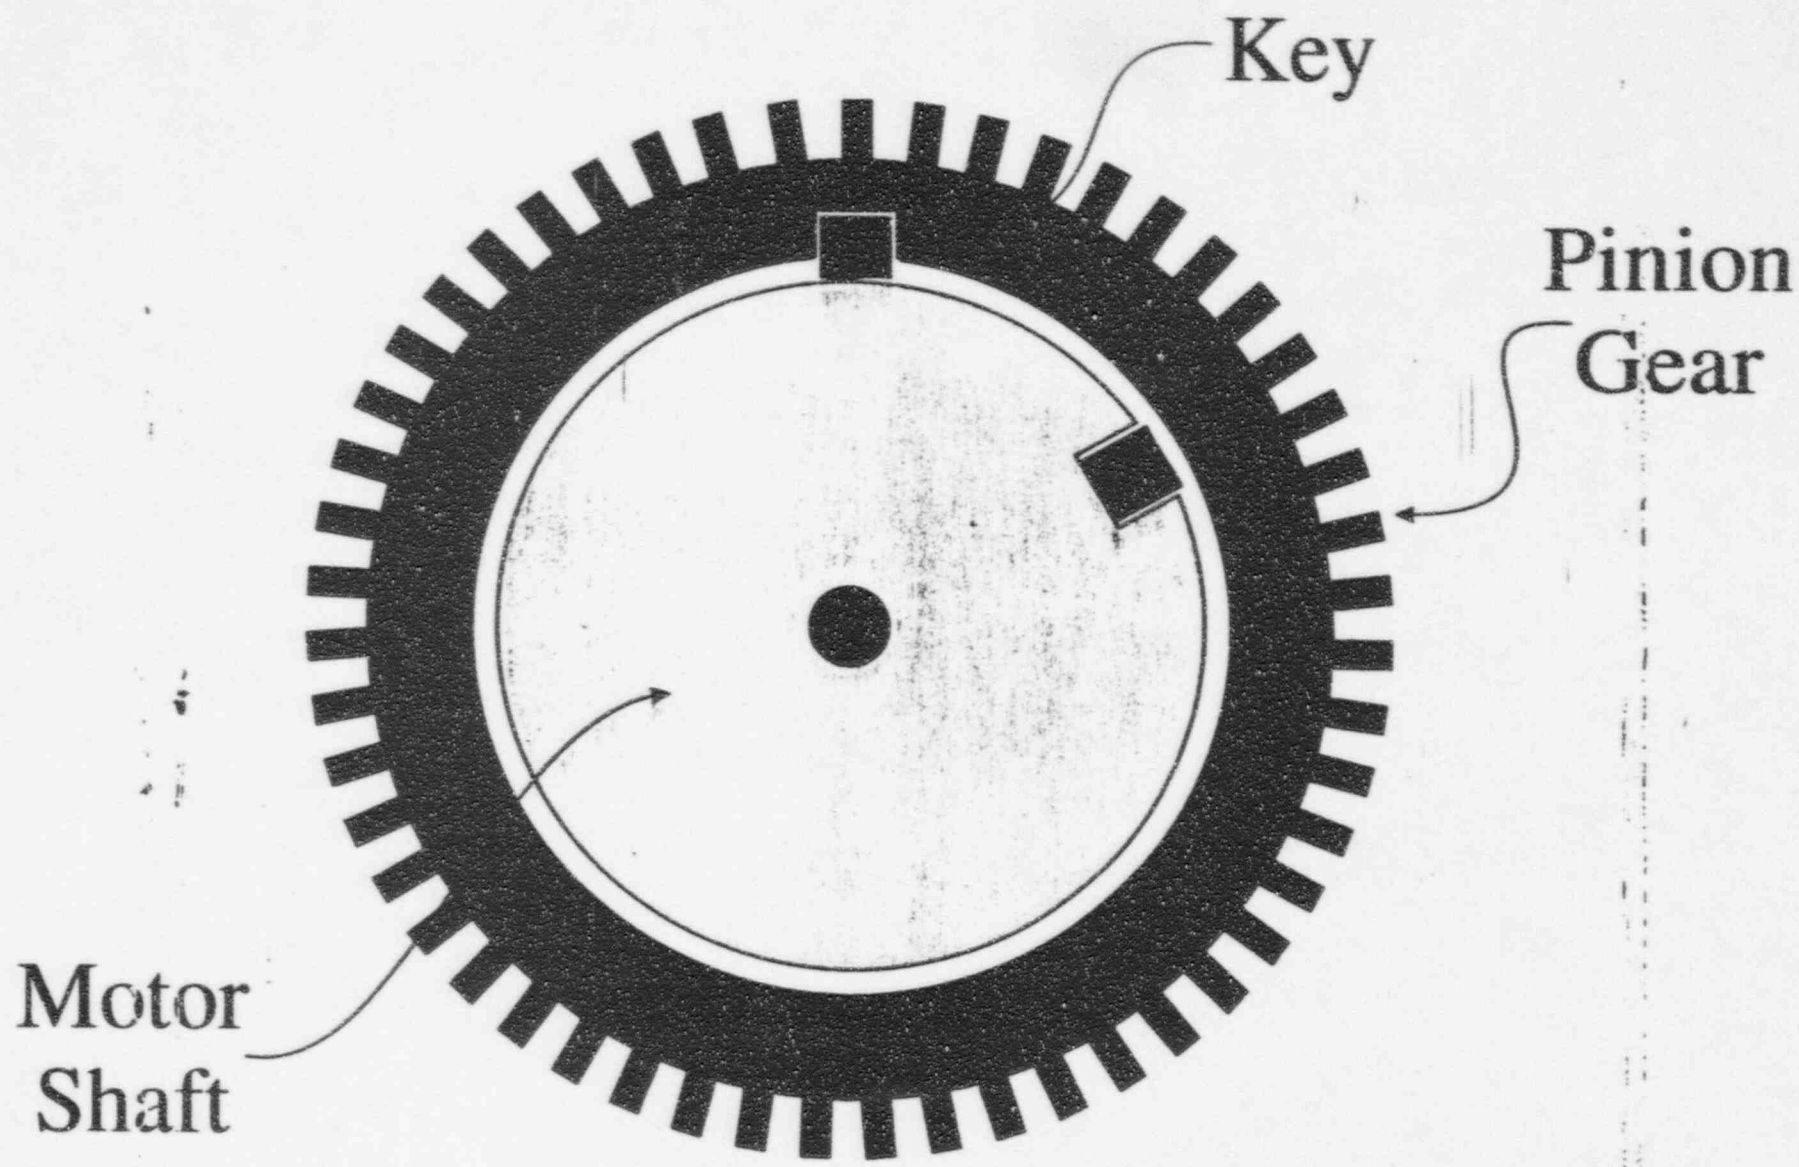
Sheared Key (1E11-F015A)
