Carolina Power & Light Company

BRUNSWICK STEAM ELECTRIC PLANT UNIT 1 AND 2
DOCKET NO. 50-325 AND 50-324
LICENSE NO. DRP-71 AND DIR-62
LICENSEE EVENT REPORT 1-92-012
AND
NOTIFICATION OF A 10CFR21 REPORTABLE OCCURRENCE

TITLE (4) **EMERGENCY DIESEL GENERATOR BUILDING INTERNAL WALL SEISMIC SUPPORT BOLTING WAS DEFECTIVELY INSTALLED DURING PLANT CONSTRUCTION**

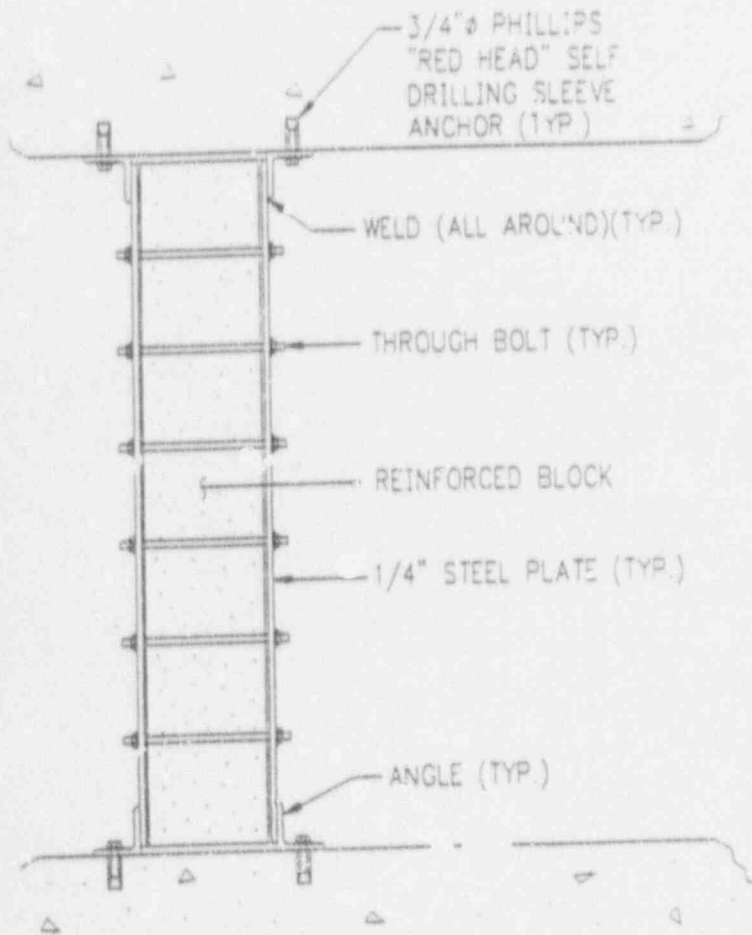
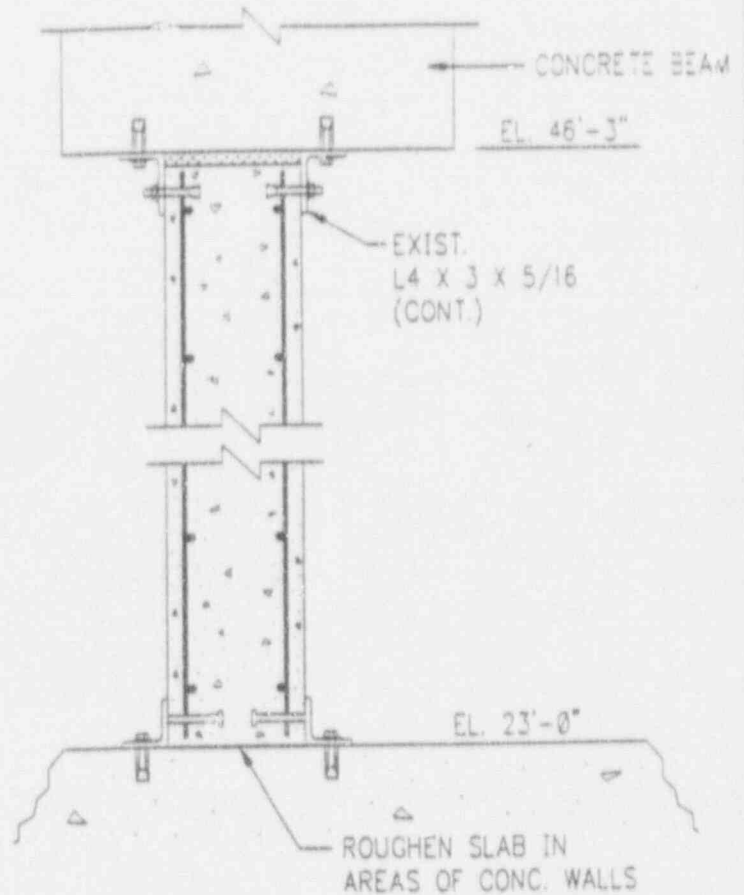
ATTACHMENT 1

On April 4, 1992, with Unit 1 at 100% and Unit 2 at 78% reactor power, an inspection of the Emergency Diesel Generator (EDG) Building masonry block walls found a substantial number of anchor bolts for the walls' seismic supports had not been installed per plant drawings (see Attachment 1 for a bolting detail sample). A preliminary evaluation determined that this condition did not make the walls inoperable. The scope of the inspections was expanded due to these findings.

- Bolt bodies cut off and welded either to inside or outside of angle supports with no hole drilled in concrete.
- Complete bolts installed, but welded to inside of angle supports with no anchor sleeves in concrete holes.
- Anchor bolts installed in angle supports and sleeves, but sleeves rotated in the holes.
- Bolt bodies cut and set in a partial holes with no sleeves, tack welded to angle supports.
- Washer plates welded on one or both sides of the wall with no through-wall bolts installed in between.
- Bolt holes with no bolts installed.

The significant number of anchor bolts that had been improperly installed during initial building construction on the interior masonry block wall invalidated the seismic integrity of the wall. The seismic integrity of the wall was restored on April 12, 1992.

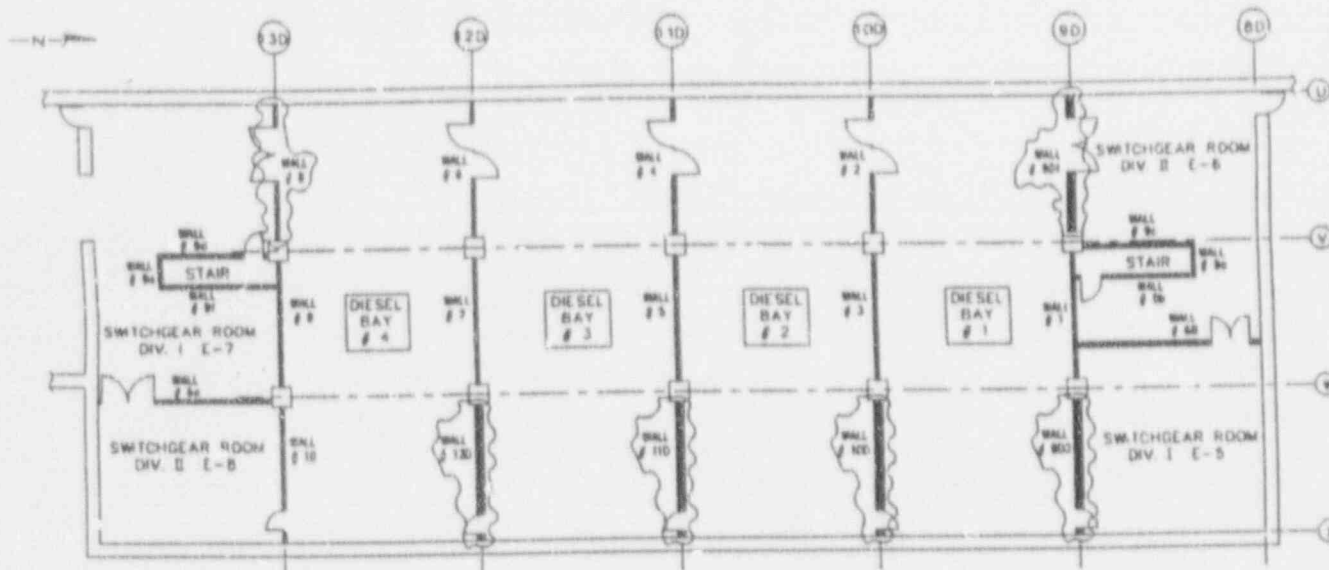
ATTACHMENT 2

On April 7, 1992, the condition of the anchor bolting of the masonry block wall (see attachment 2) between EDG #4 and its associated 480 volt Emergency Bus (E8) resulted in EDG #4 being declared inoperable.
