Northern States Power Company

Prairie Island Nuclear Generating Plant  
Docket No. 50-282, License No. DPR-42  
Docket No. 50-306, License No. DPR-60

In response to IE Bulletin 84-03, the following is offered.

RESPONSE TO I.E. BULLETIN 84-03

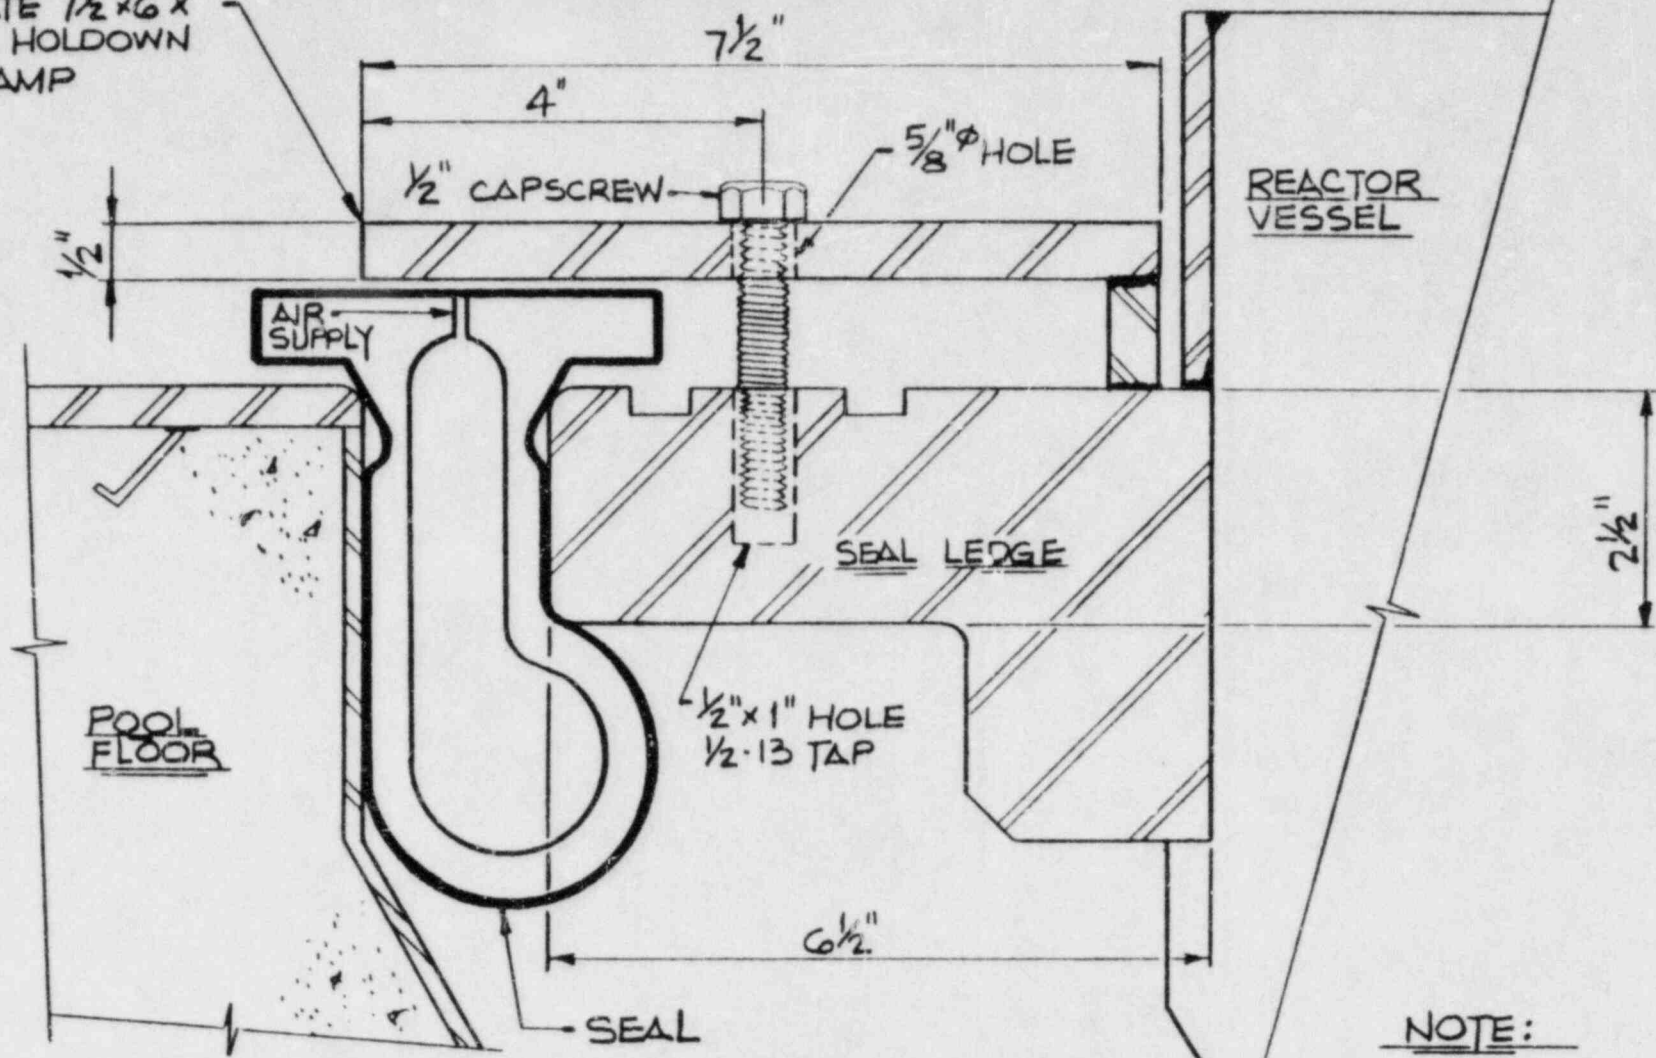
Figure for attachment to NSP Prairie Island response to IE Bulletin 84-03

The gap between the reactor vessel flange and the refueling cavity floor is 2 inches. The gap is bridged by a single inflatable seal. See Figure attached. Testing has shown that the seal is leaktight whether inflated or deflated. Failure of an active component will not cause significant leakage from the cavity.

Since the Prairie Island seal is a passive component, we could not postulate a credible failure that would result in fuel clad damage. In order to address the items in the Bulletin, however, an event which we consider extremely unlikely was postulated. The seal is covered with holddown plates before flooding the cavity. We postulated one holddown plate was removed and the seal under the plate torn away, opening the 2-inch gap between the adjacent holddown plates. Conservative calculations give an initial leakage rate of about 4200 gal/min.

In conclusion, the evaluation showed there is no active failure which could cause significant leakage from the refueling cavity. The leakage that was postulated here is extremely unlikely and small enough that operator action can easily place the fuel assembly where it will remain covered.
