<b>Nuclear</b> <b>TECHNICAL DATA REPORT</b>	TDR NO. <u>580</u>	REVISION NO. <u>1</u>
	BUDGET ACTIVITY NO. <u>323357</u>	PAGE <u>1</u> OF <u>110</u>
PROJECT: <u>Oyster Creek Nuclear Generating Station</u>	DEPARTMENT/SECTION <u>E&amp;D</u>	
RELEASE DATE <u>9-17-84</u> REVISION DATE <u>9-11-84</u>

DOCUMENT TITLE: Isolation Condenser System Piping Cracked Welds - Repair and Failure Analysis

**TITLE** Isolation condenser system cracked welds-repair and failure analysis

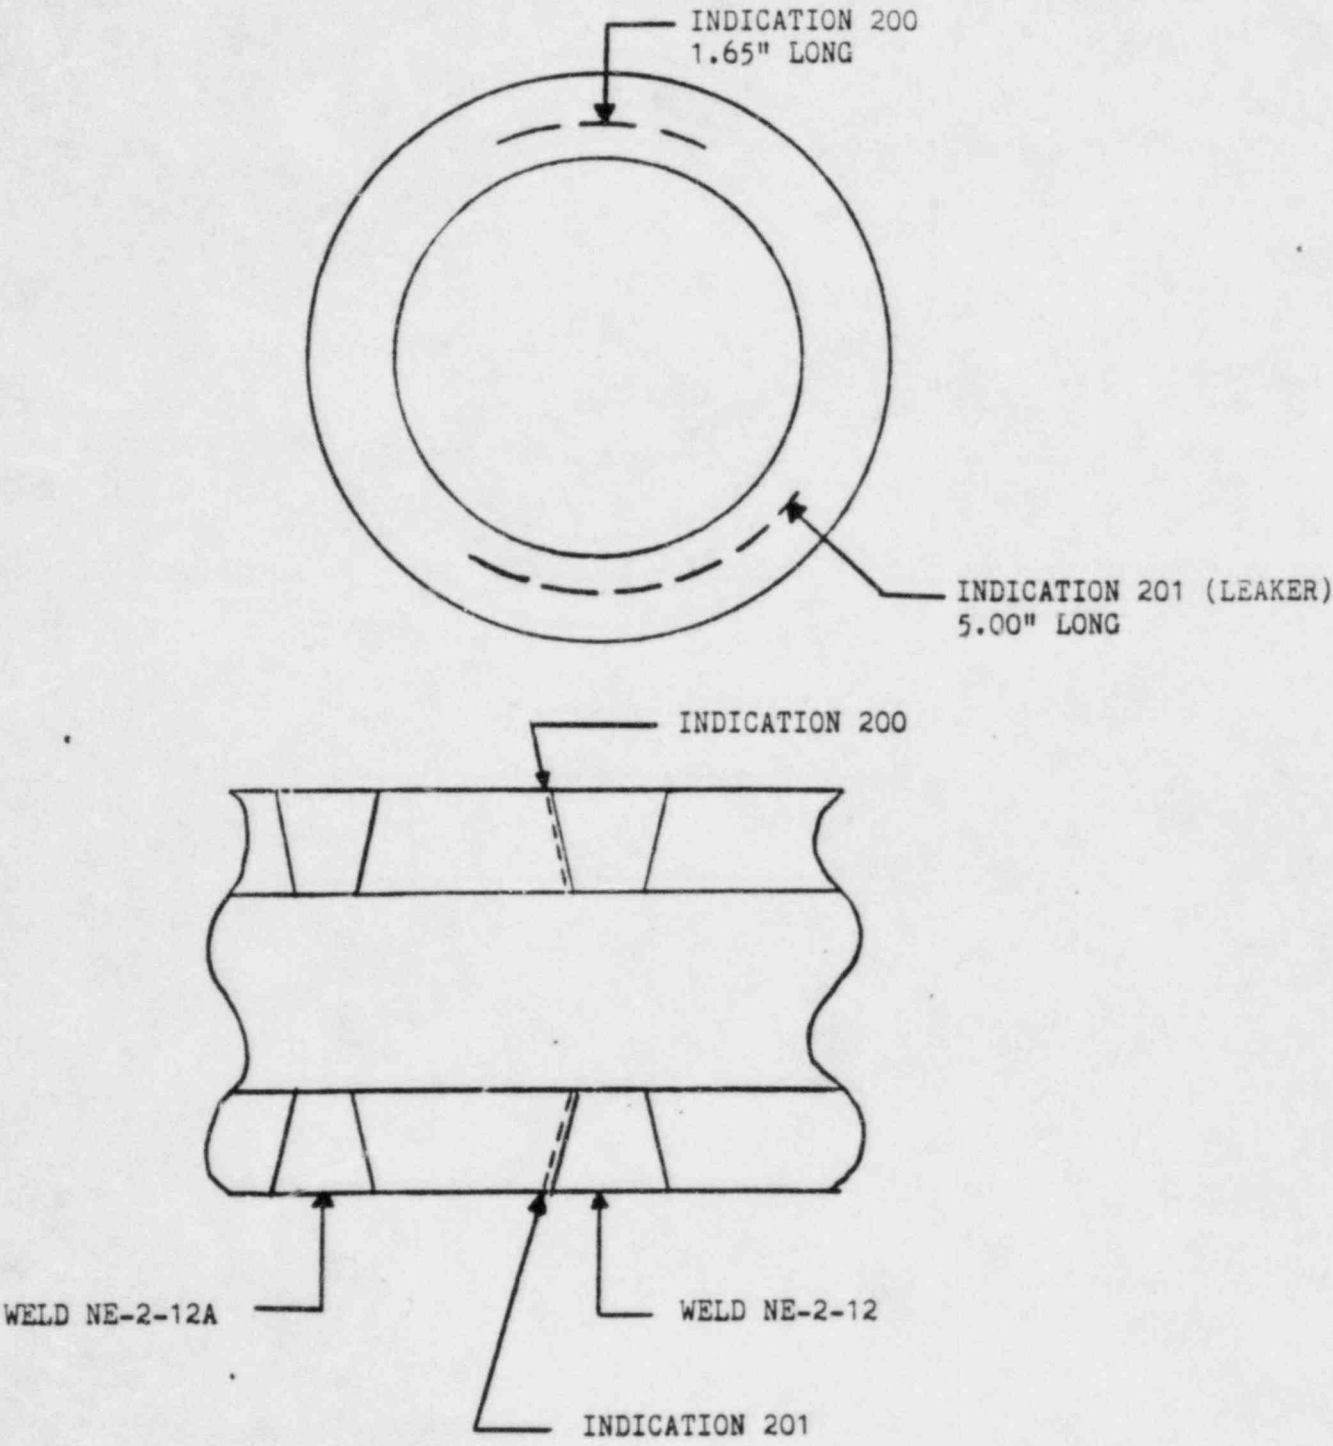
Weld NE-2-12 (the leaker) contained one through-wall crack and one crack-like indication (Figure 1).

FIGURE 1- Defects in Weld NE-2-12

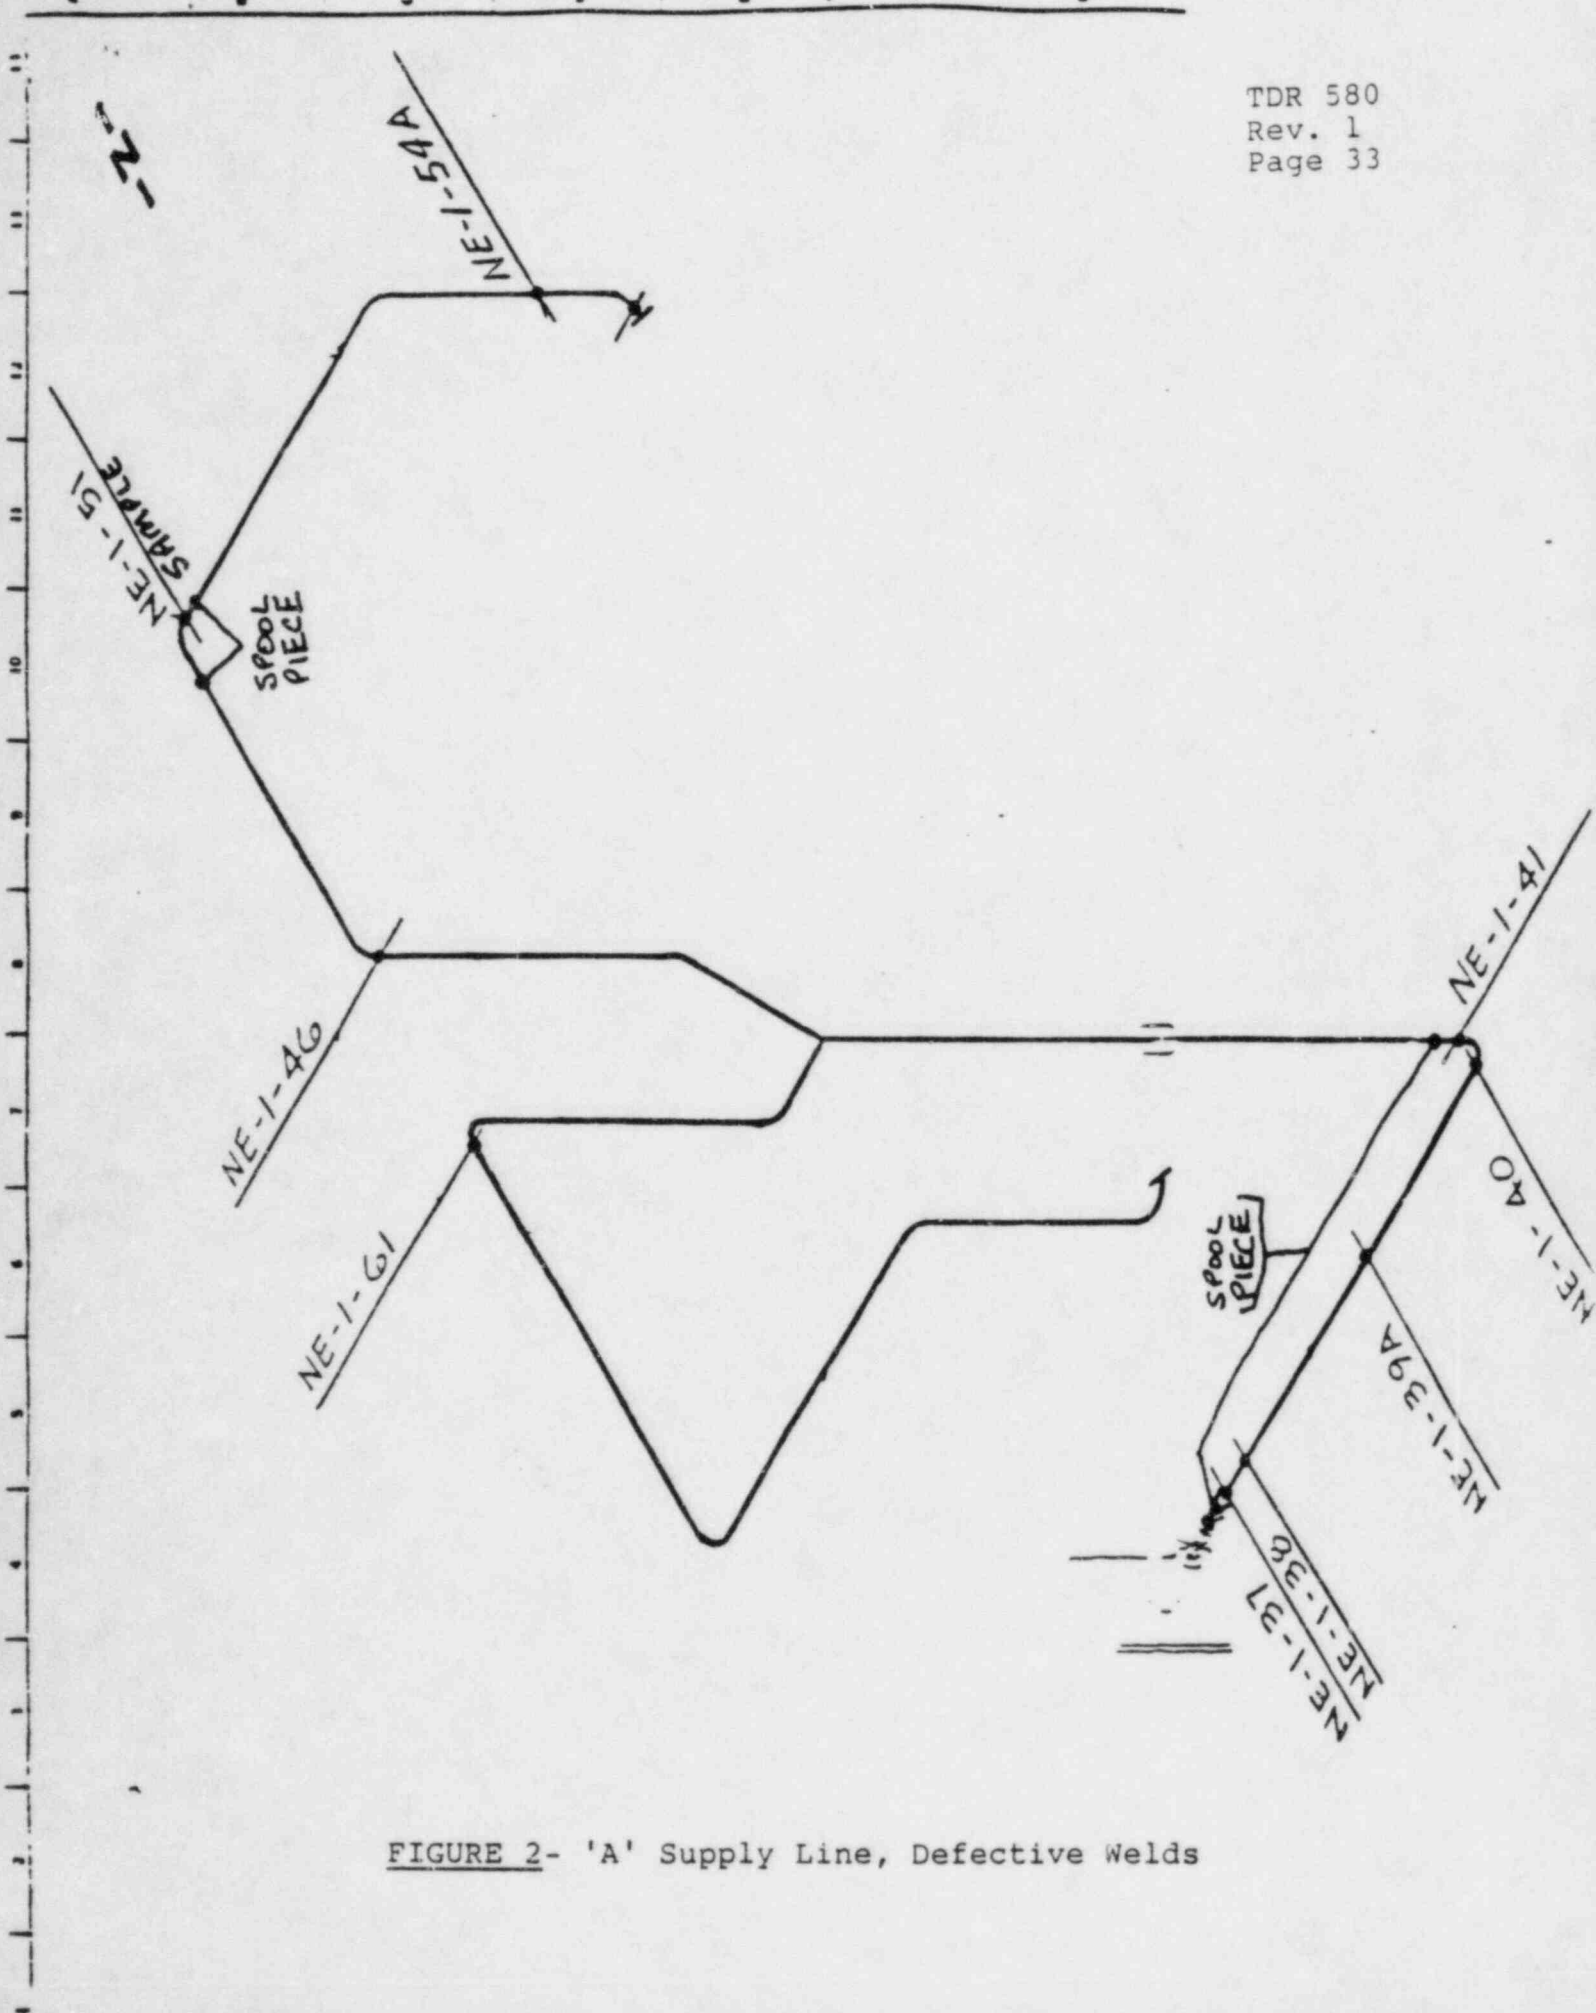
FIGURE 2- 'A' Supply Line, Defective Welds

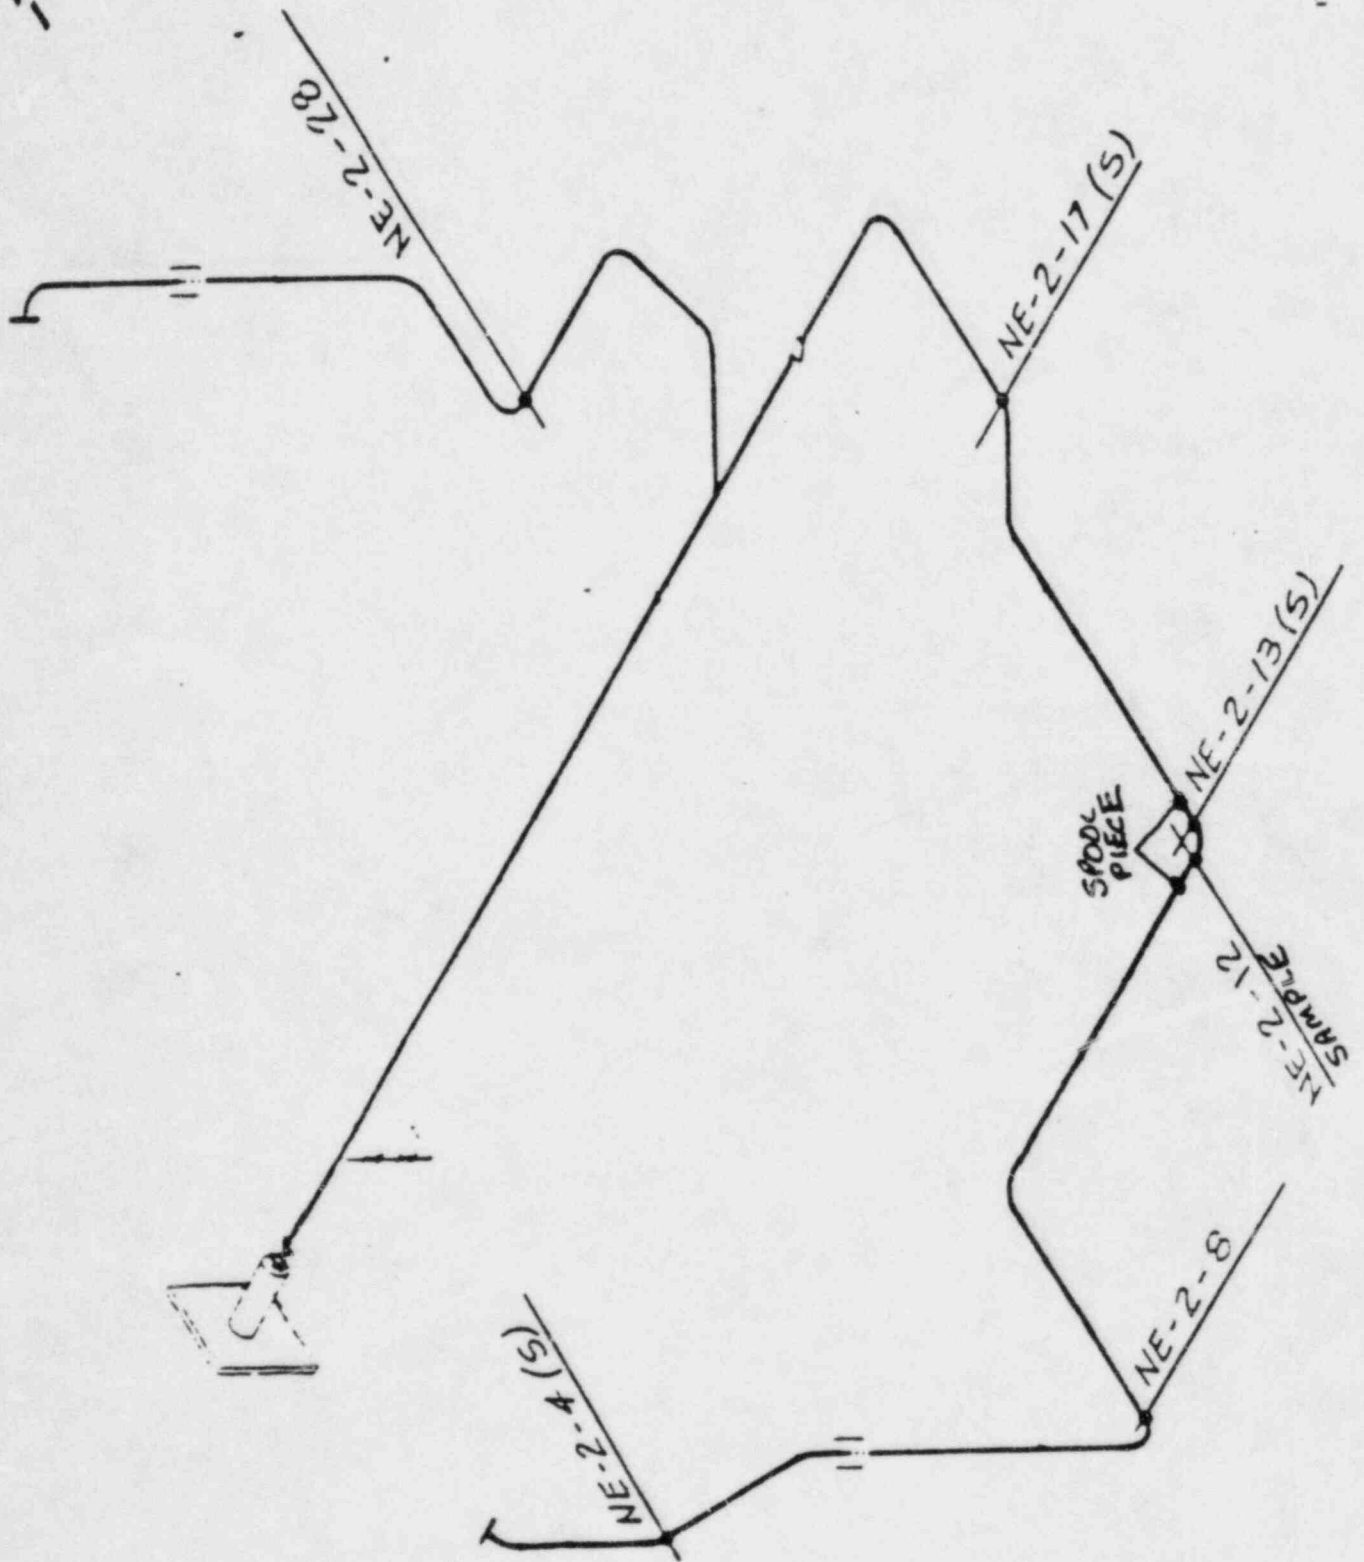
FIGURE 3- 'A' Return Line, Defective Welds

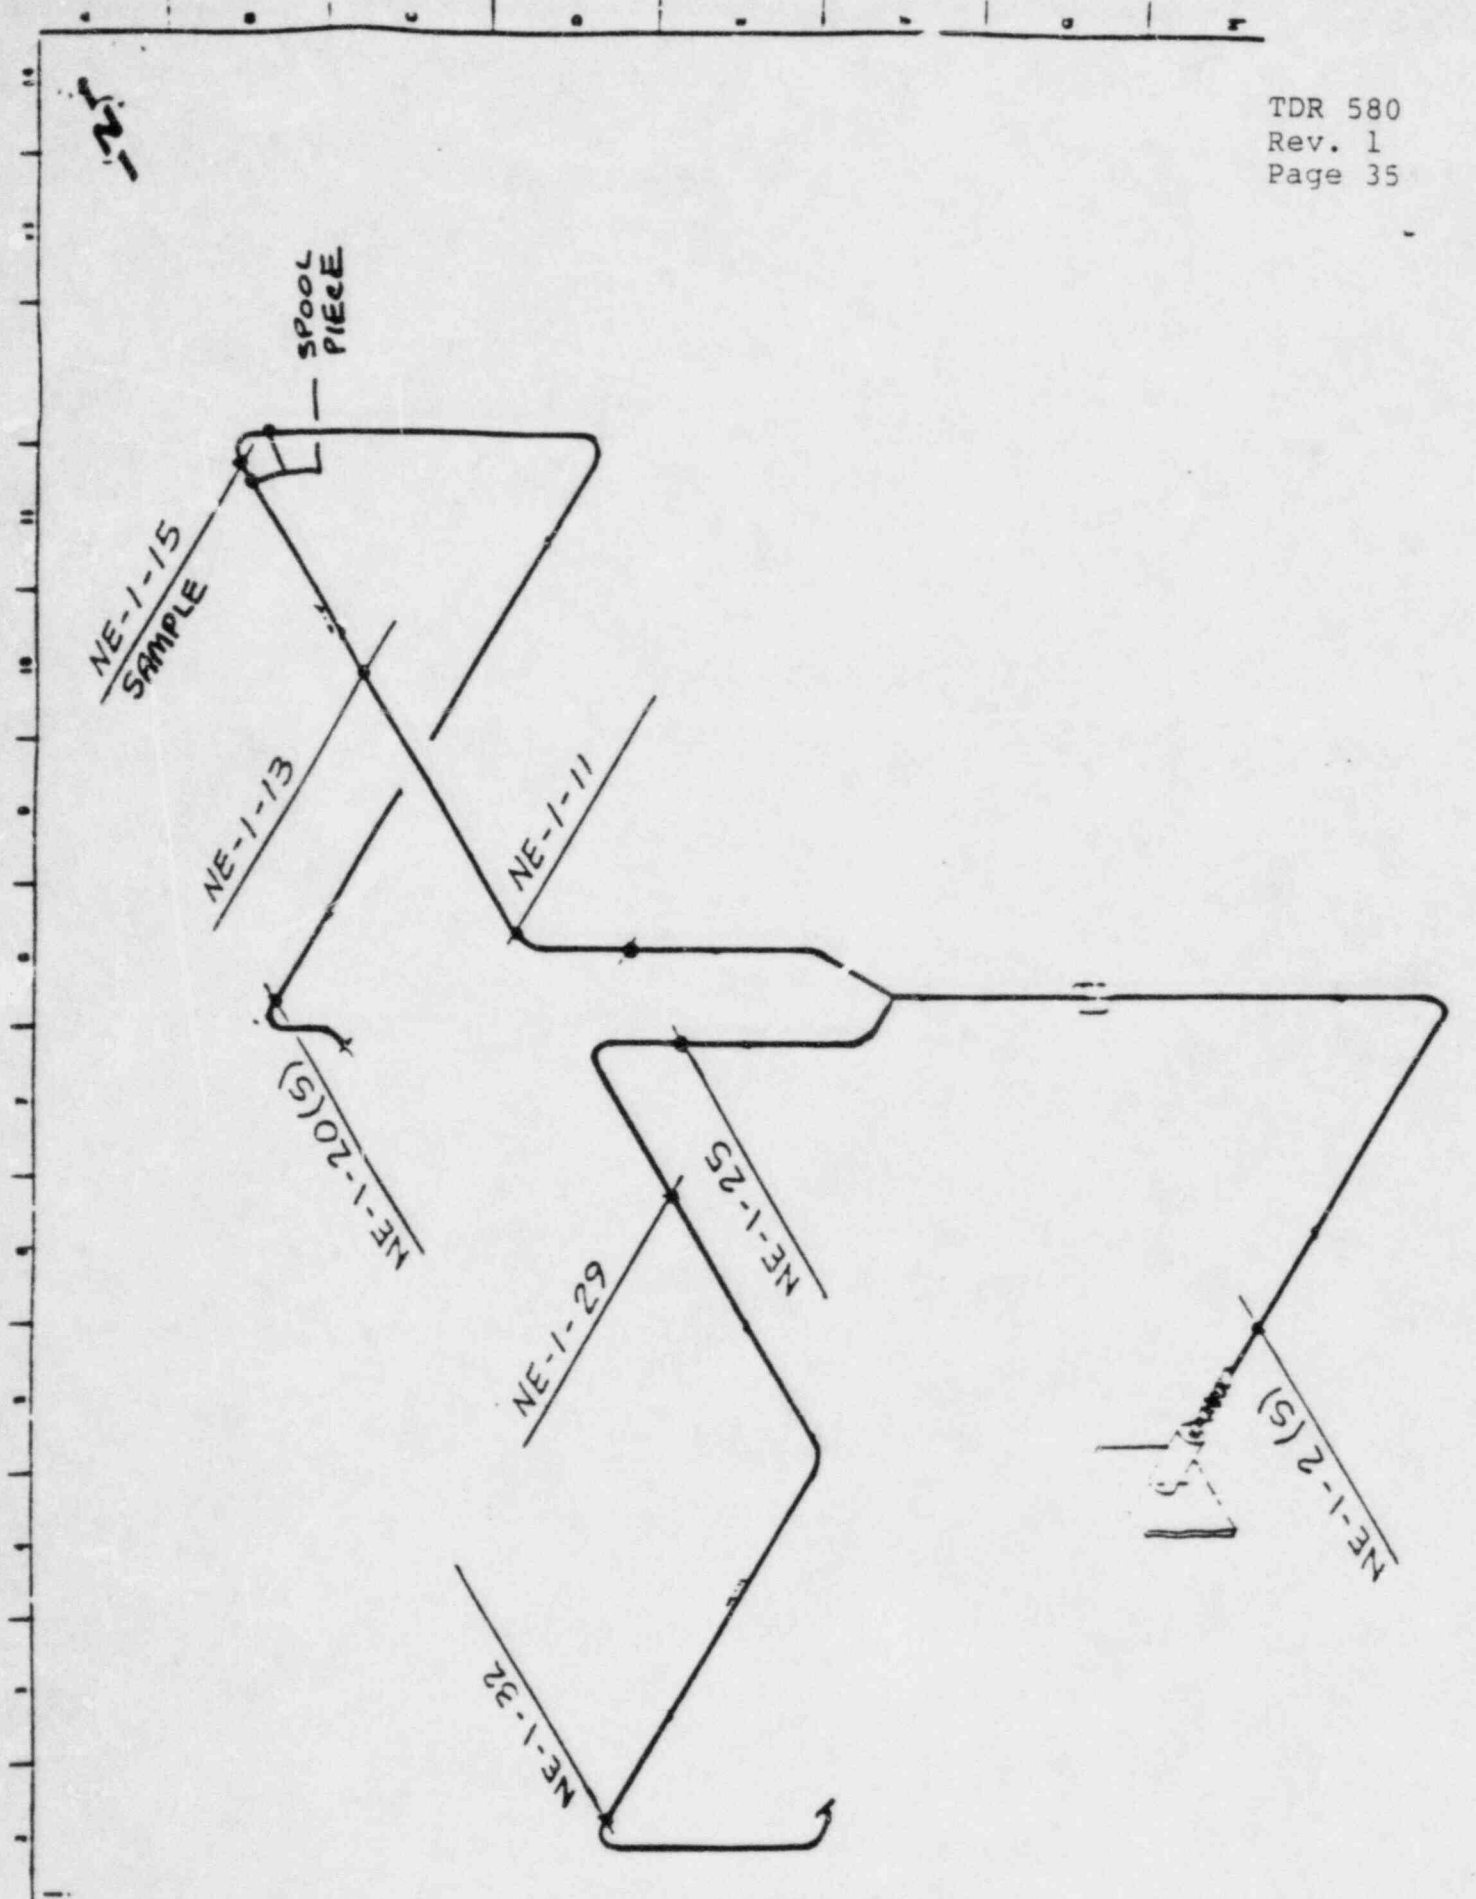
FIGURE 4- 'B' Supply Line, Defective Welds

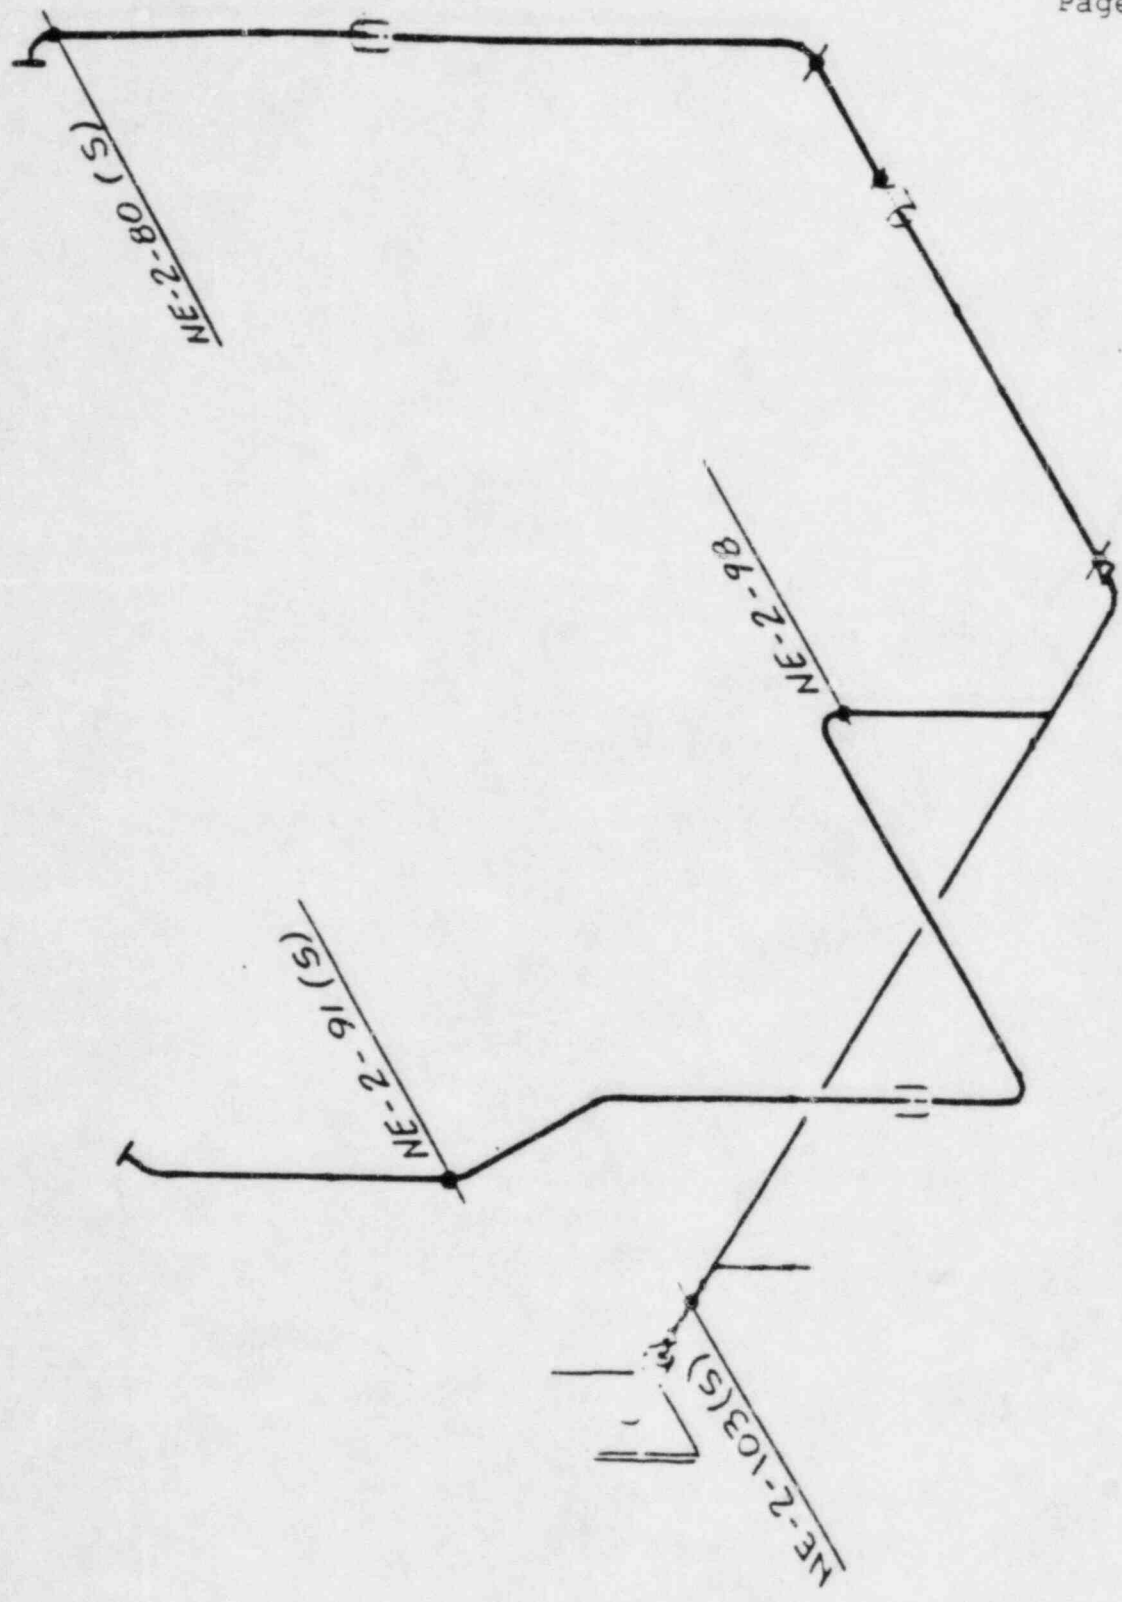
FIGURE 5- 'B' Return Line, Defective Welds

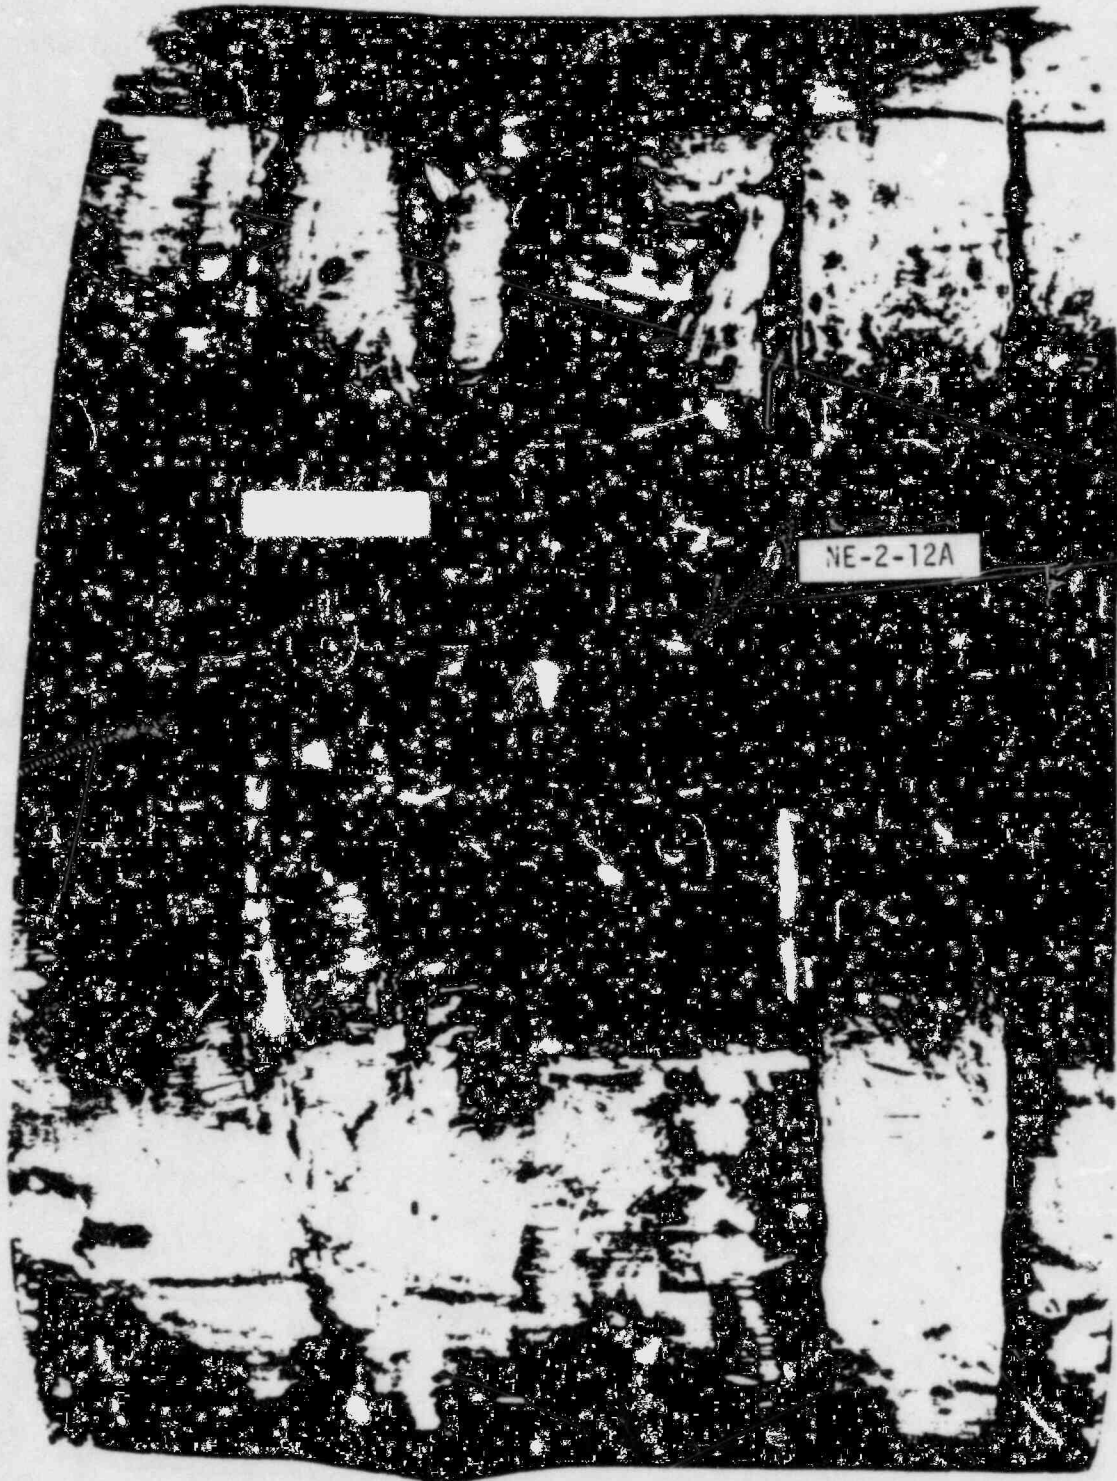
Figure 4 - Macrophotograph of 8 inch pipe weld NE-2-12 and NE-2-12A  
Neg. No. 4-1461 .93X

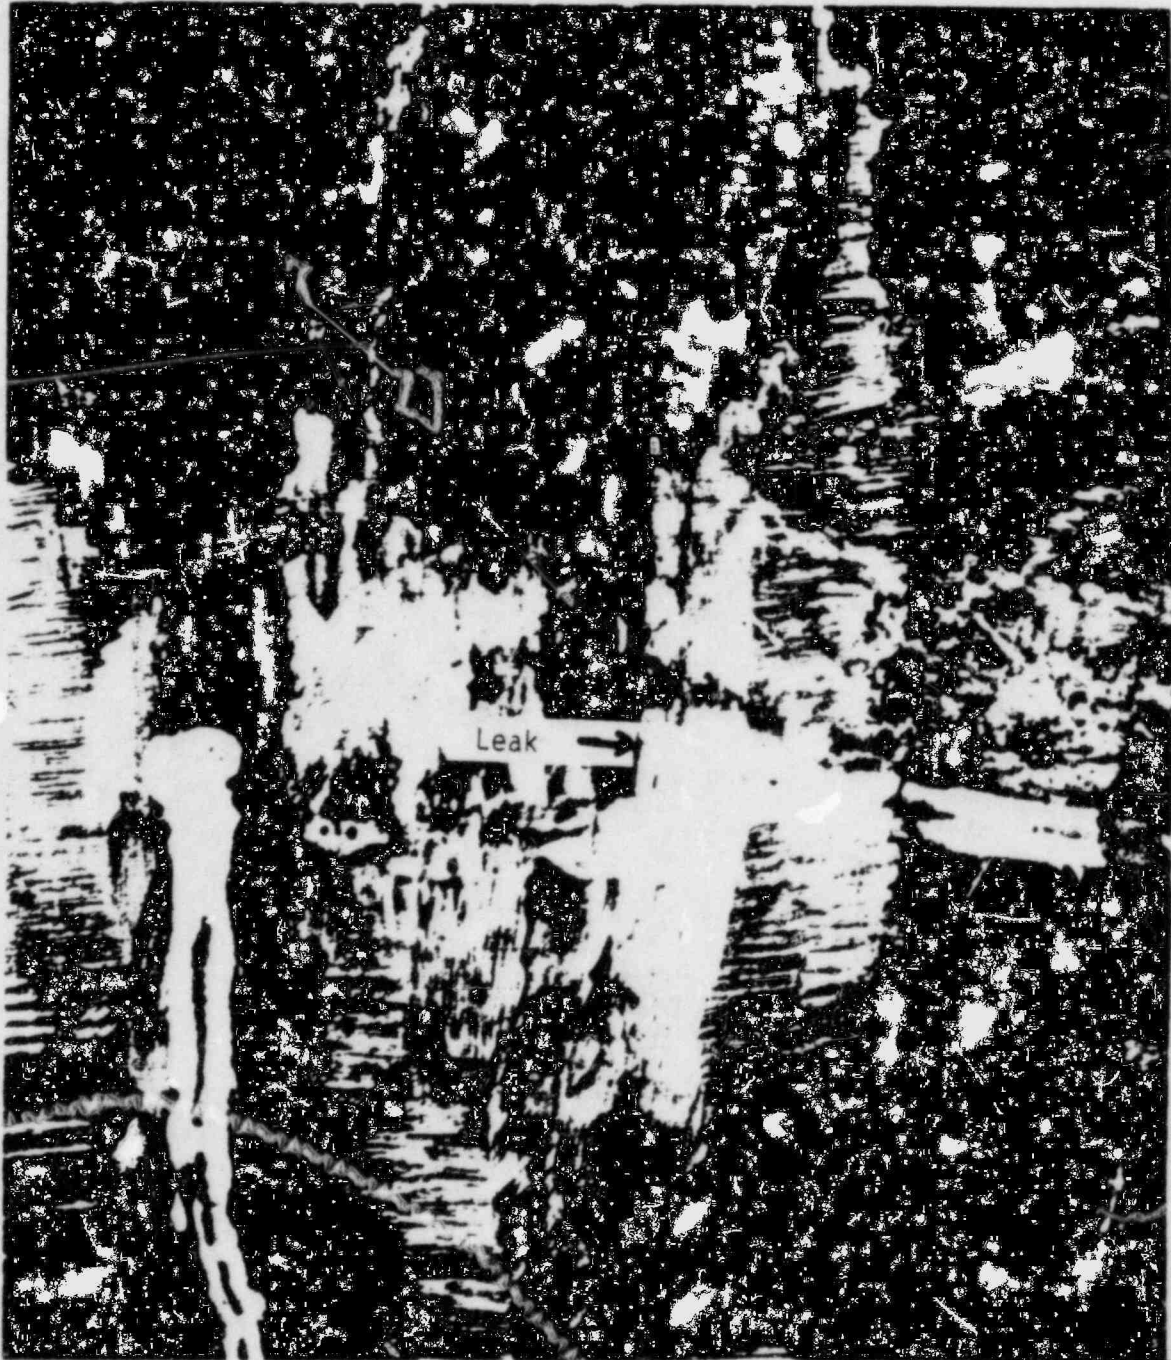
Figure 5 - Closeup of leak in weld NE-2-12  
Neg. No. 4-1461 2.2X

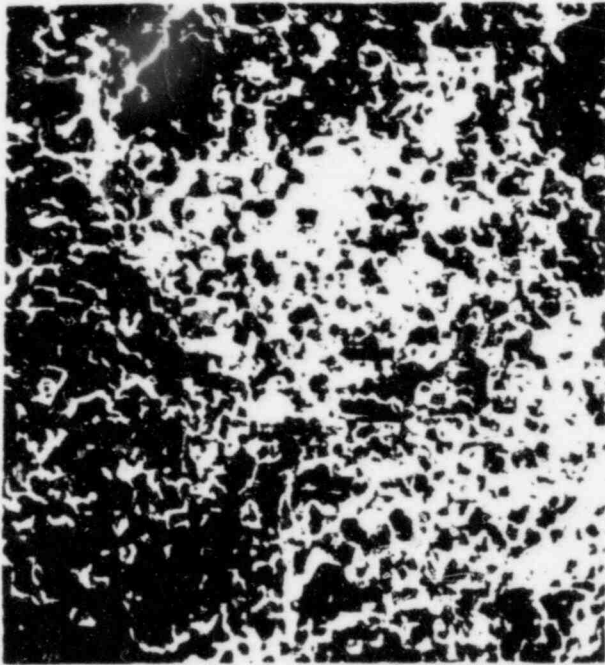
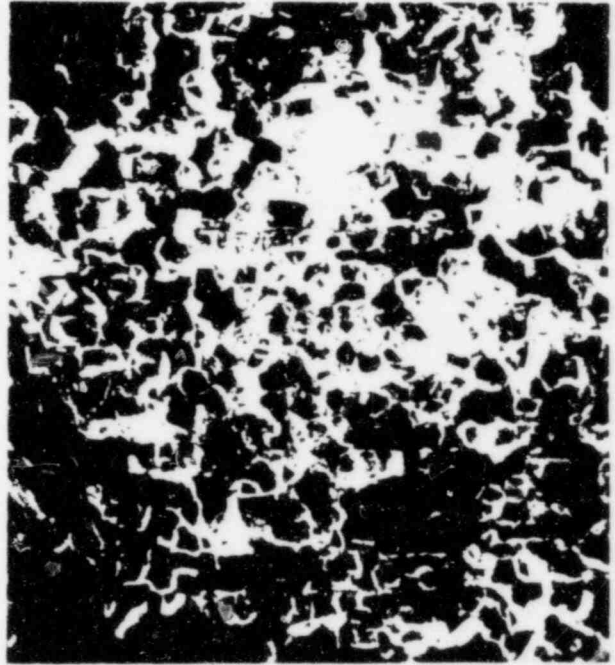
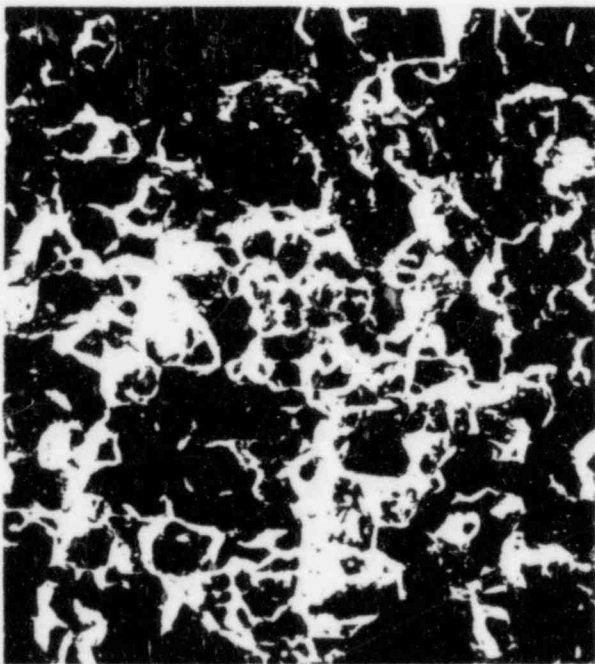
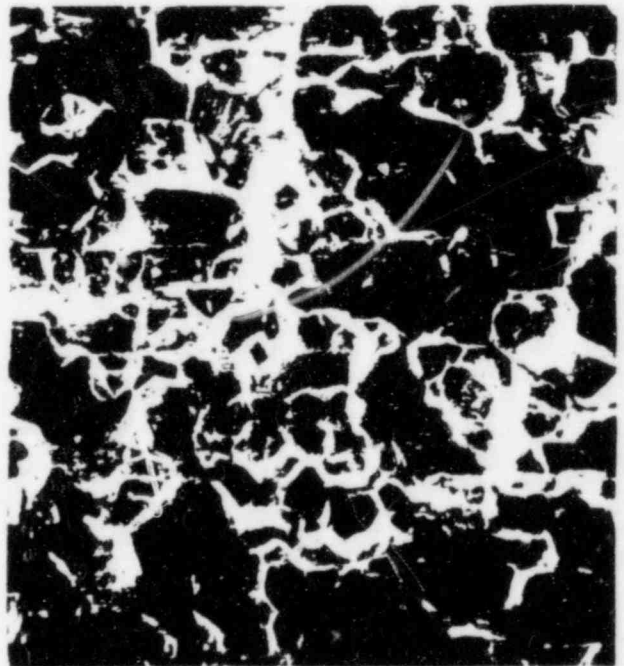
Fractography of the crack surface of welds NE-2-12 (the leaker) and NE-1-15 revealed an intergranular surface on both.

Figure 6 - Scanning electron microscope fractographs of the leaking indication (201) on 8 inch pipe

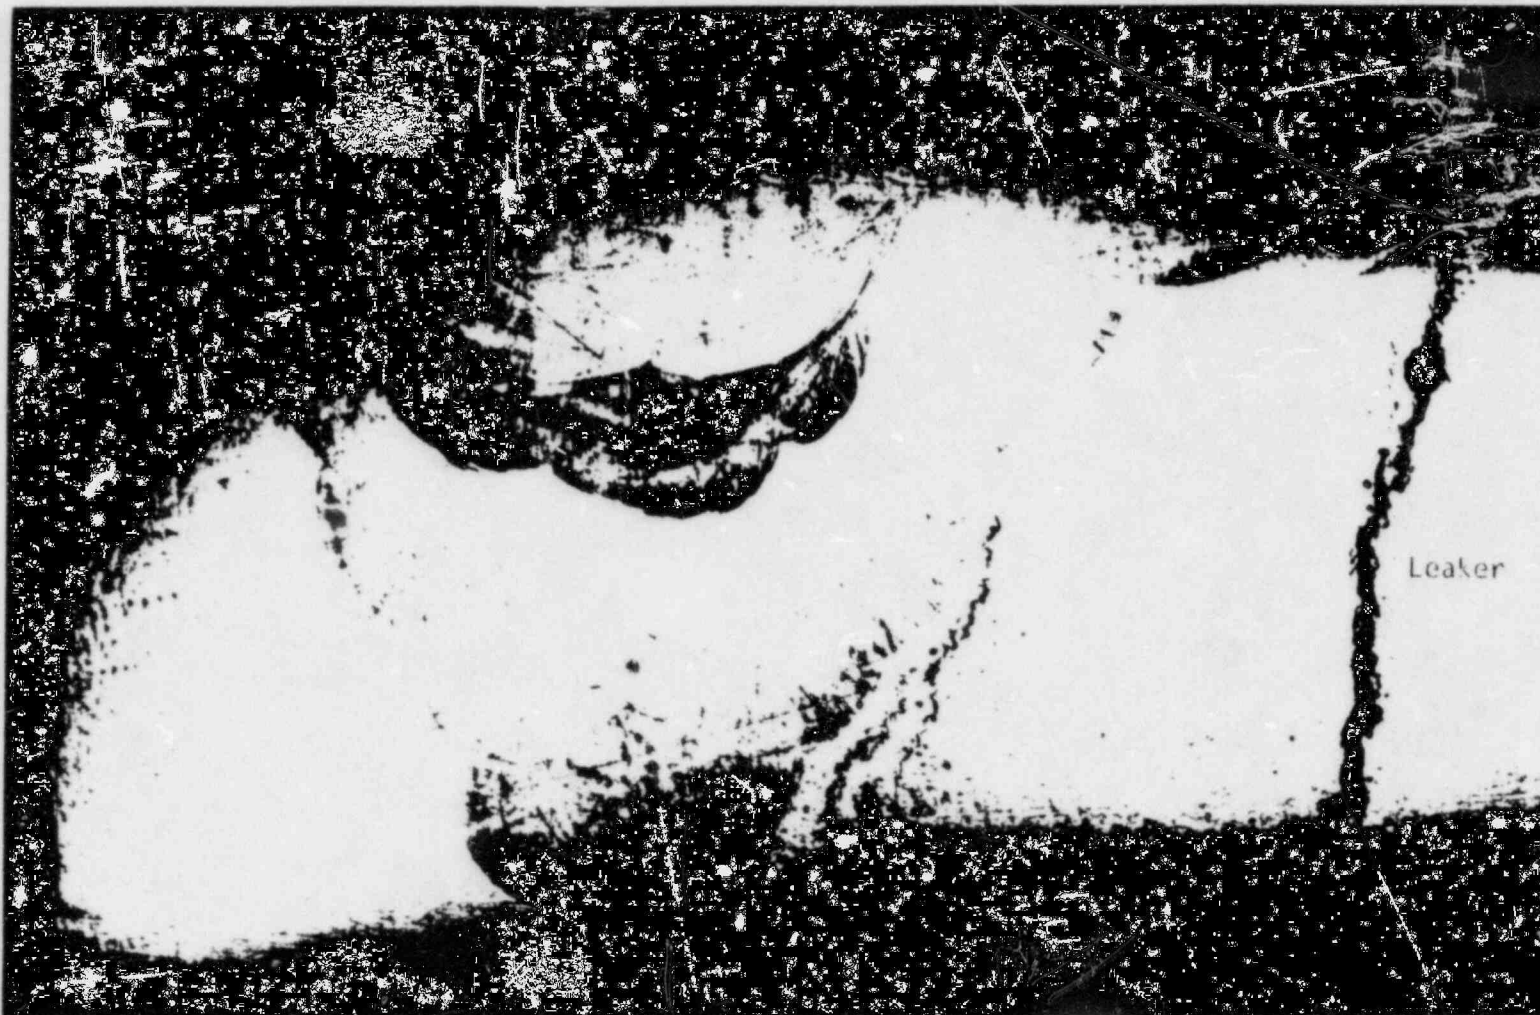
Metallography of NE-2-12 and NE-1-15 revealed that both had cracks that were intergranular and adjacent to the weld bead. And, in NE-2-12, metallography revealed a second crack in the base material between the weld bead and the leaking crack. All the cracks were located within the heat-affected zone of the weld.

Figure 7 - Weld bead and two cracks found in NE-2-12 8 inch - Oyster Creek  
Neg. No. 4-1481F-4

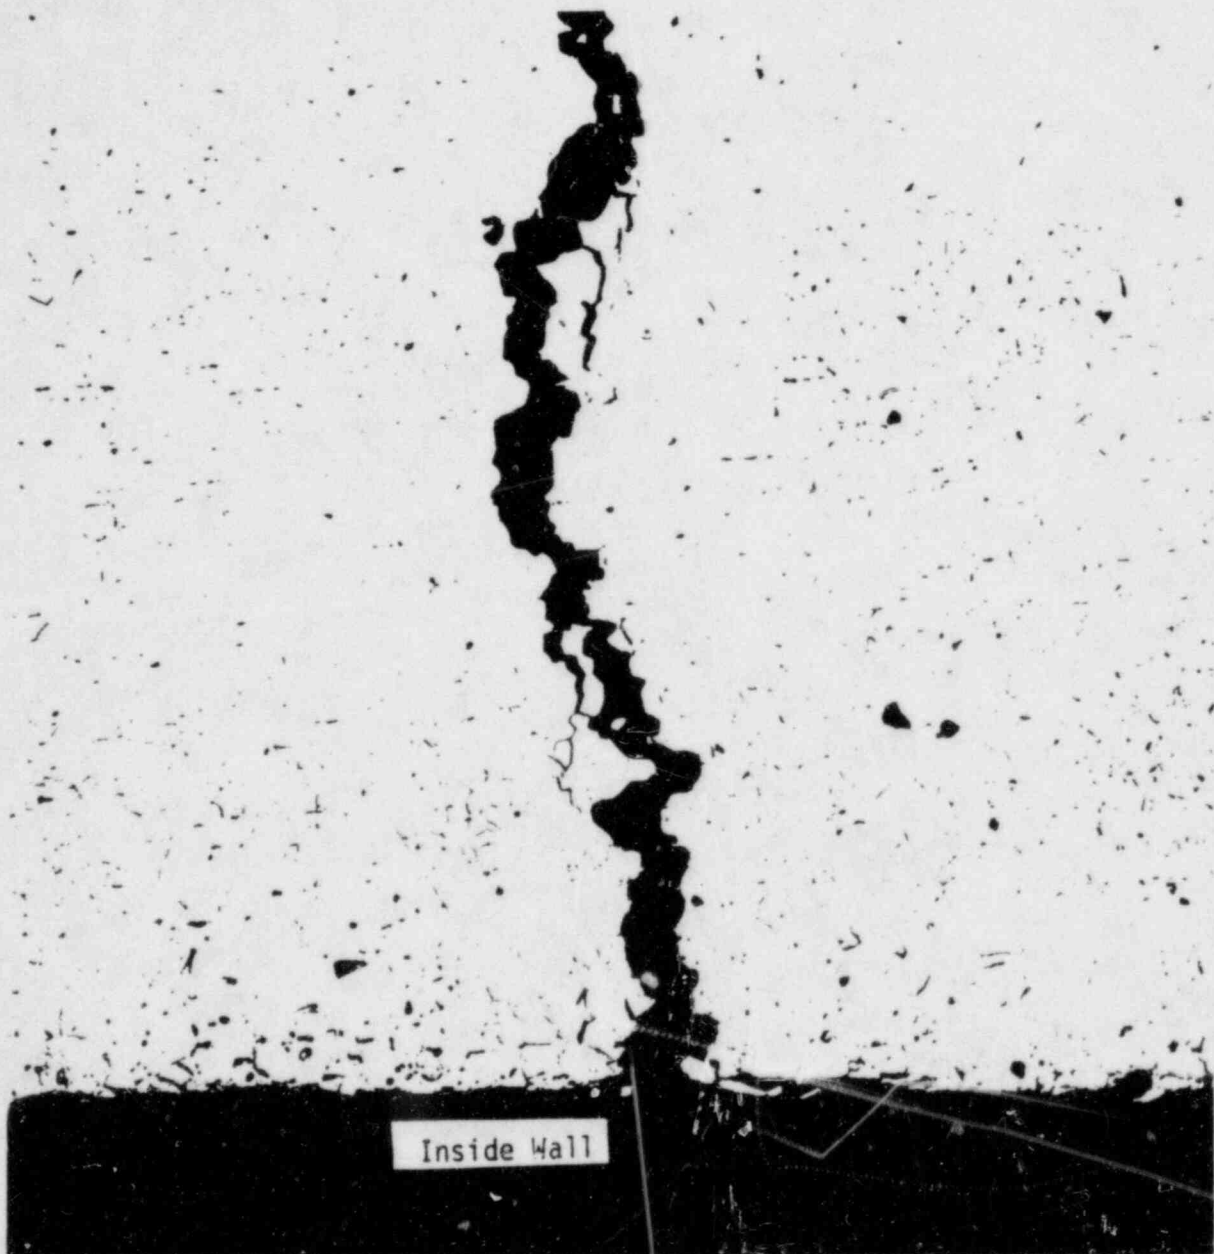
Figure 8 - Leaking crack in weld NE-2-12 8 inch diameter pipe.  
Crack origin inside wall. 50X  
Neg. No. 4-1481F-1 Kallings

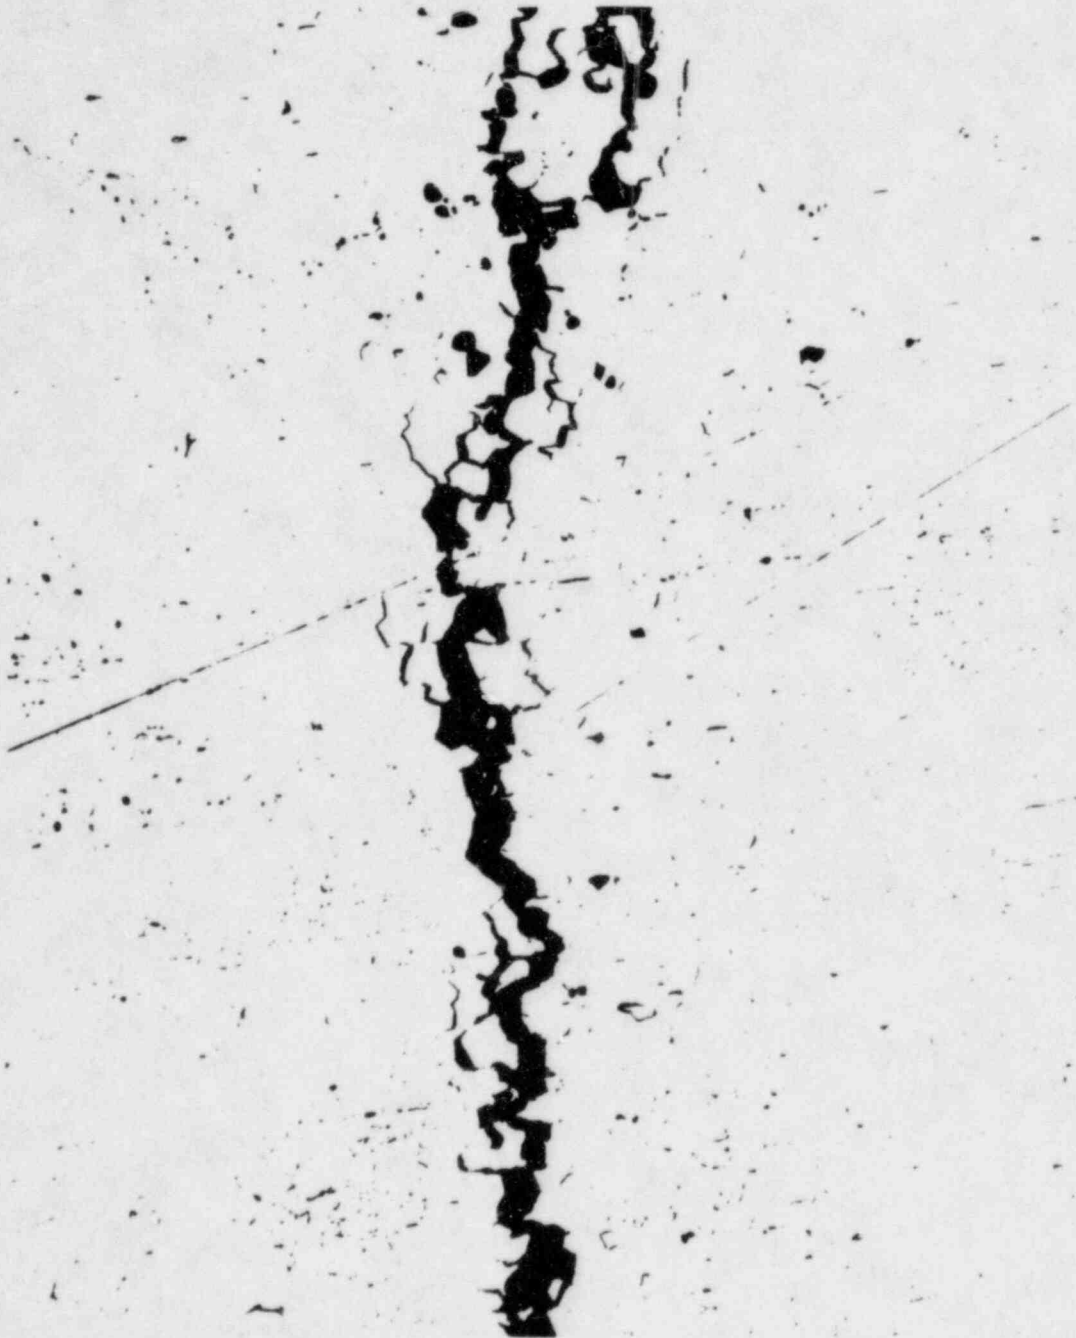
Figure 9 - Leaking crack in weld NE-2-12 8 inch diameter pipe.  
Midwall location. 50X  
Neg. No. 4-1481F-2 Kallings

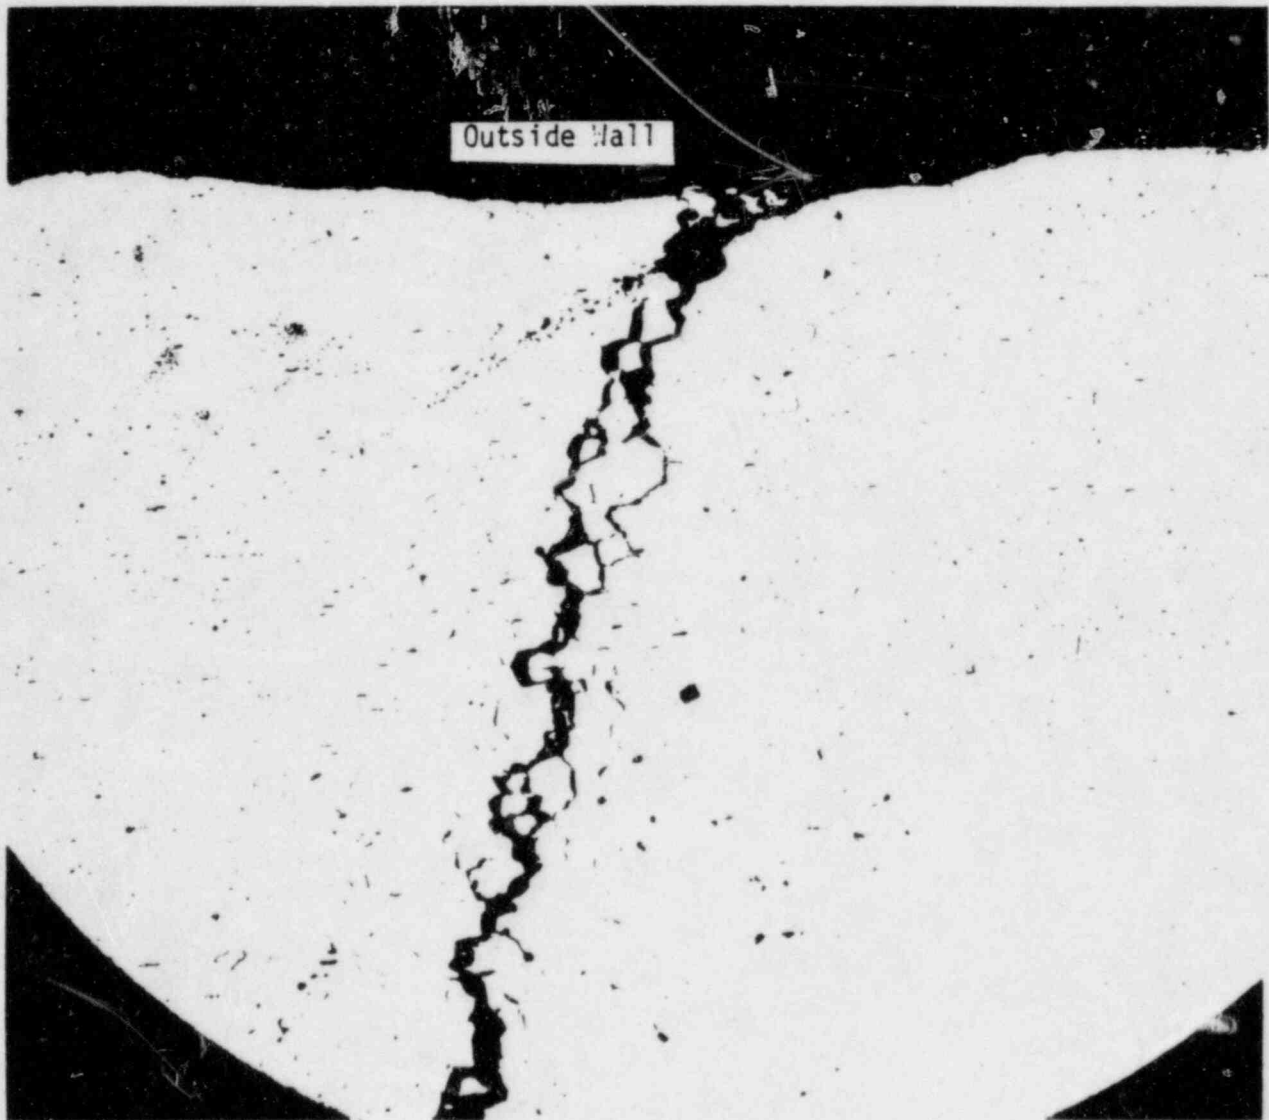
Figure 10 - Leaking crack in weld NE-2-12 8 inch diameter pipe.  
Outside wall. 50X  
Beg. No. 4-1481F-3 Kallings
