<b>Nuclear</b> <b>TECHNICAL DATA REPORT</b>	TDR NO. <u>580</u>	REVISION NO. <u>1</u>
	BUDGET ACTIVITY NO. <u>323357</u>	PAGE <u>1</u> OF <u>110</u>
PROJECT: <u>Oyster Creek Nuclear Generating Station</u>	DEPARTMENT/SECTION <u>E&amp;D</u>	
RELEASE DATE <u>9-17-84</u> REVISION DATE <u>9-11-84</u>

DOCUMENT TITLE: Isolation Condenser System Piping Cracked Welds - Repair and Failure Analysis

**TITLE** Isolation condenser system cracked welds-repair and failure analysis

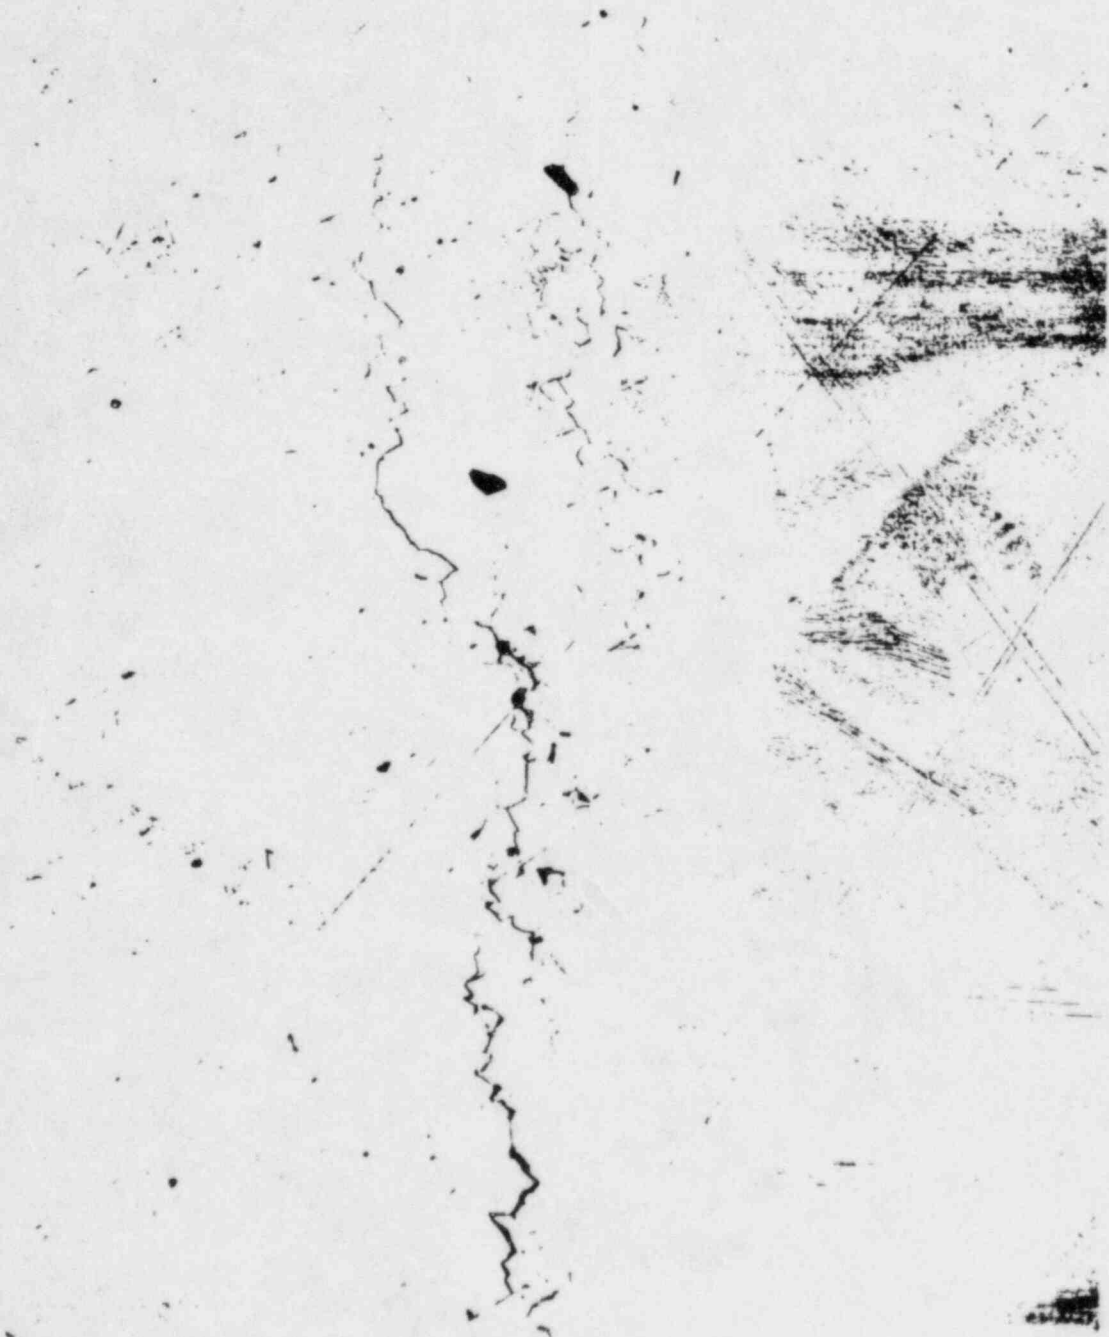
Figure 12 - Second crack found in NE-2-12 8 inch diameter pipe.  
Midwell location "Growing End".  
Neg. No. 4-1481F-5

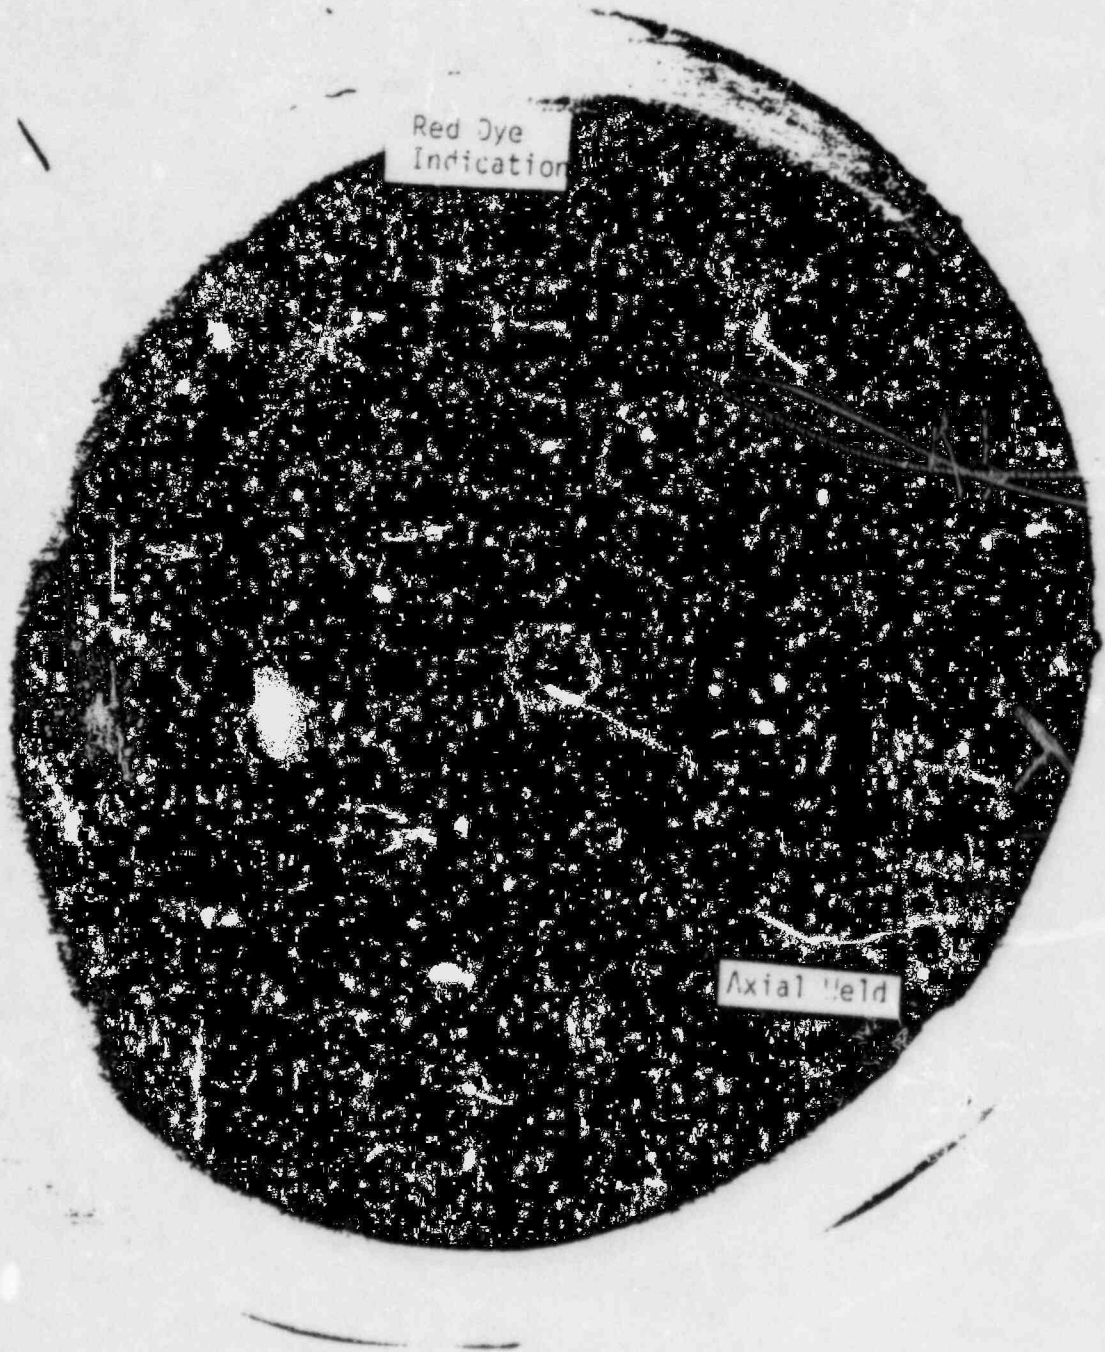
Figure 13 - Eight inch diameter pipe looking from NE-2-13 toward NE-2-12.  
Red dye inspection of weld NE-2-13. Note axial weld for orientation.  
Neg. No. 4-1461 .81X

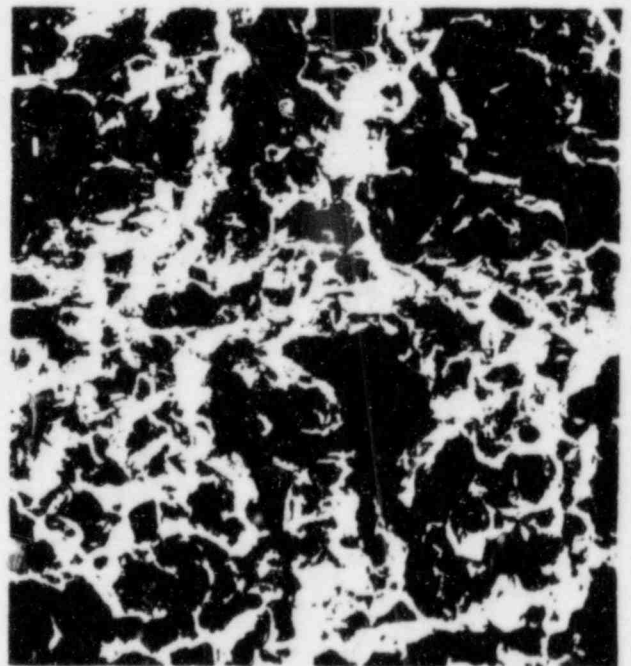
Figure 18 - Scanning electron microscope fractographs at the inside pipe wall of the 12 inch pipe

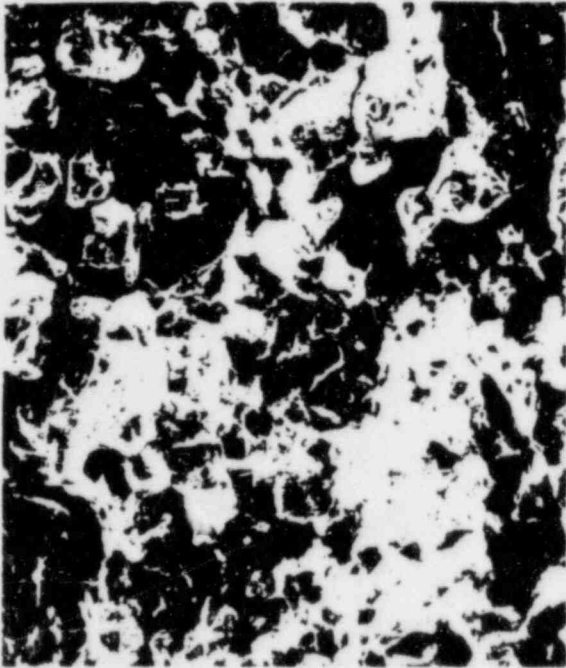
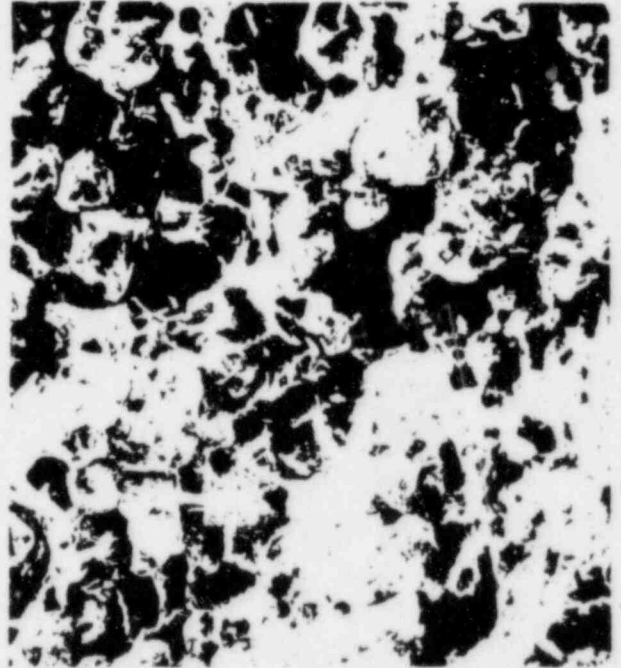
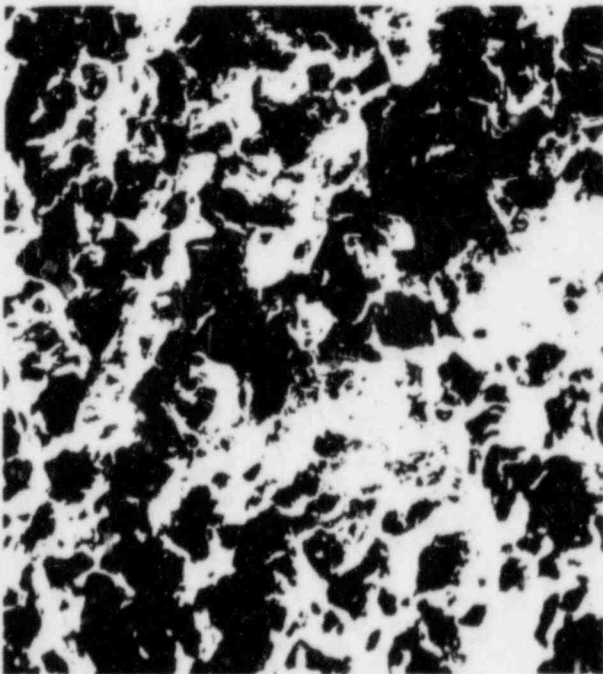
Figure 19 - Scanning electron microscope fractographs at the mid wall location - near the crack end 12 inch pipe

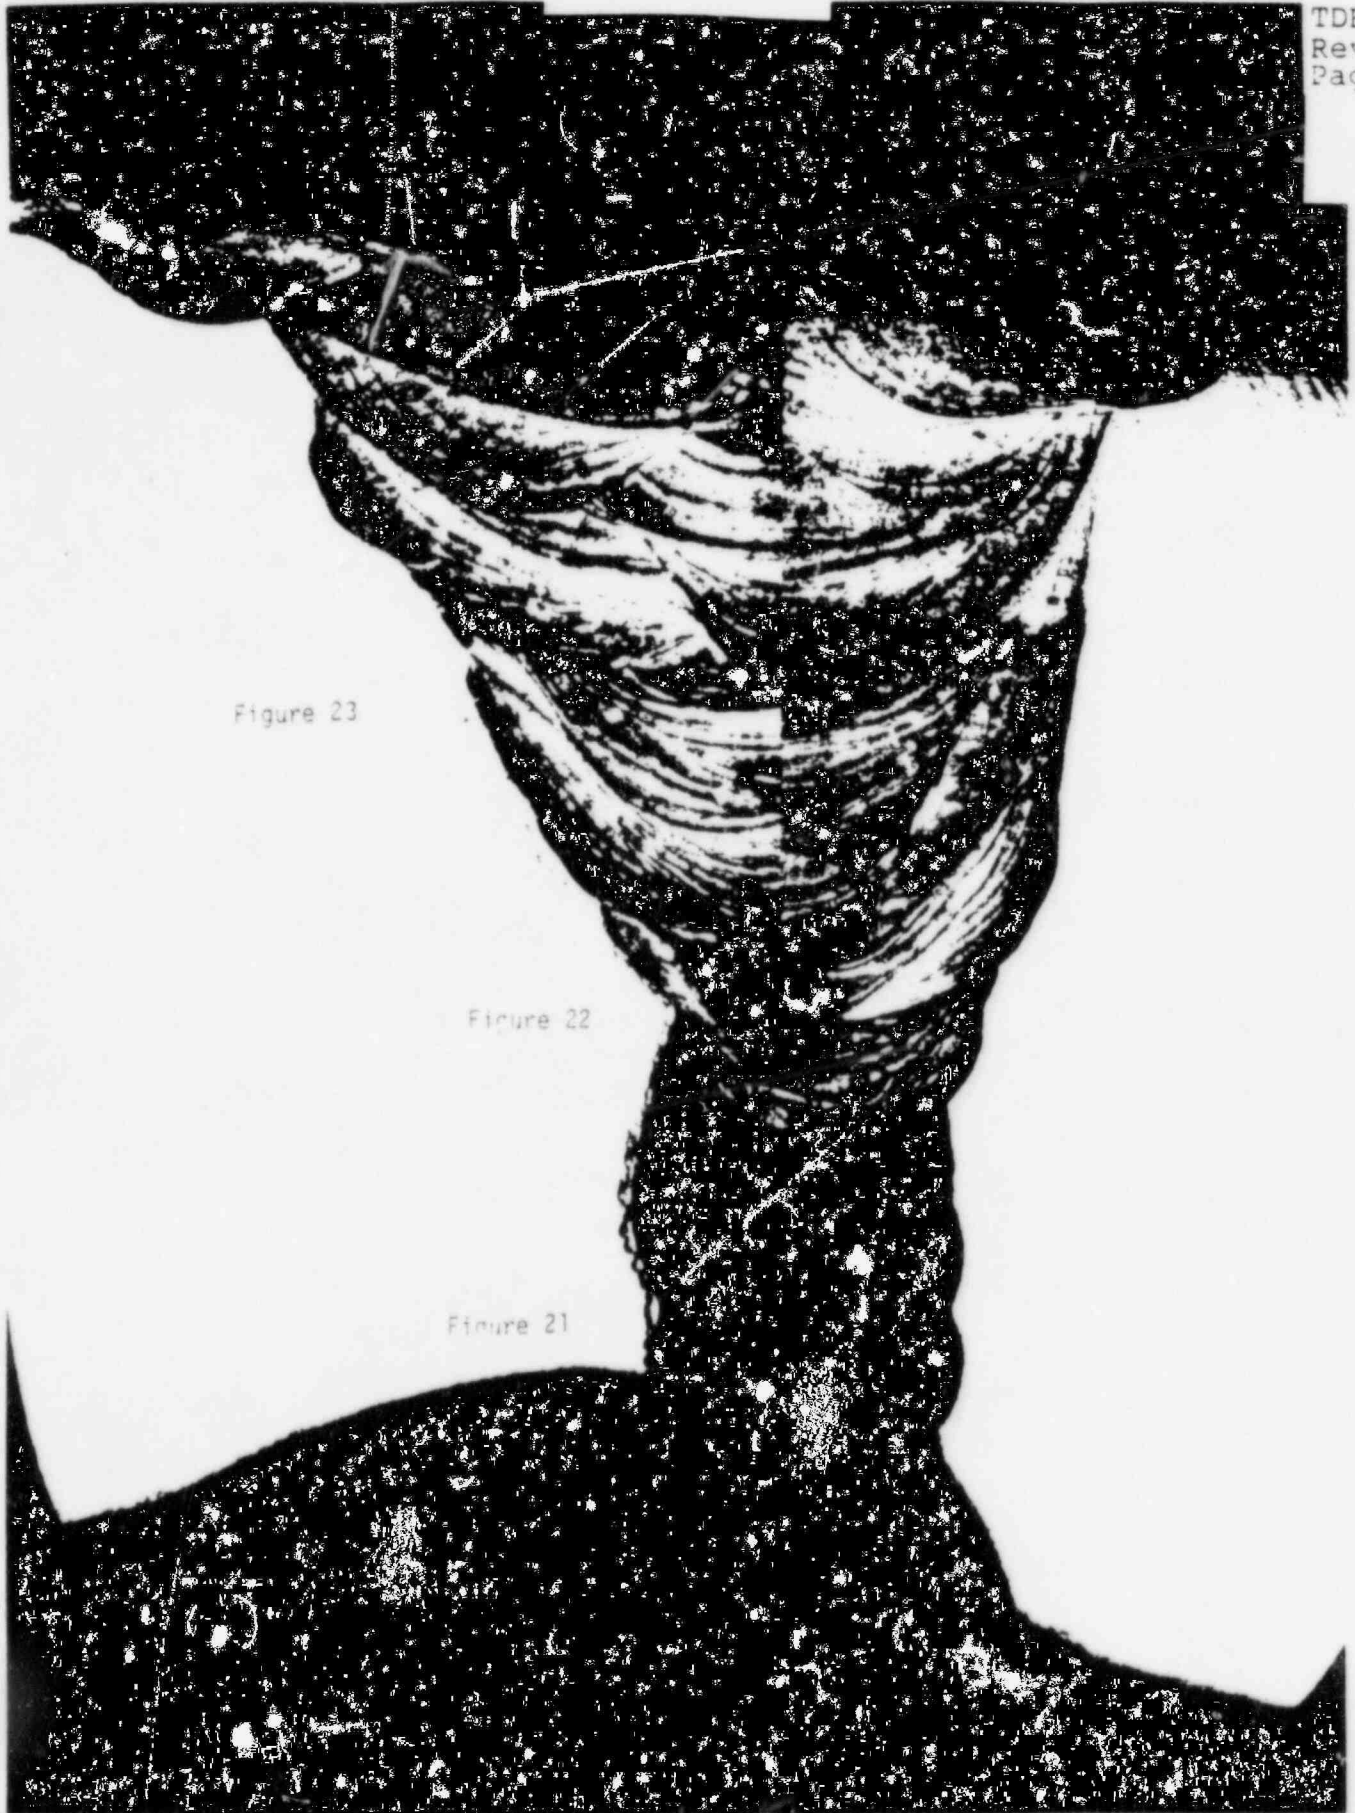
Figure 20 Twelve Inch Diameter Pipe Weld Bead and Associated Crack  
Neg. No. 4-1480F1-3

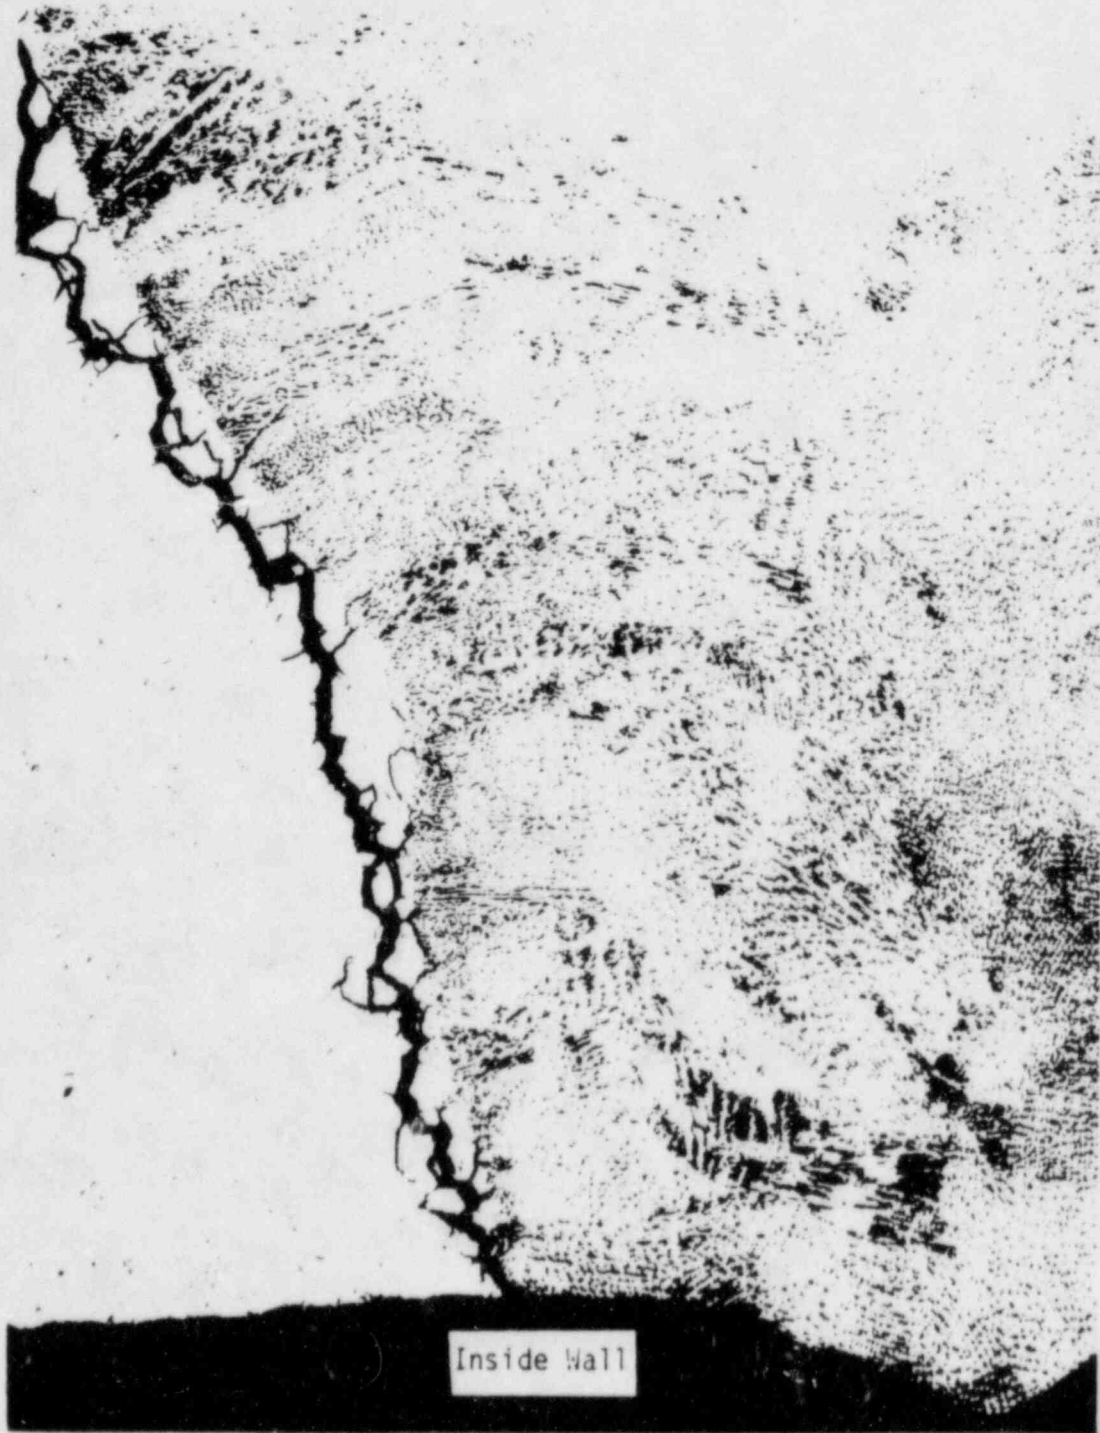
Figure 21 - Twelve inch diameter pipe crack at the inside surface; origin.  
Neg. No. 4-1480F-4  
50X  
Kallings

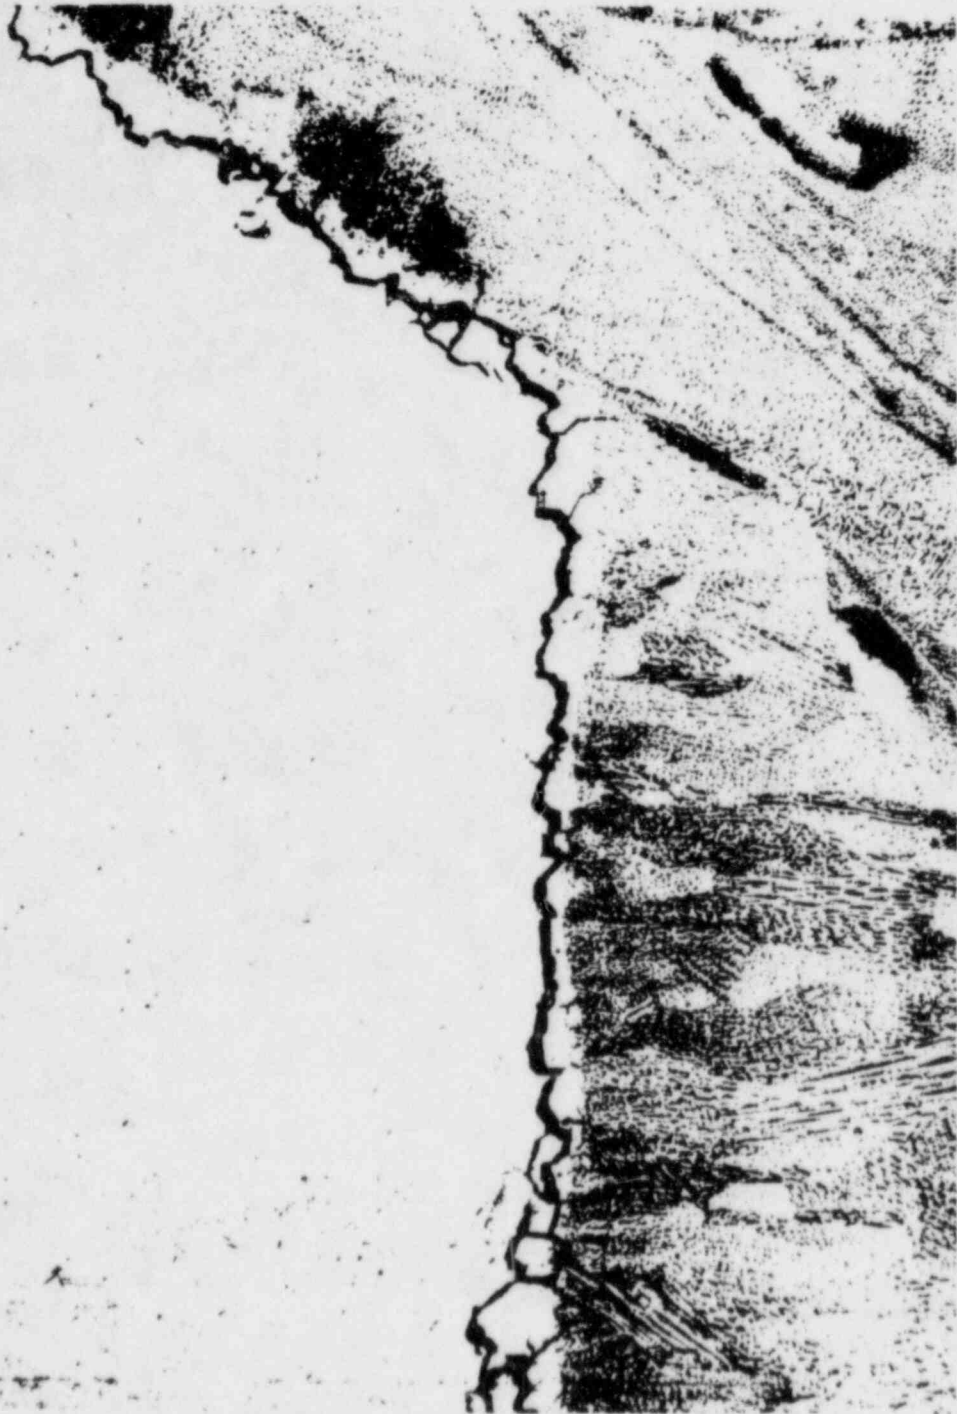
Figure 22 - Twelve inch diameter pipe crack at mid wall. Note the change in direction.  
Neg. No. 4-1480-5

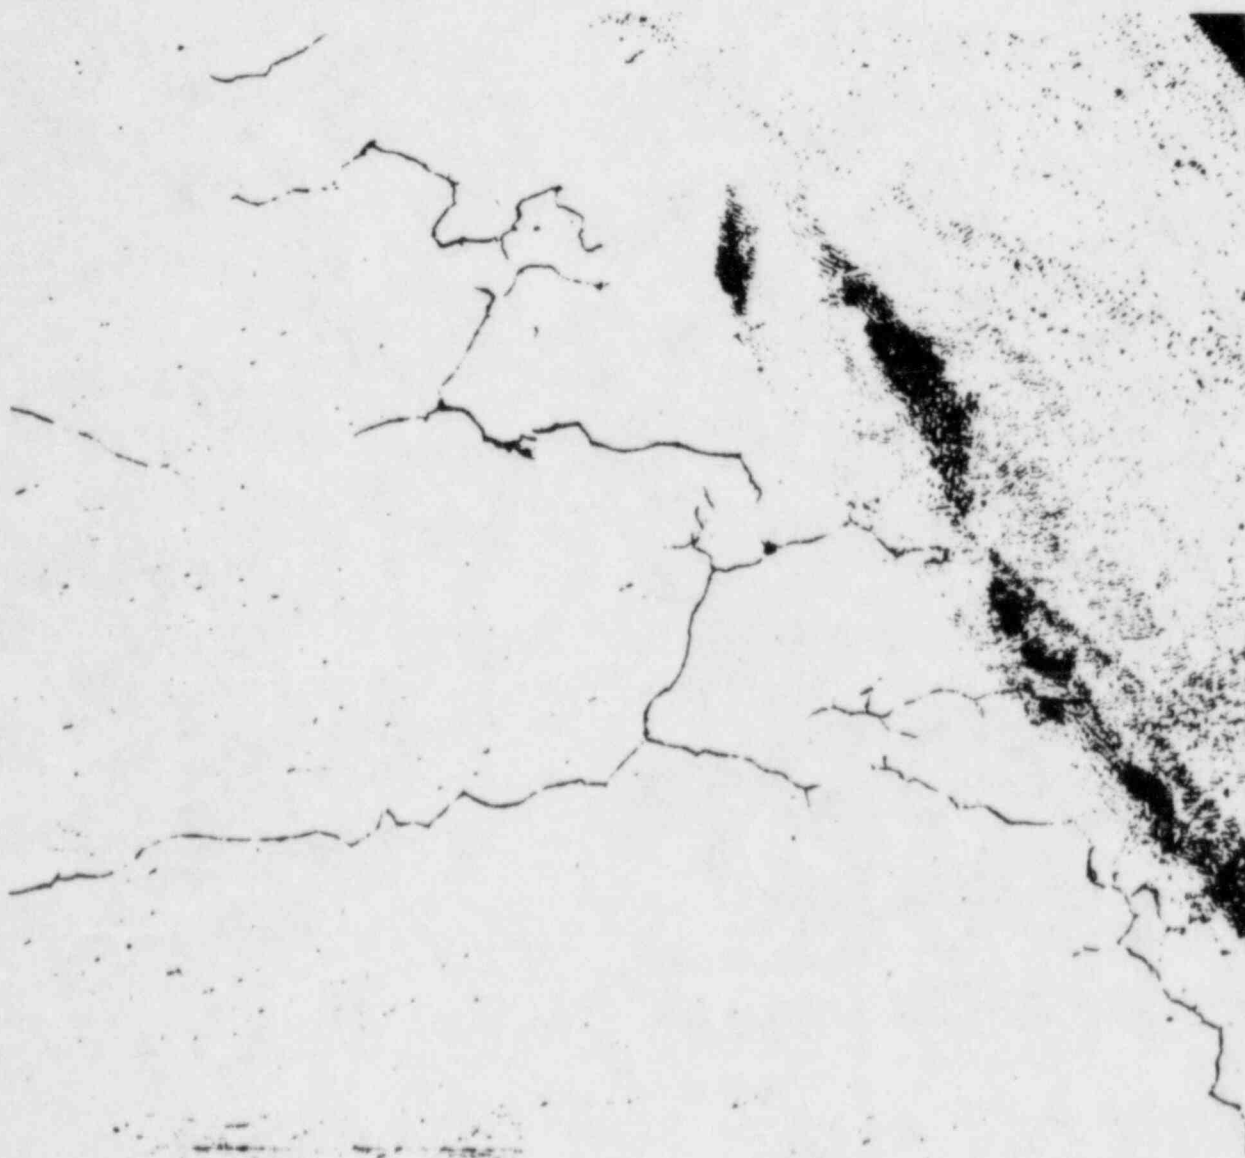
Figure 23 - Twelve inch diameter pipe crack at the "growing" end.  
Neg. No. 4-1480F-6  
50X  
Kallings
