Doc. No. BECO/ESR-1
SEPTEMBER 1984
REV. 1

Detailed Control Room Design Review

Executive Summary Report

Pilgrim Station

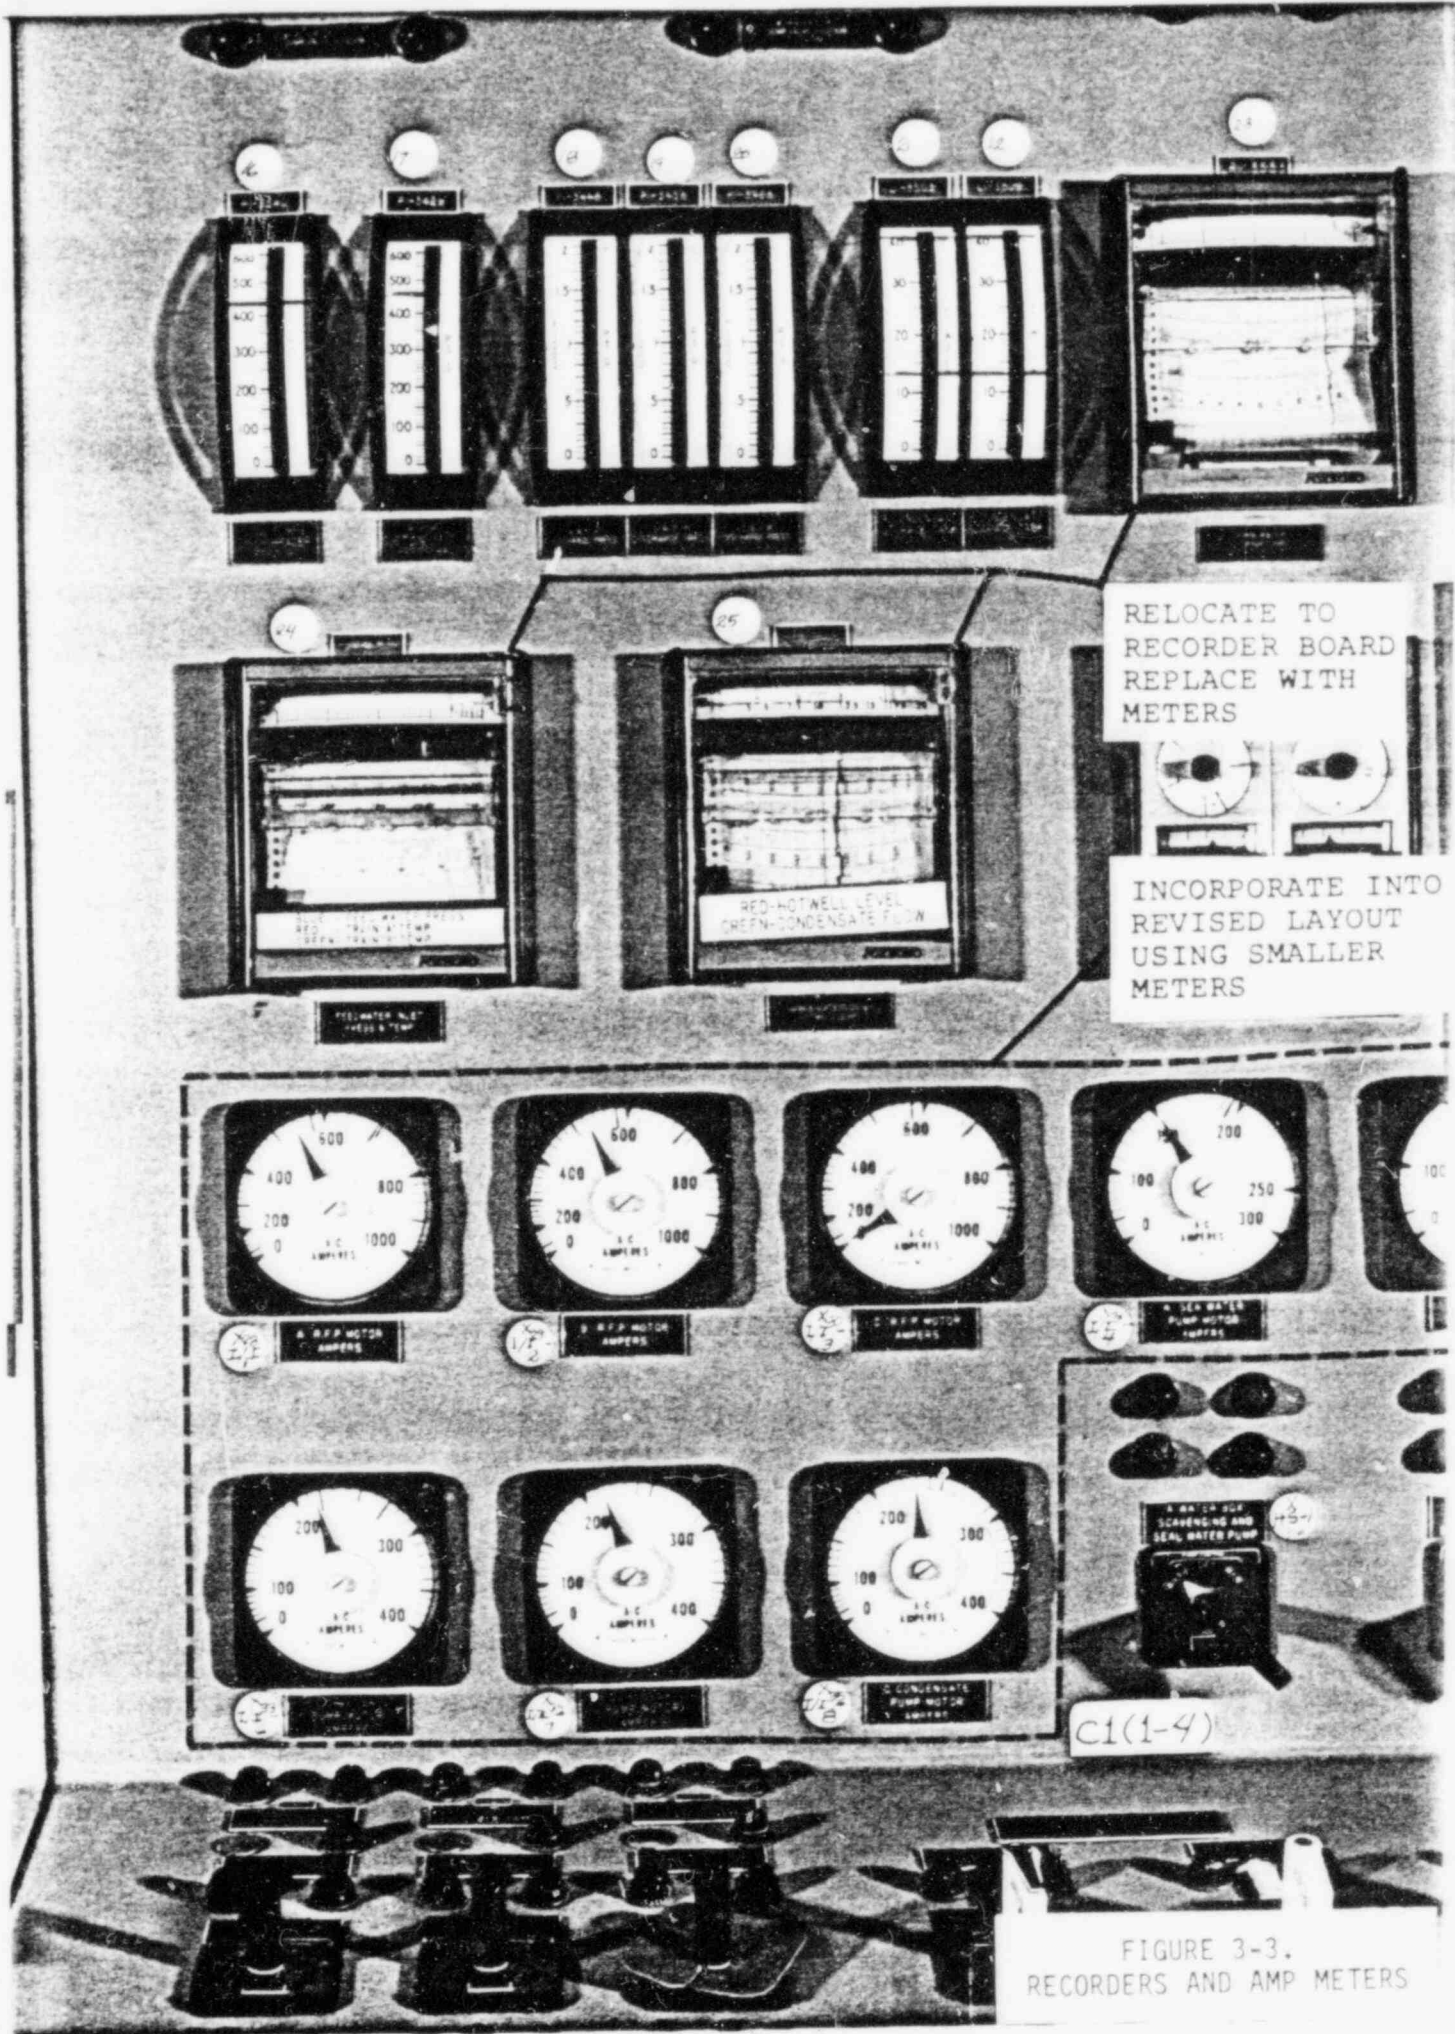
FIGURE 3-3.
RECORDERS AND AMP METERS

8A008.5: All controls are too close and too cluttered.

1B001.5: Instrumentation requiring continuous monitoring during an emergency but is not in the main control area. (Drywell temperatures, containment purge and vent control, torus temperature.)

RELOCATE TO
RECORDER BOARD
REPLACE WITH
METERS

INCORPORATE INTO
REVISED LAYOUT
USING SMALLER
METERS
