Report No.: 50-302/92-11

Facility Name: Crystal River 3

Inspection Conducted: May 4-8, 1992

This special announced inspection was conducted to review the circumstances involving the failure of Emergency Feedwater valve EFV-14 to close completely during a differential pressure test performed on October 15, 1991, as recommended by Generic Letter, GL 89-10, "Safety-Related Motor Operated Valves Testing and Surveillance."

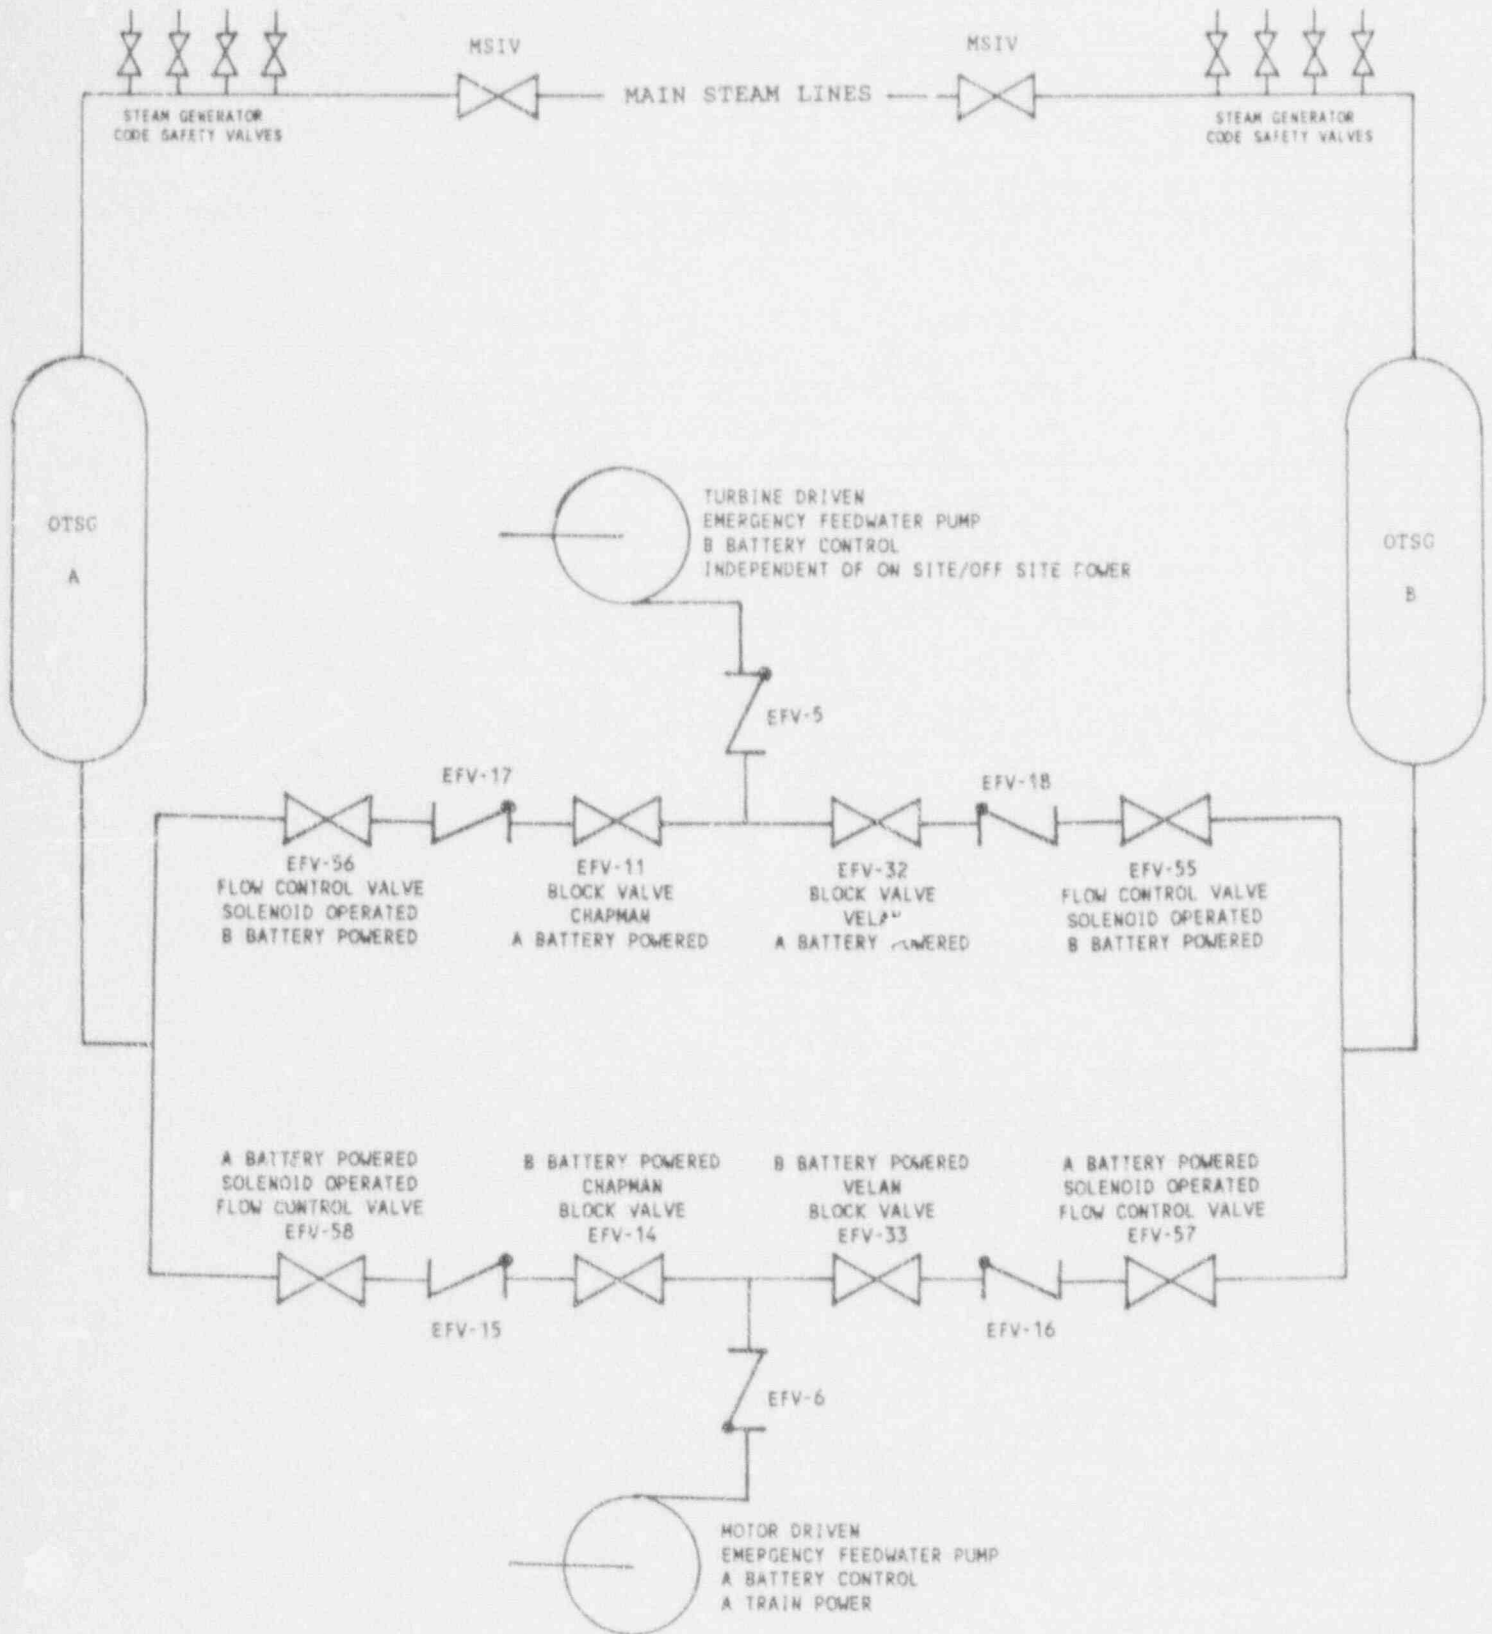
FIGURE 1. CRYSTAL RIVER UNIT 3 EMERGENCY FEEDWATER SYSTEM

The emergency feedwater system, EFS, consists of two full capacity, independent systems, which includes two pumps and associated valves and piping. (See Figure 1) The system automatically supplies emergency feedwater to one or both steam generators, OTSG, to provide decay heat removal for normal reactor cooldown and a number of analyzed events.
