FERMI 2  
RESPONSE TO RECOMMENDATIONS  
FROM THE DUKE POWER COMPANY  
FINAL ASSESSMENT OF CONSTRUCTION

DETROIT EDISON  
SEPTEMBER 1984

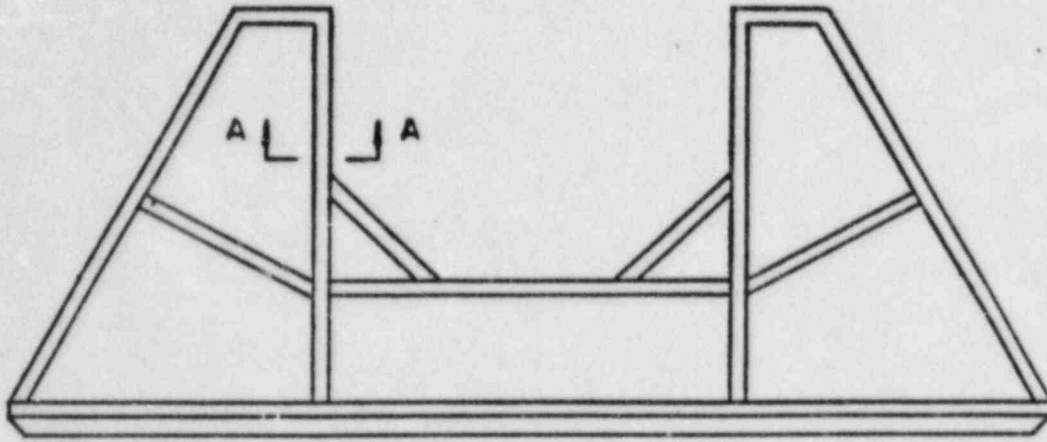
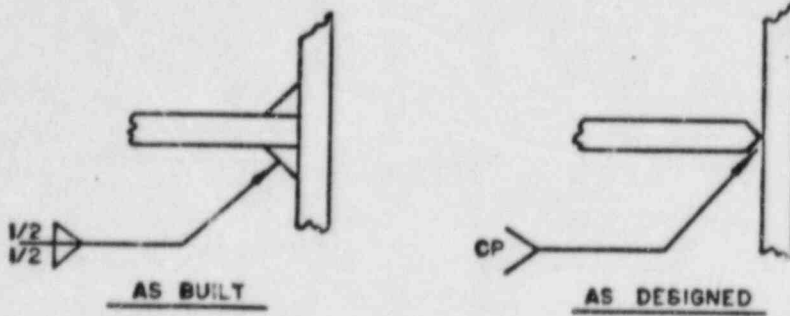
FIGURE 3-1

In addition, the associated conclusion included a recommendation that the systems be walked down to verify that whip restraints have been installed on locations as shown on drawings. During the assessment, one case was found where the location of two whip restraints was different from that shown on the drawing.

The apparent discrepancy in the location of two whip restraints was found to be due to a drafting error on entering the information on a drawing. The physical location was correct; the drawing was revised.

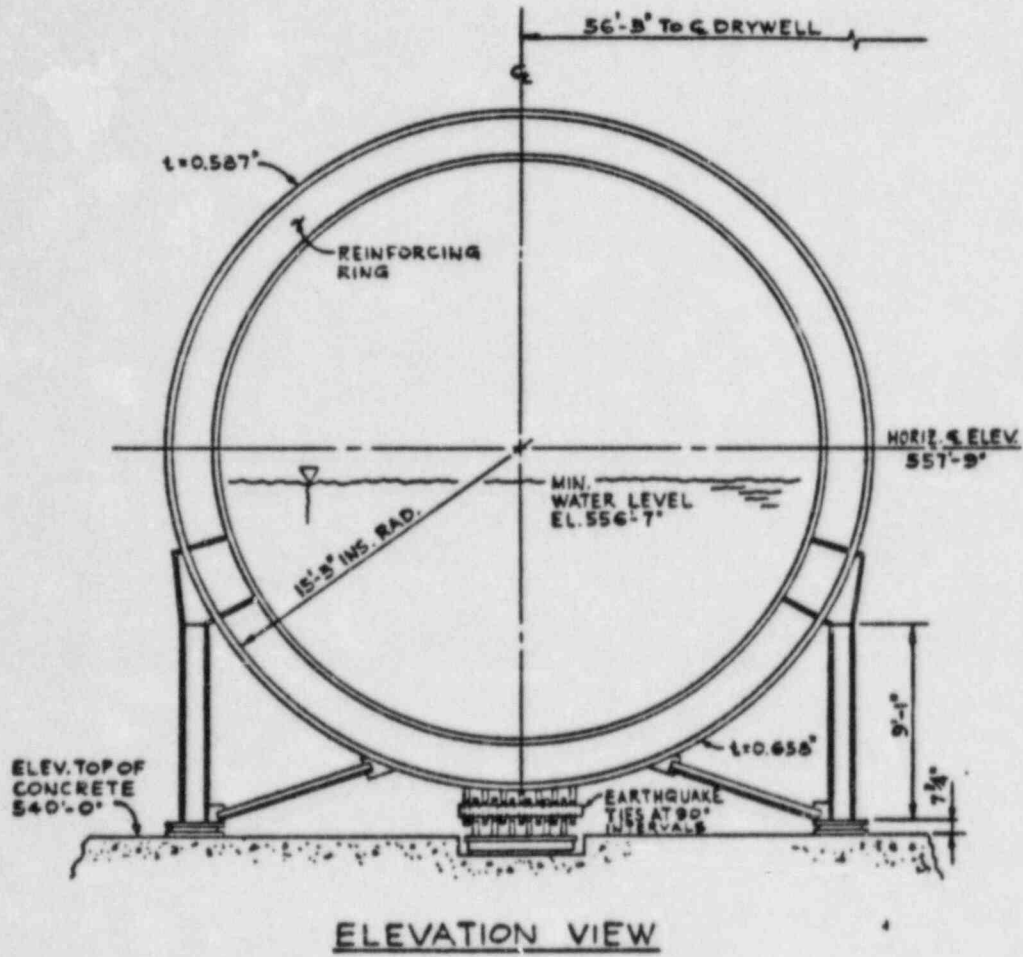
FIGURE 4-1

The torus supports have some welds that are smaller than the design documents indicate. Other than this deviation, the torus supports were found to conform to the design documents.

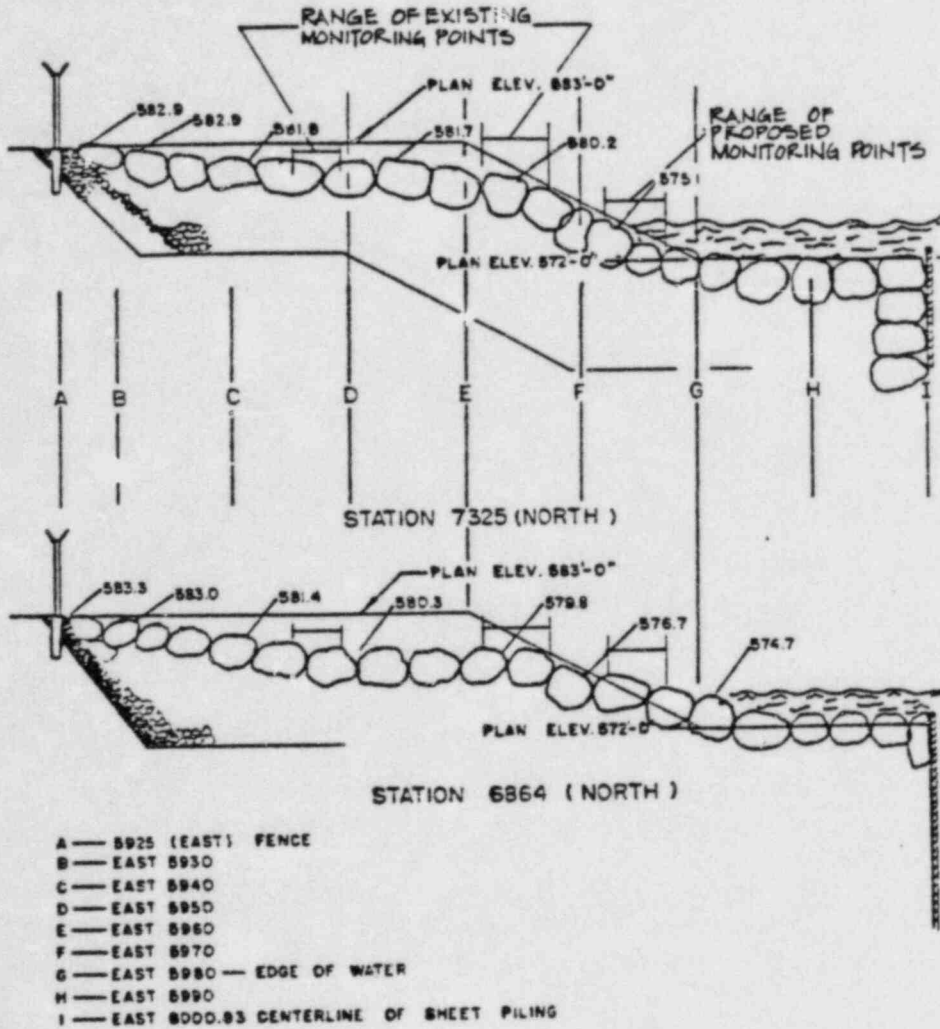
FIGURE 6-2

After the barrier construction, it was noted that the profile at the south end of the barrier did not match the design. Surveys at 100-foot intervals were taken and a deviation disposition request issued. It was dispositioned by Engineering to use-as-is and to add the as-built elevations to the design drawing.

During the construction assessment, this same low area was resurveyed. The survey results indicated elevations lower than the previous surveys had shown. This was attributed to the fact that the CAT survey profiles were taken at locations between the previous 100-foot intervals where the original elevations were taken in 1983. Based on this new data, a nonconformance report was issued and dispositioned. Selected points on the barrier have also been monitored recently to identify if any settlement and/or storm damage has occurred since construction. Results of this effort indicate that there has been virtually no movement since construction.

Mr. Noble evaluated the as-built elevations with respect to the design conditions and has determined that the shore barrier is capable of withstanding the probable maximum meteorological event. The observed and surveyed low areas of shore barrier cap stone will not adversely affect the shore barrier's ability to maintain the integrity of the plant site at El 583'.

Because the shore barrier has shown no sign of movement and the as-built condition has been reviewed and accepted by the designer, the shore barrier will fulfill its intended function. With the establishment of the additional monitoring points, all recommendations have been implemented. This fully responds to Recommendation No. 6.
