DETROIT EDISON COMPANY

FERMI 2

FINAL ASSESSMENT OF CONSTRUCTION

Duke Power Company
Management and Technical Services
422 South Church Street
Charlotte, N.C.
July 1984

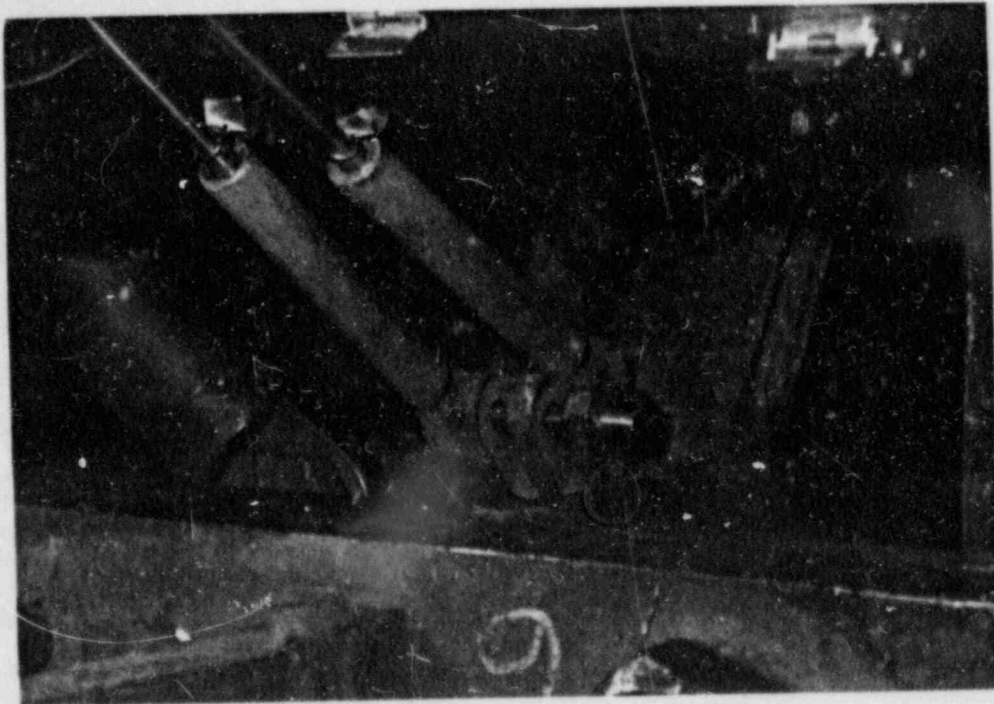
While performing this evaluation several pipe whip restraints were found to have missing cotter pins and one whip restraint was disconnected from its structural attachment (see Photograph 3.1.2). Detroit Edison advised that piping insulation was put up after the whip restraints were installed. Some restraints had to be disconnected to insulate the pipe and apparently not all the whip restraints were replaced correctly.

Photograph 3.1.2 Disconnected Pipe Whip Restraint discovered during walk down.

- (1) Perform an engineering analysis to determine if 1/2" fillet welds are acceptable for GE supplied whip restraints which were required to have full penetration welds.
- (2) Walkdown systems containing pipe whip restraints to verify field locations versus drawing locations and observe completeness of installation (i.e. no disconnected or missing parts).

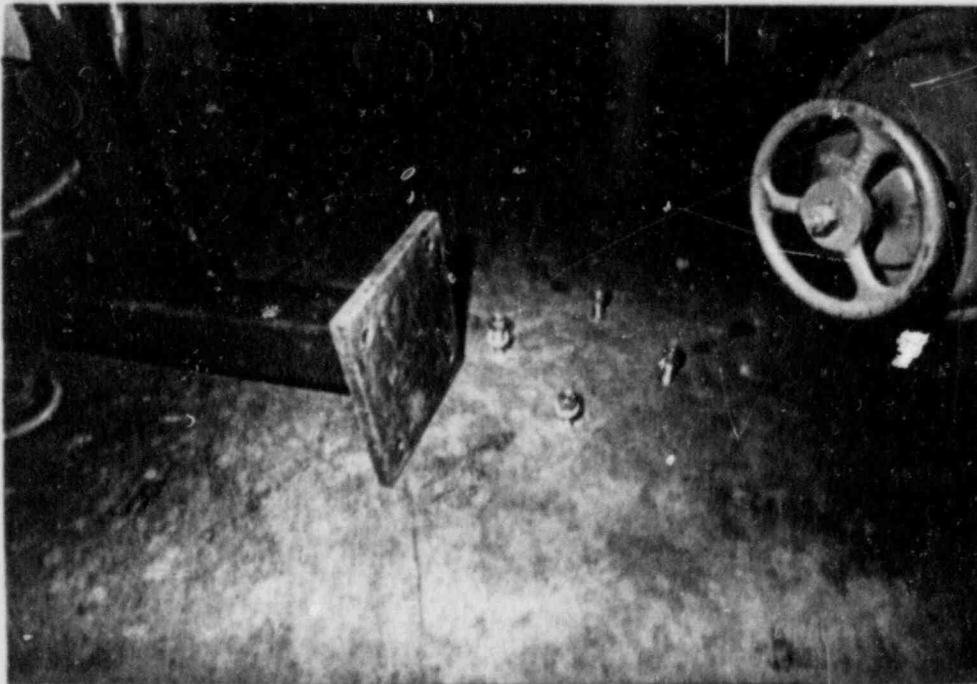
During the evaluation of the 50 expansion anchor connections, the team found that several anchors had considerably higher torque values than that shown on the latest revision of Drawing 5C721-2002. From the evaluation, it was determined that the high torque values could be caused by 1) baseplate bearing against anchor, 2) grout seepage in hole of baseplate and in threads of anchor, or 3) high

Photograph 3.1.4 Removal of support due to high torque values. Anchors were binding against side of holes on baseplate.

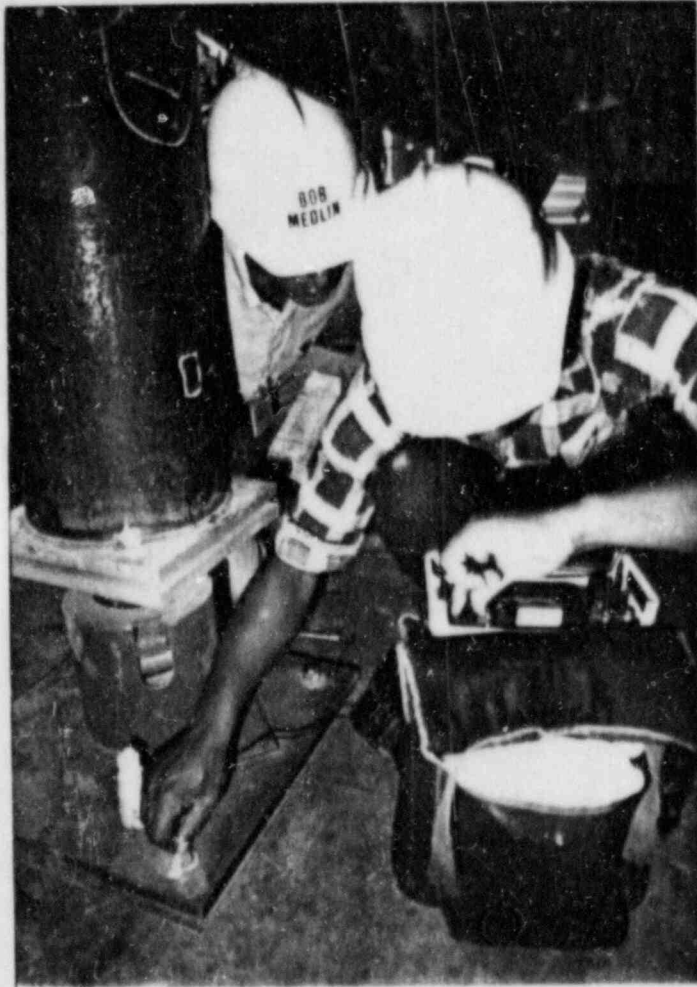
Ultrasonic examination was performed on the 50 expansion anchors to verify length. From the 50 checked there was difficulty verifying the length of some 3/8" diameter anchors. A rough edge on the end of these anchors would not produce an acceptable UT reading. However, the UT results obtained showed the expansion anchor lengths to be acceptable (see Photograph 3.1.5). Subsequent minimum embedment was checked and found to be acceptable.

Photograph 3.1.5 Observation of UT measurements used to determine expansion anchor length.

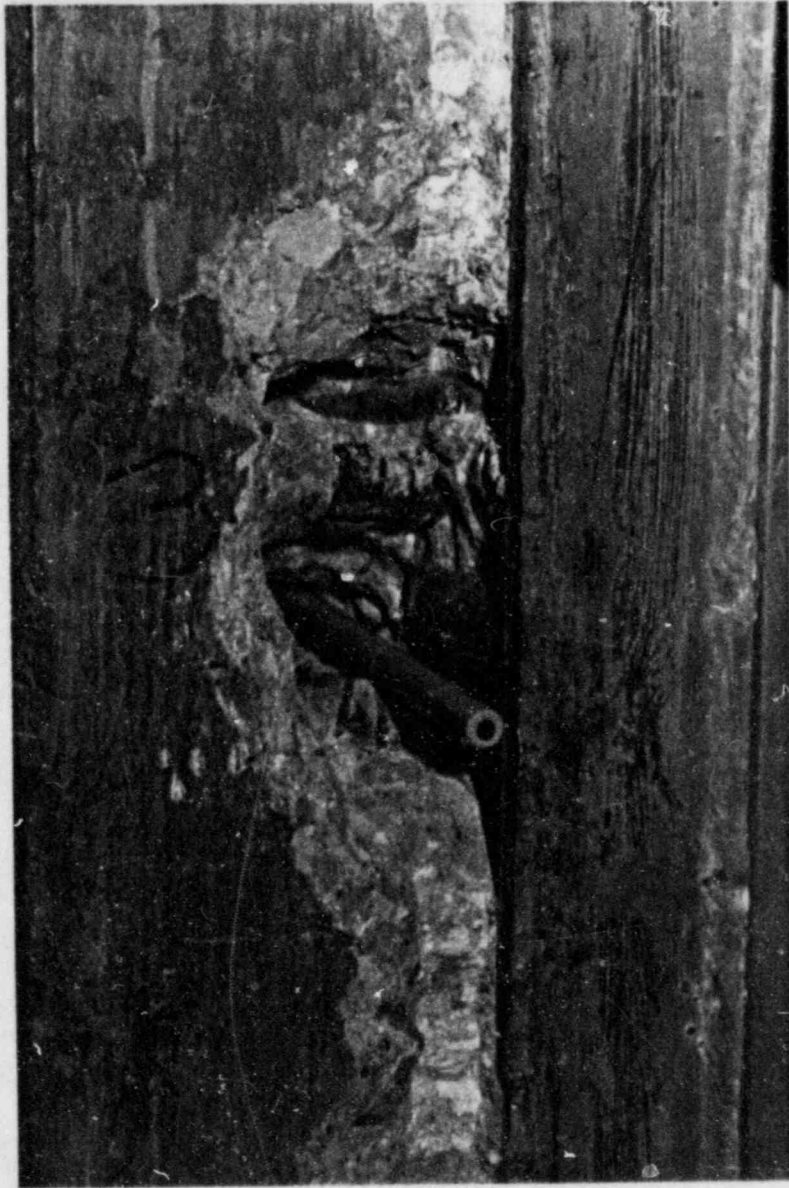
Photograph 3.2.4 Honeycomb concrete around a watertight door frame.

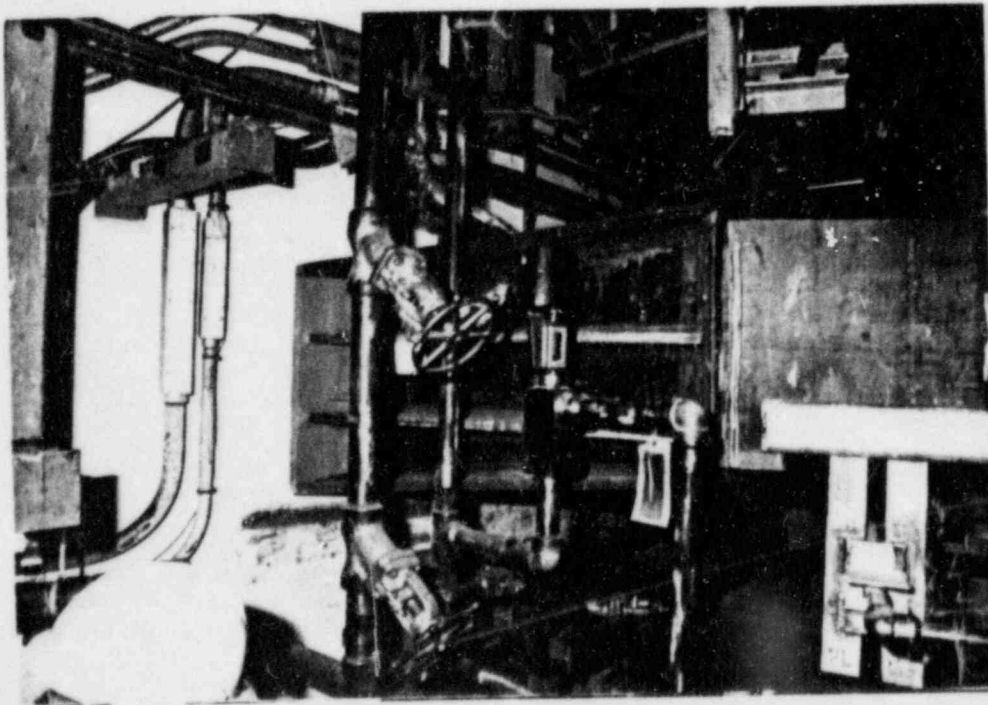
Photograph 3.4.2 Typical condition of Drywell area. The concrete wall in this area had been repaired. The restraint located in the center of this picture is not coated. The small support shown in the lower right hand corner has been properly coated, but the welds were not coated.

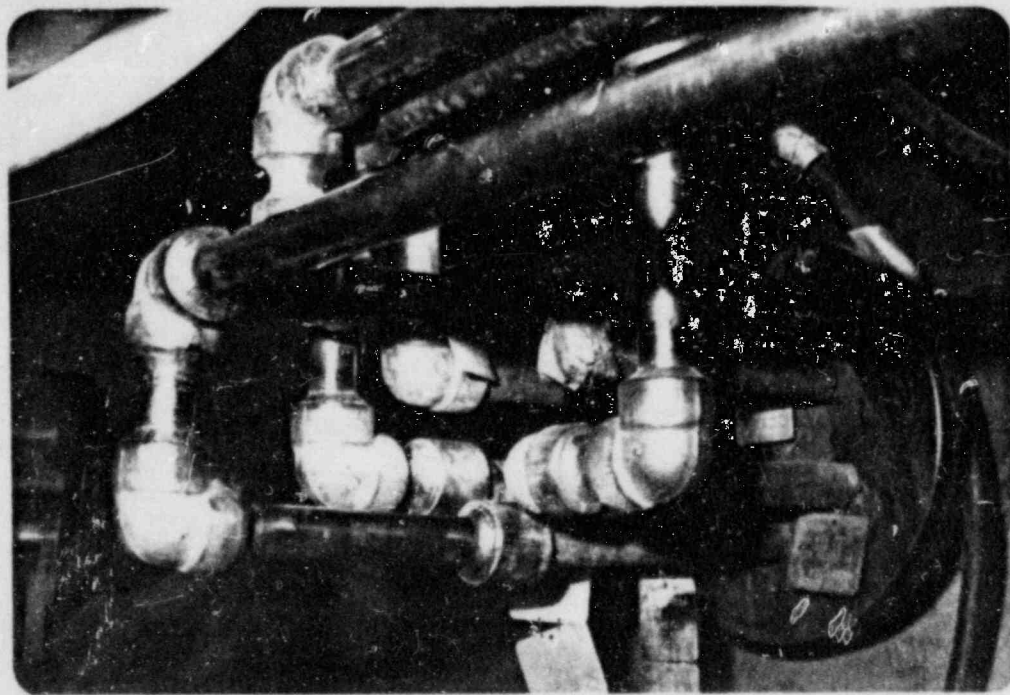
Photograph 3.6.2 Instrumentation penetration X-33A. One line covered over with tape. Should be capped off or piped up.

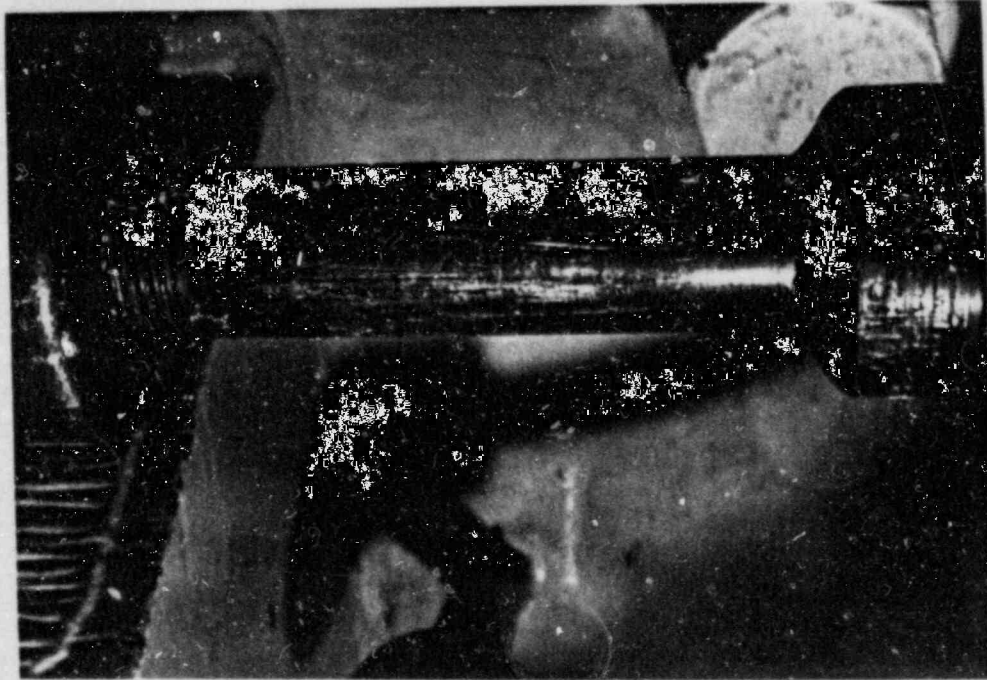
Photograph 3.7.1 Seal piping to HPCI Main Pump. Piping shows severe scoring by pipe wrench during assembly and/or disassembly.

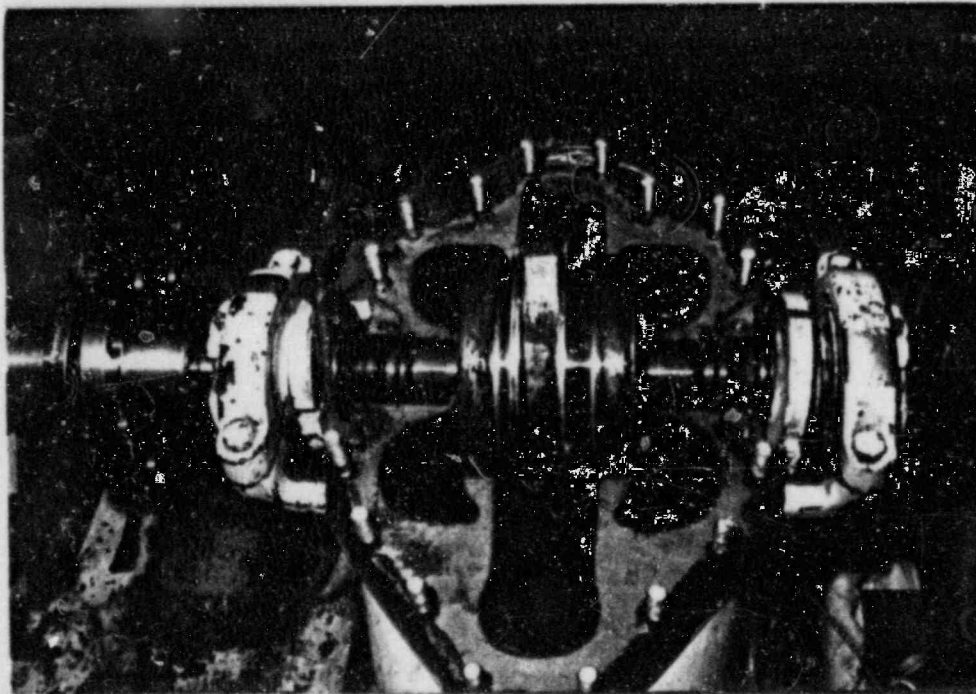
Photograph 3.7.3 EECW Pump (Div. II)-Pump disassembly. Lower half of pump casing assembly showing condition of internal surfaces as well as poor condition of coating on external surfaces.

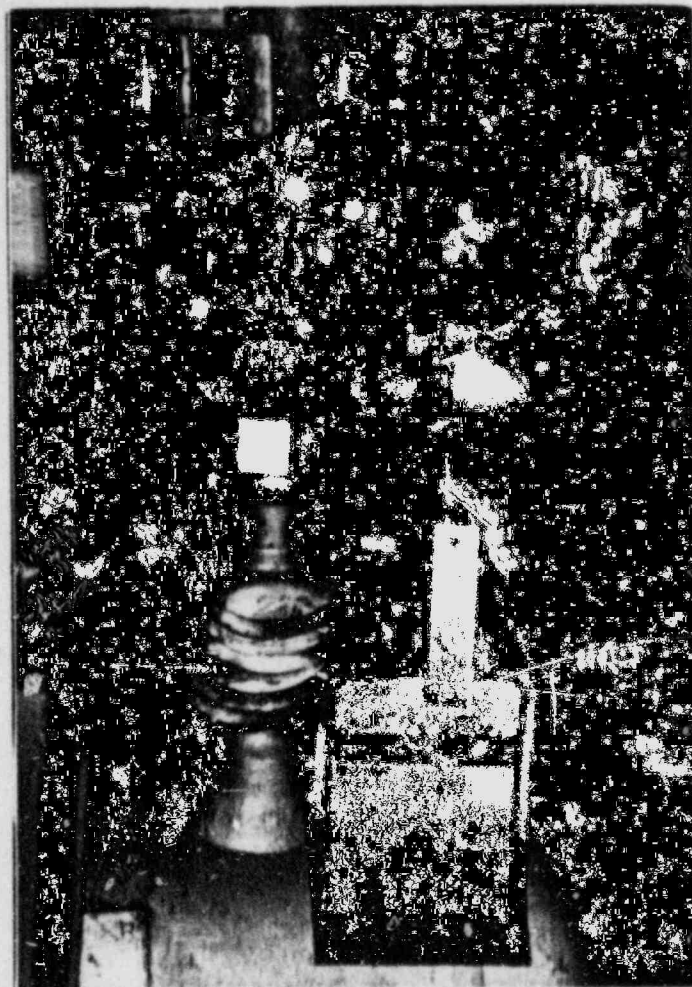
Photograph 3.7.6 HPCI Turbine Exhaust Steam Line Drain Pot Level Sensing Instrument (E4100-N018). This instrument controls a Class B valve (V8-2212) and is QA Level 1. The instrument cover was not secured and the cooling fins were badly damaged. No tags indicating that this problem had been formally reported were present.

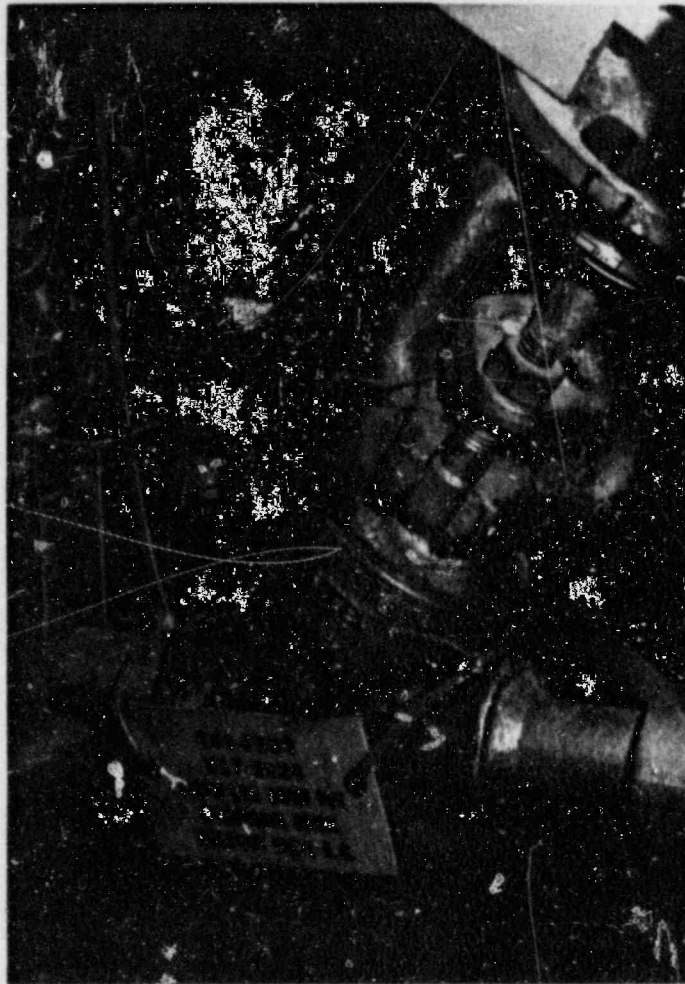
Photograph 3.7.7 Severe Corrosion of HPCI System Valve V17-2024 Yolk.

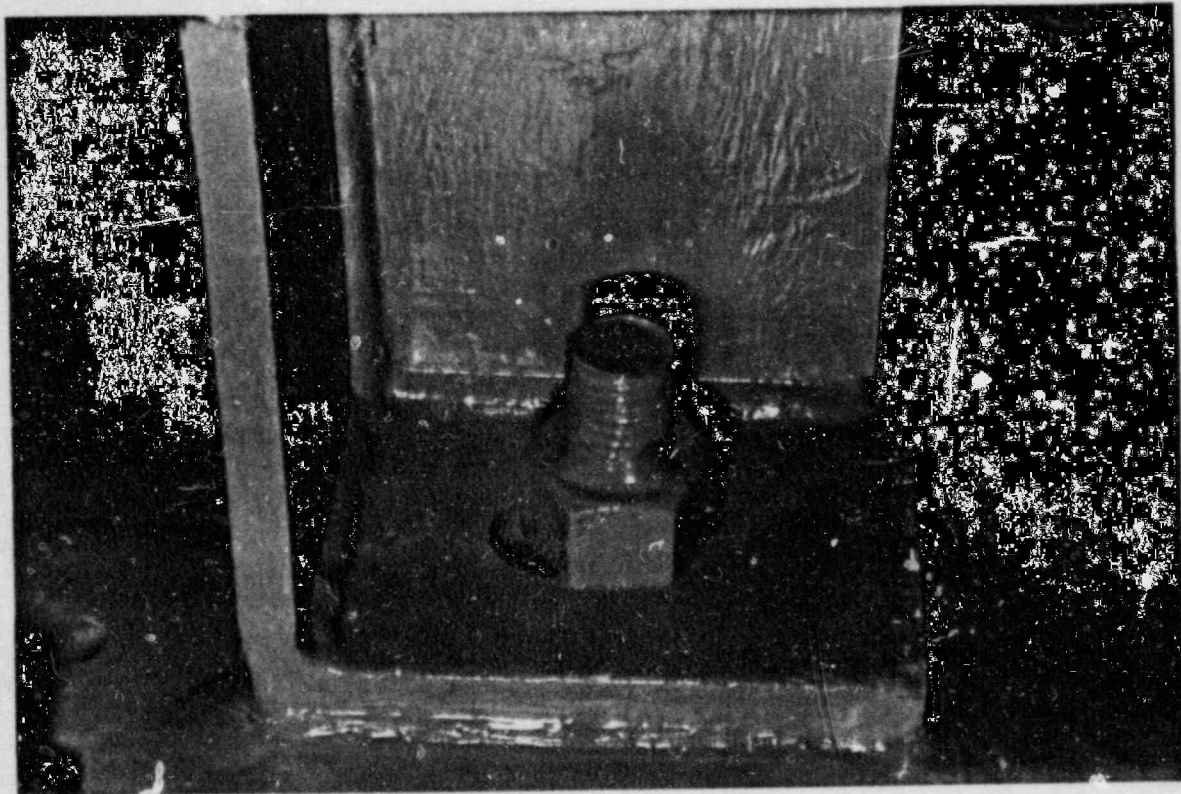
Photograph 3.7.9 EECW heat exchanger-sliding support slotted anchor bolt hole. Potential lack of clearance for thermal expansion shown.

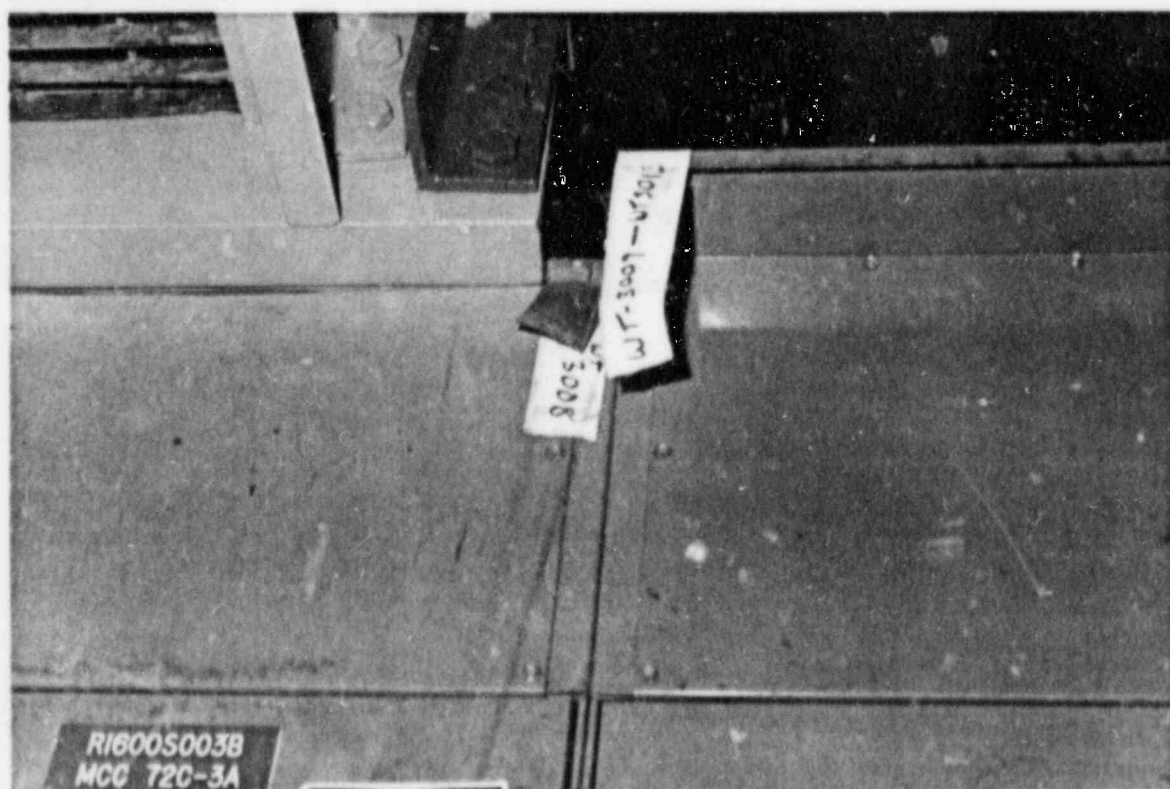
Photograph 3.10.1 MCC 72C-3A with EECW piping overhead and stair landing in direct contact.

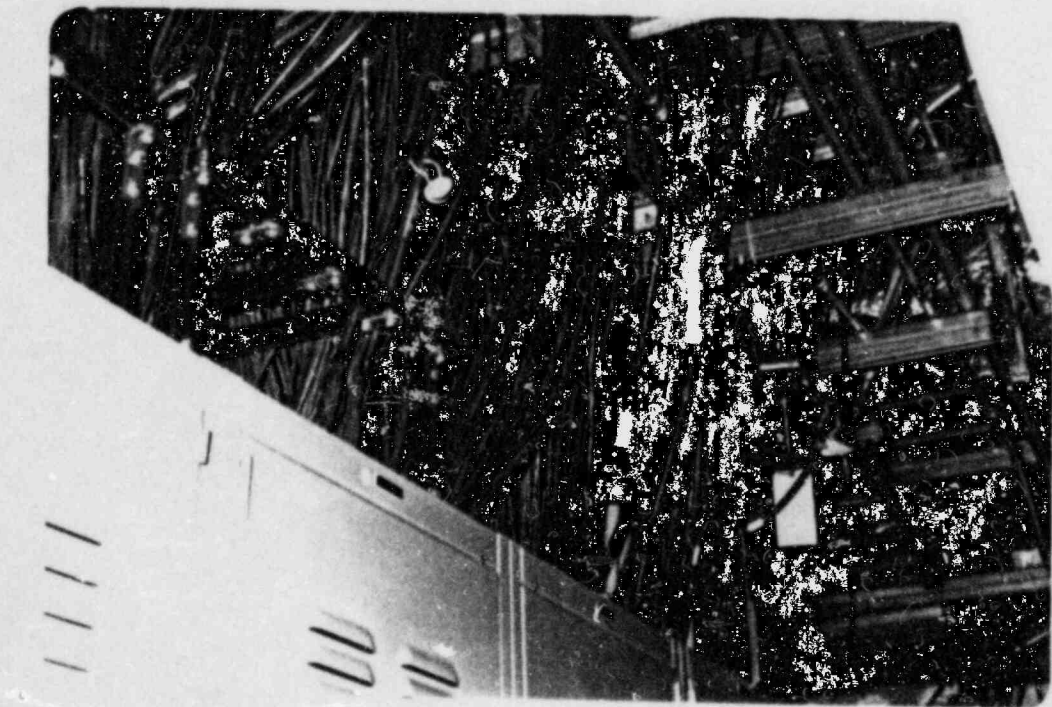
Photograph 3.11.1 Example of cables entering cabinets from above without specified grip supports.

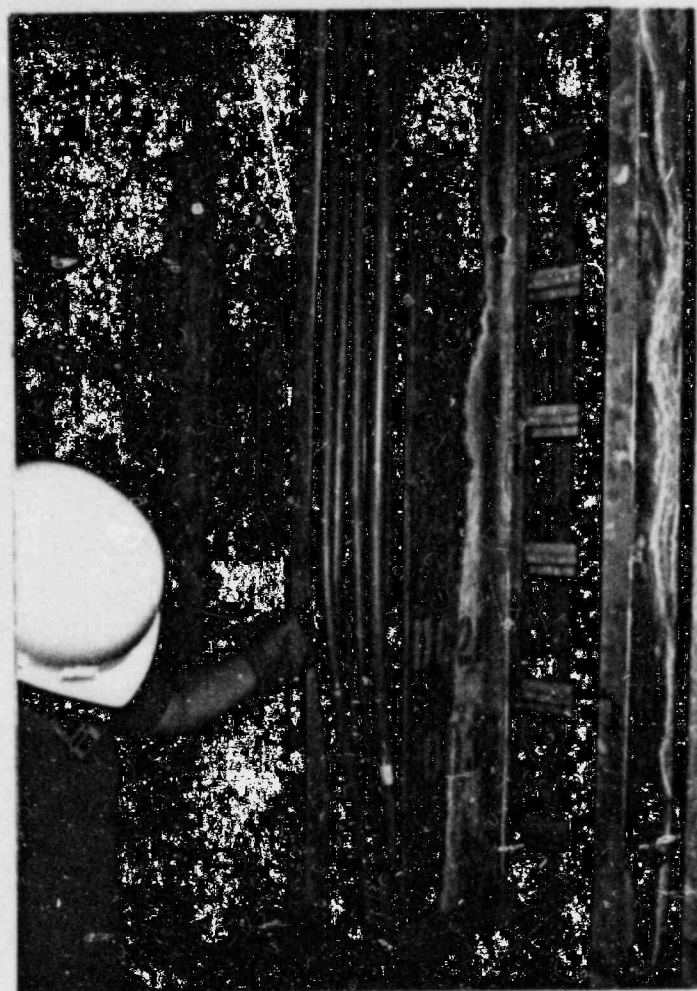
Photograph 3.11.2 Cables installed in vertical tray-cables not attached to tray.

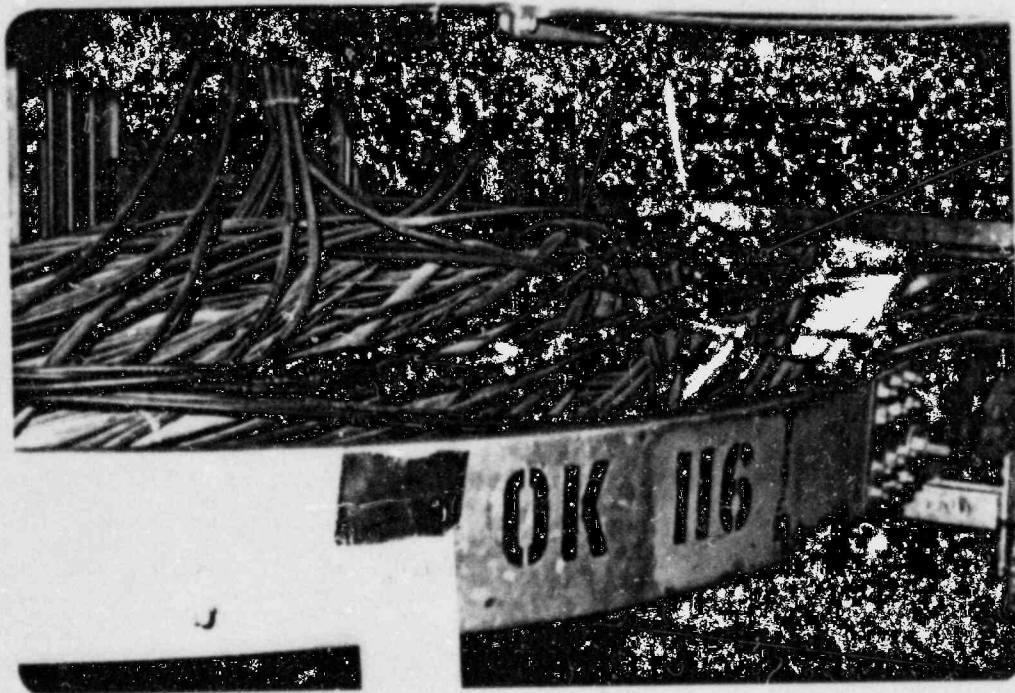
Photograph 3.11.3 Example of cable tray overfill.

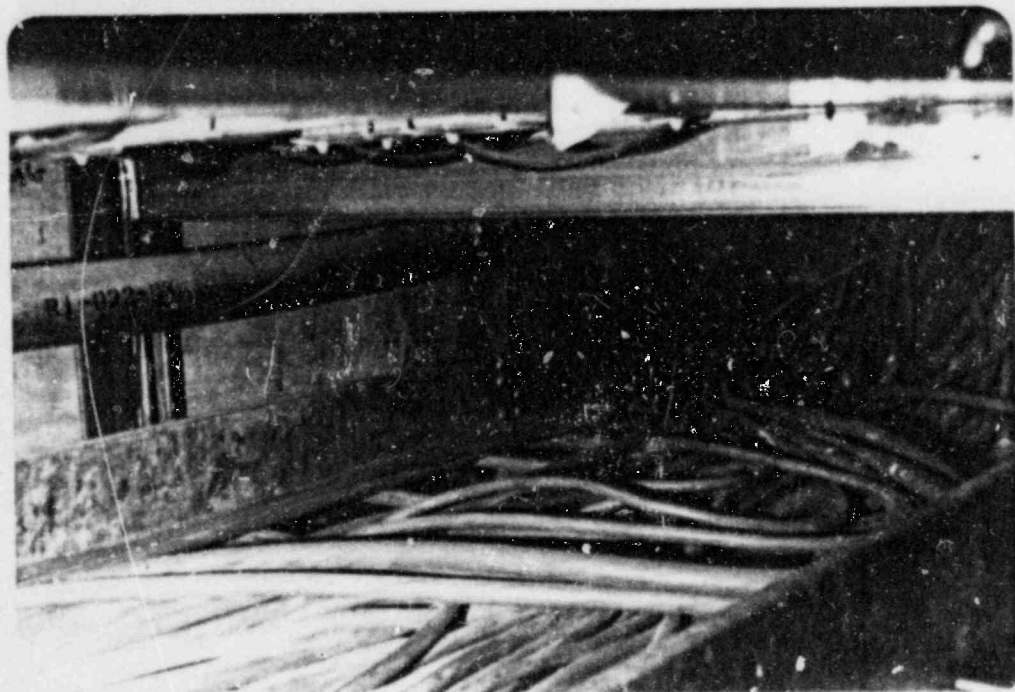
Photograph 3.11.4 Cables not installed in a neat manner in cable tray.

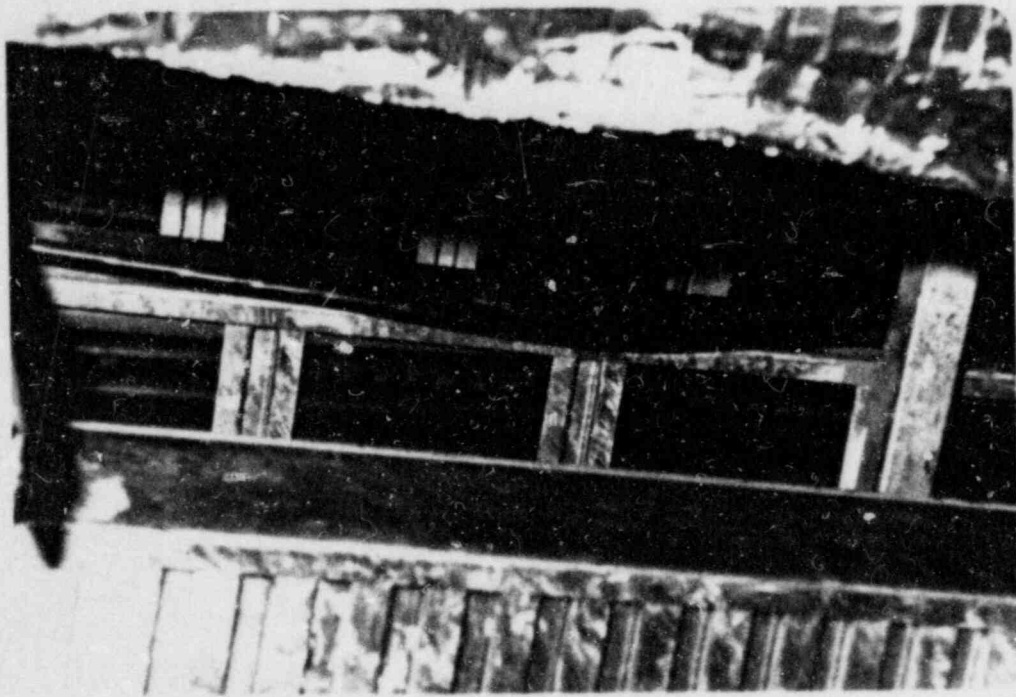
Photograph 3.11.6 BOP cable installed outside cable tray.

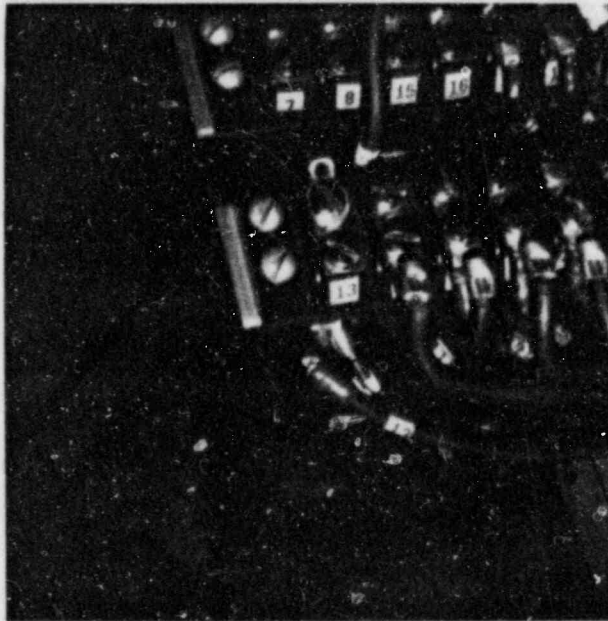
Photograph 3.12.1 Example of a broken terminal lug on connections to limit switch terminations on electric motor operated valve.

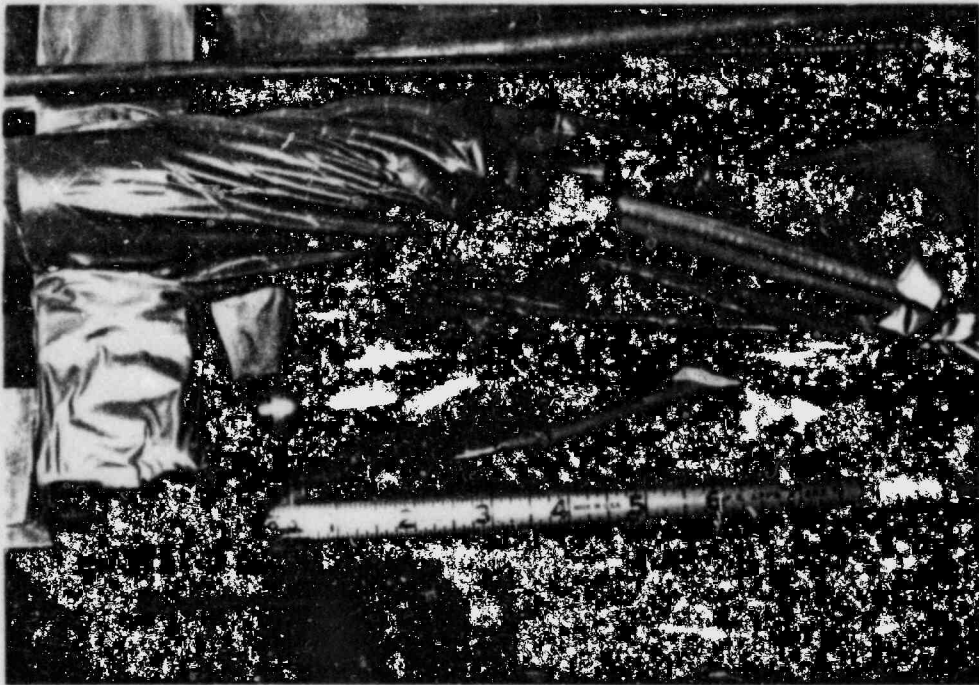
Photograph 3.13.1 Example of radiation monitor cable disconnection at sensor.

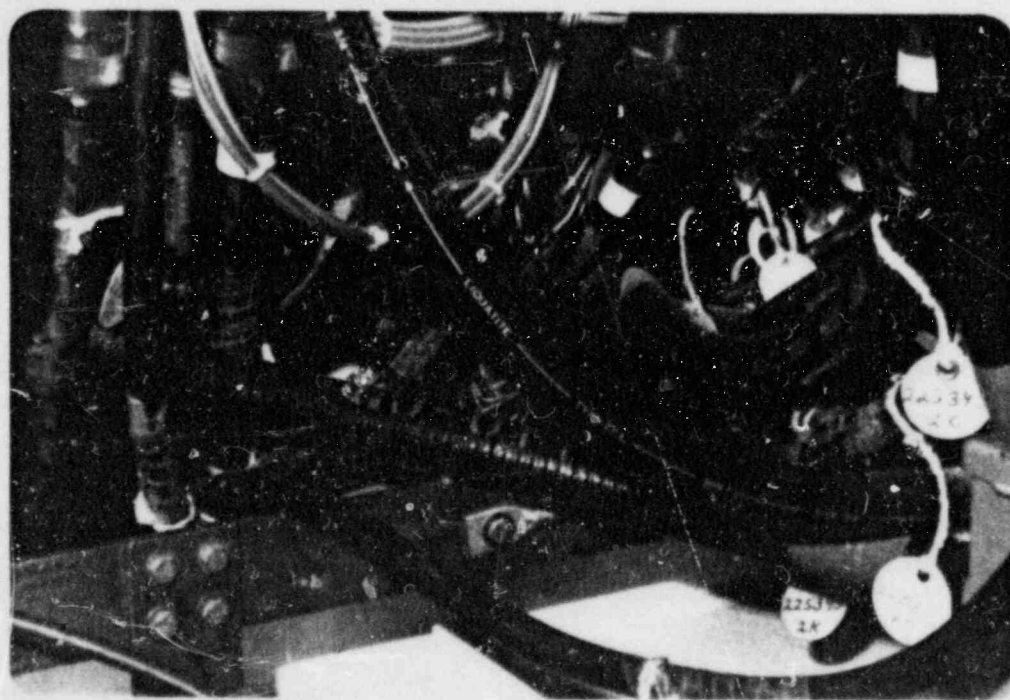
Photograph 3.14.5 Separation problem in control boards Division I and II cables in violation of separation criteria.
