Subject: Byron and Braidwood Stations Units 2 and 3
Response to IE Bulletin 84-03
NRC Docket Nos. 50-454/455 and 50-456/457

RESPONSE TO IE BULLETIN 84-03
REFUELING CAVITY WATER SEAL

BYRON AND BRAIDWOOD STATIONS

Evaluation of Byron/Braidwood Refueling Cavity Water Seal

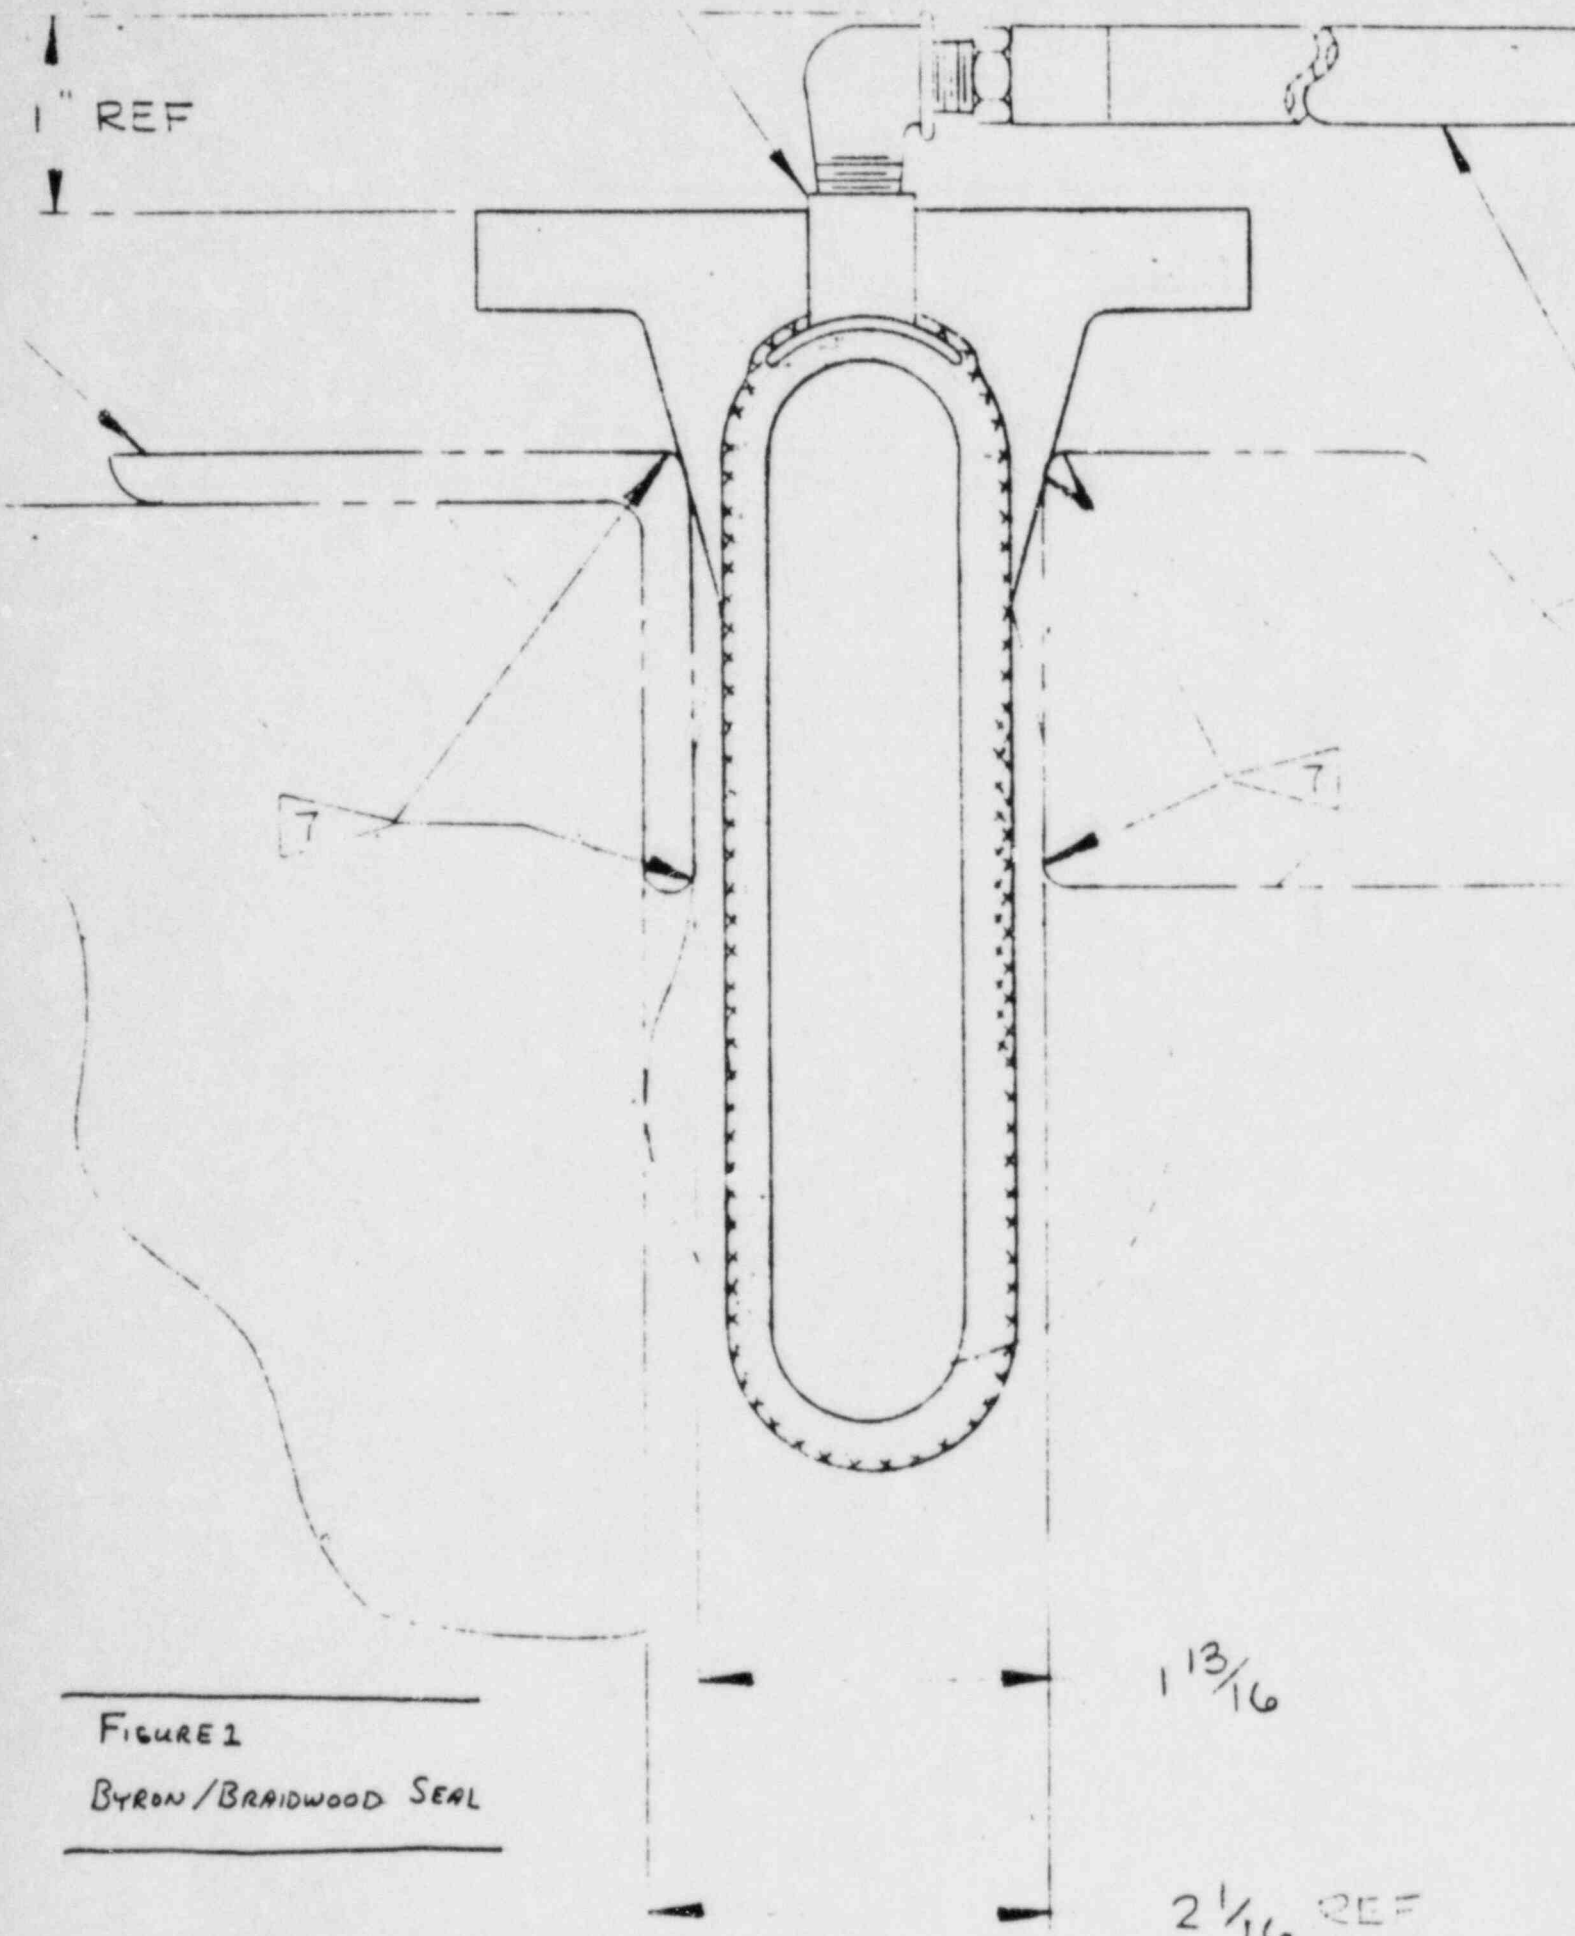
FIGURE 1

The Byron/Braidwood refueling cavity seal consists of a single split-joint type PRS 585 inflatable rubber ring supplied by the Presway Corporation. Figure 1 shows a cross section of the Byron/Braidwood seal. Figure 2 shows a cross section of the Haddam Neck seal arrangement. The major difference between the two designs is the steel ring in the HN seal which requires that two inflatable rubber seals be in place on either side of the ring. The ring is about one foot wide with a two inch gap on each side of it. The ring is supported by nine hangers (strongbacks) arranged around the reactor vessel flange. It is reported that this ring can be displaced horizontally, (there is no alignment fixture for the seal ring) thus changing the width of the gaps on each side of the ring. It is believed by Presway that this actually happened and contributed to failure of the seal. The Byron/Braidwood seal consists of a single rubber seal, similar to one of the Haddam Neck seals, but with a fixed, unadjustable gap width. The problem of misalignment therefore does not exist at Byron/Braidwood.

These dimensions are all in the conservative direction against failure of the Byron/Braidwood designs in the event of overinflation. Overinflation of the seal is thought to cause failure by causing the seal top to buckle downward. This effect combined with the water pressure from the filled cavity forces the seal through the cavity floor gap. The Byron/Braidwood seal top is made of harder rubber and is wider than the Haddam Neck design and therefore less susceptible to buckling. Also, the gaps at Byron/Braidwood are narrower than the Haddam Neck gaps, and more importantly, not adjustable.

BYRON/BRAIDWOOD SEAL

Although very unlikely to occur, this event has potentially serious consequences. Therefore we are adding precautions to the station fuel handling procedures to ensure that the seal is inflated to an acceptable pressure range. The seal dimensions and the reactor vessel/refueling cavity floor gap tolerances will be checked against design values, and the design will be reviewed with the supplier. Unless further information from the Haddam Neck event warrants it, neither we nor the seal supplier are recommending any design changes to the Byron/Braidwood seal at this time.

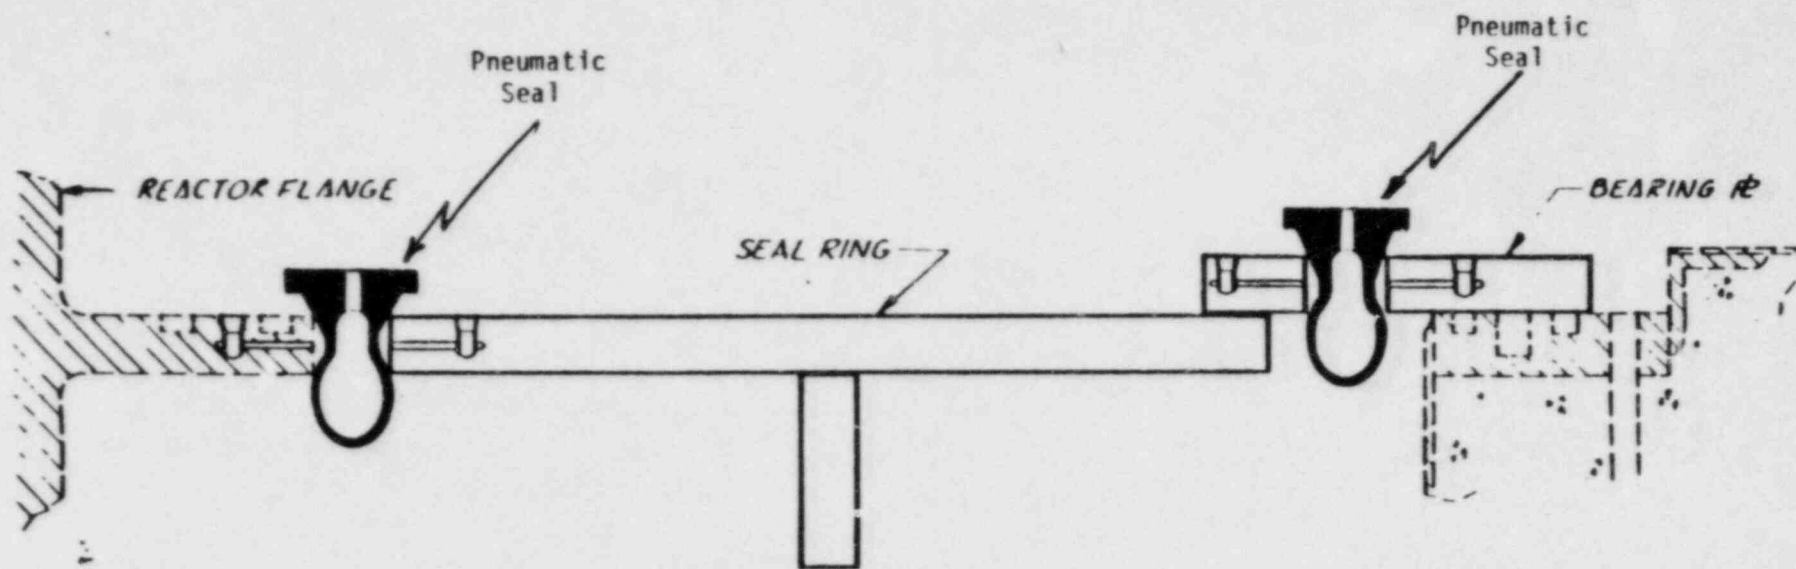
Important design differences between the Byron/Braidwood refueling cavity seal and the Haddam Neck seal make a loss-of-seal integrity event at Byron/Braidwood significantly less likely to occur. Discussions with the seal supplier and the Haddam Neck staff indicate the cause of the seal failure to be misalignment and/or overinflation of the seal bladder, or improper design tolerances. Based upon these discussions and the evidence to date, it is our opinion that overinflation of the seal to the pressure reported at Haddam Neck without a corresponding misalignment or out-of-tolerance problem with the seal would not cause a seal failure at Byron/Braidwood. Since the Byron/Braidwood design does not require alignment of any sort, we conclude that occurrence of this event at Byron/Braidwood remains very unlikely.

- (1) There are two gaps in the Haddam Neck seal arrangement as shown in Figure 2.
- (2) The durometer readings of the seal top are 60 and 40 for the Byron/Braidwood and Haddam Neck seals respectively.
- (3) The Haddam Neck seal was reportedly inflated to about 40 psig at the time of failure.

Figure 2 - Haddam Neck Refueling Cavity Water Seal
