September 18, 1984
ANPP-30551-TDS/TRB

Subject: Final Report - DER 84-38
A 50.55(e) Reportable Condition Relating To Improperly Welded
Flange In Unit 2.
File: 84-019-026; D.4.33.2

FINAL REPORT - DER 84-38
DEFICIENCY EVALUATION 50.55(e)
ARIZONA PUBLIC SERVICE COMPANY (APS)
PVNGS UNIT 2

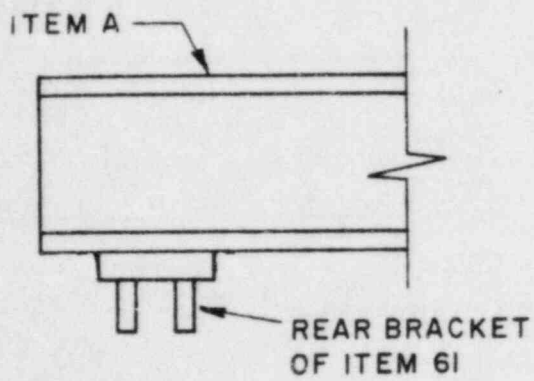
PARTIAL SECTION LOOKING WEST
DESIGN CONDITION

Pipe support #13-AF-005-H-007, Rev. 1, was installed and accepted in Unit 2 by Field Engineering and Quality Control in November of 1981. The existing documentation required the miscellaneous steel (Item A) to be installed at an evaluation of 85'-0 3/4" and the beam attachment of sway strut (Item 61) to be welded to Item A on the north and south sides (see Figure 1). Documentation was prepared in March of 1984 to partially disassemble this support for piping rework. Upon completion of the piping work and reassembly of the support, two discrepancies in the original installation were noted in NCR PC-8250:

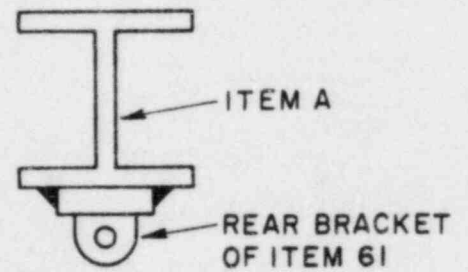
SECTION LOOKING NORTH
INSTALLED CONDITION

1. The miscellaneous steel (Item A) is installed at elevation 85'-3".
2. The rear bracket (of Item 61) is welded on the east and west sides.

The root causes of the deficiency described herein are (a) the craftsman did not install the pipe support per design drawings and (b) the field engineer and the quality control inspector approved the incorrect installation. A recent investigation revealed that none of the people responsible for this deficiency are presently employed at the PVNGS jobsite.

The change in elevation of miscellaneous steel (Item A) also lengthened the overall dimension from beam bracket to centerline of pipe of sway strut (Item 61) from 2'-8 3/4" to 2'-11". This causes no additional loading or induced stresses in Item A and the existing sway strut length is still within vendor requirements for the design loading condition so the structural integrity of the pipe support is not degraded.

However, with the beam attachment welded on the east and west sides, the bottom flange of Item A will not induce loads to the structural member as intended. This results in exceeding the structural capacity of the bottom flange during a DBE. Once the capacity of the support has been exceeded, piping stresses will reach unacceptable levels. Based upon the above, this condition is evaluated as reportable under the requirements of 10CFR50.55(e); since, if left uncorrected, it would be a significant safety hazard.

- A. NCR PC-8290 will be dispositioned repair to add additional weld on the north and south sides of the beam attachment.
- B. As part of the corrective action identified in the response to the NRC Enforcement Letter and Notice of Violations, dated 12/12/83 (Violations II.B.3 and II.B.4), Bechtel Construction initiated a comprehensive reinspection program established under WPP/QCI 543.0. This reinspection program included 2199 pipe supports and pipe racks in Unit 1. All nonconforming conditions noted during the reinspection program were documented on NCRs PX-7370 and PA-7313. The "as-built" calculations indicate that the installed conditions of all welding nonconformances are sufficient to carry the project design loads. Therefore, the installed pipe supports were found to be acceptable without repair.
