Docket No. 50-346

September 27, 1984

This is in response to your August 24, 1984 letter, IE Bulletin 84-03 (Log No. 1-1021), concerning Refueling Cavity Water Seal. Specifically, Toledo Edison has evaluated the potential for, and consequences of, a refueling cavity water seal failure at the Davis-Besse Nuclear Power Station and this letter provides a summary of that evaluation.

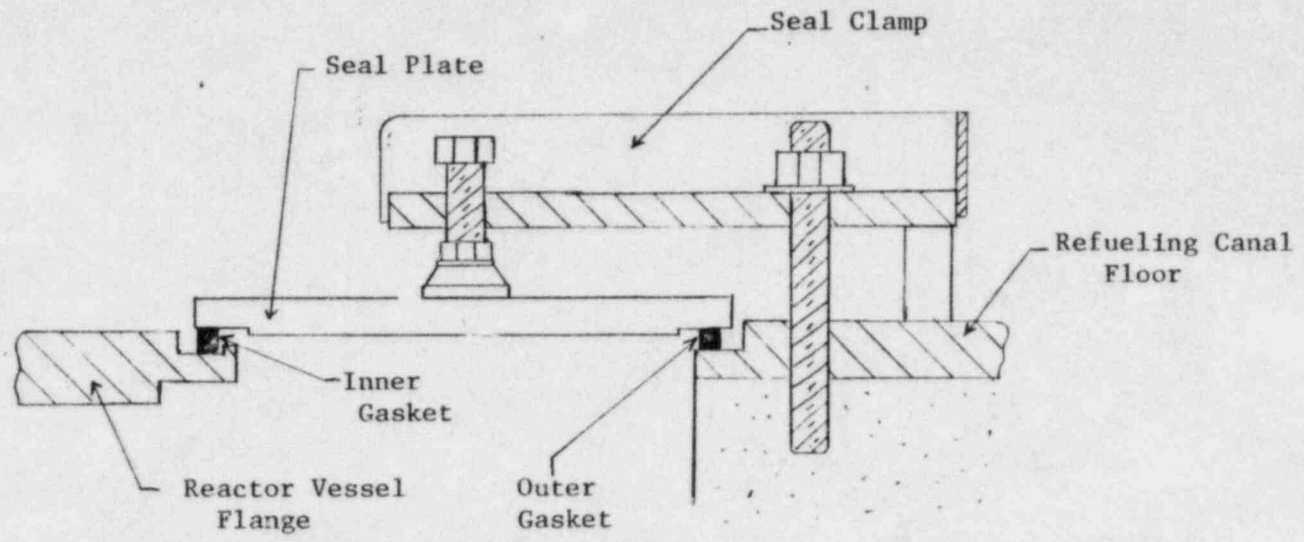
Figure 1

The seal ring arrangement at Davis-Besse is a passive system. There are no active components, such as pressurized seals, involved in the design. A cross sectional sketch of the seal ring configuration is provided in Figure 1.

The seal ring is a continuous ring of stainless steel plate wide enough to span the gap between and overlap the reactor vessel flange and the refueling canal floor. The seal ring sits in a depression on the vessel flange and the canal floor. A rubber gasket is placed between the seal ring and a groove in each seating surface. The rubber gasket is designed to accommodate any difference in elevation between the vessel flange and canal floor. The seal plate is held in place by 36 adjustable clamps, which are torqued in a specified sequence to apply a downward pressure on the seal ring. An additional seal is provided by applying a commercial sealant to the inner and outer edges of the seal ring after the holddown clamps have been adjusted. Toledo Edison considers a gross seal failure of this arrangement to be an extremely low probability event.

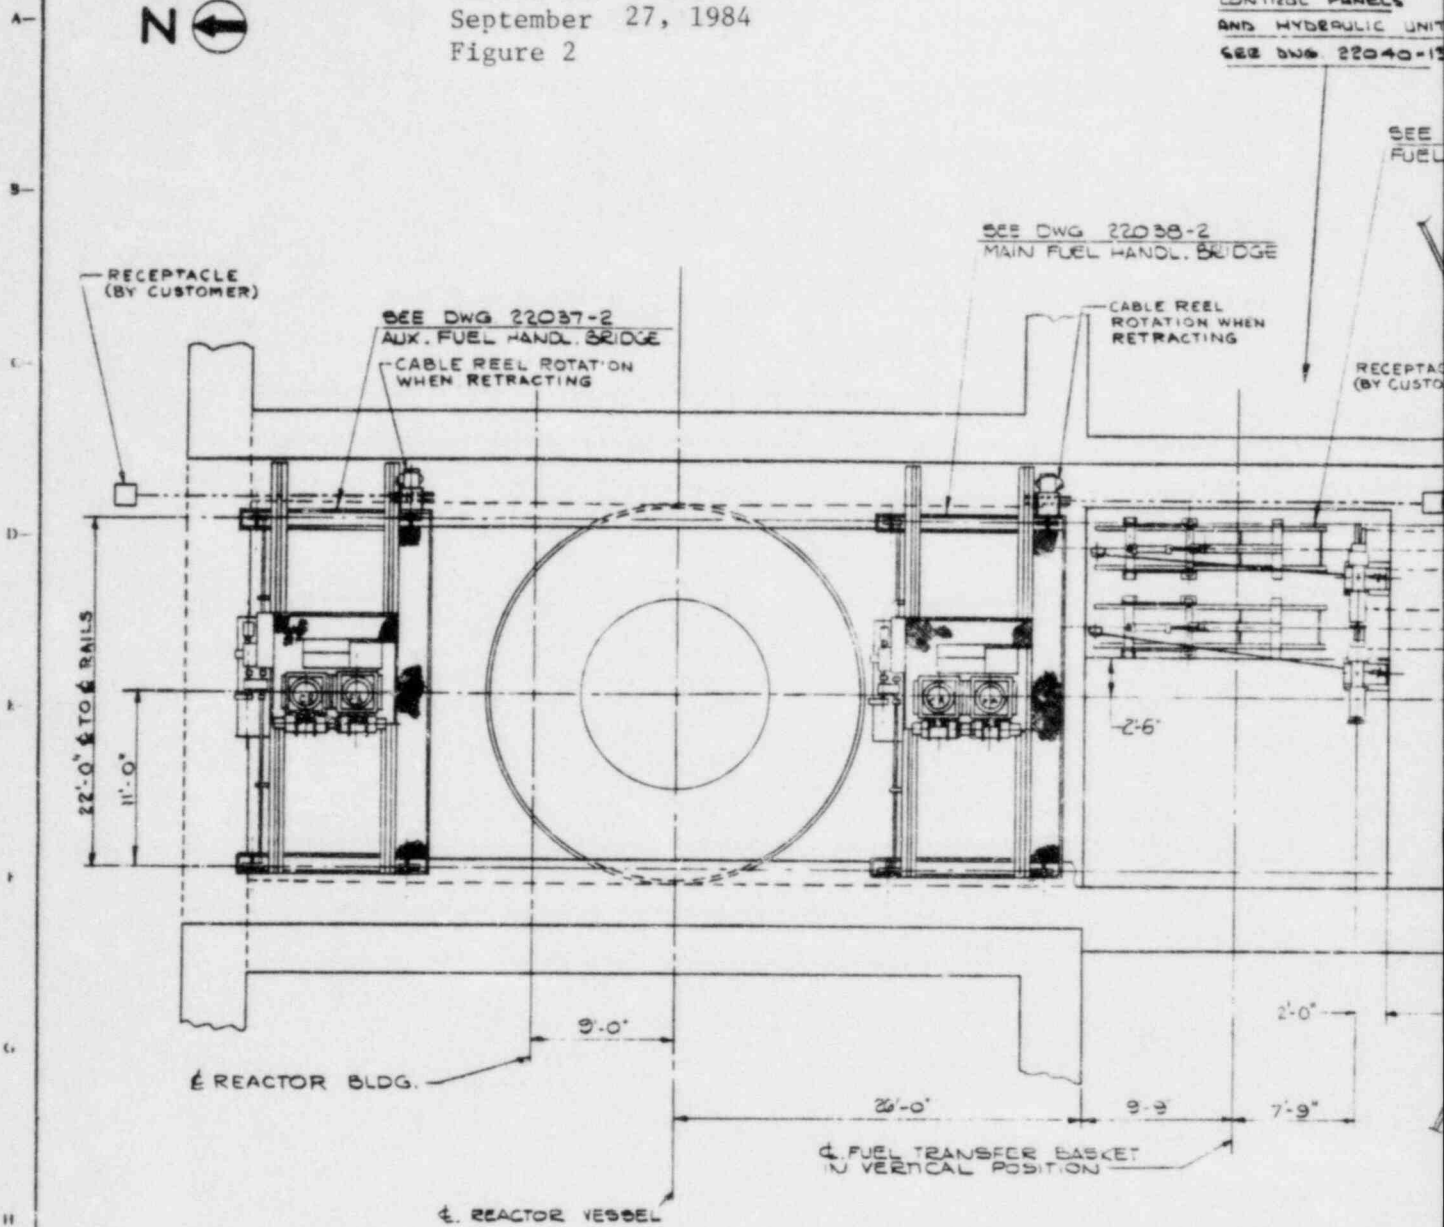
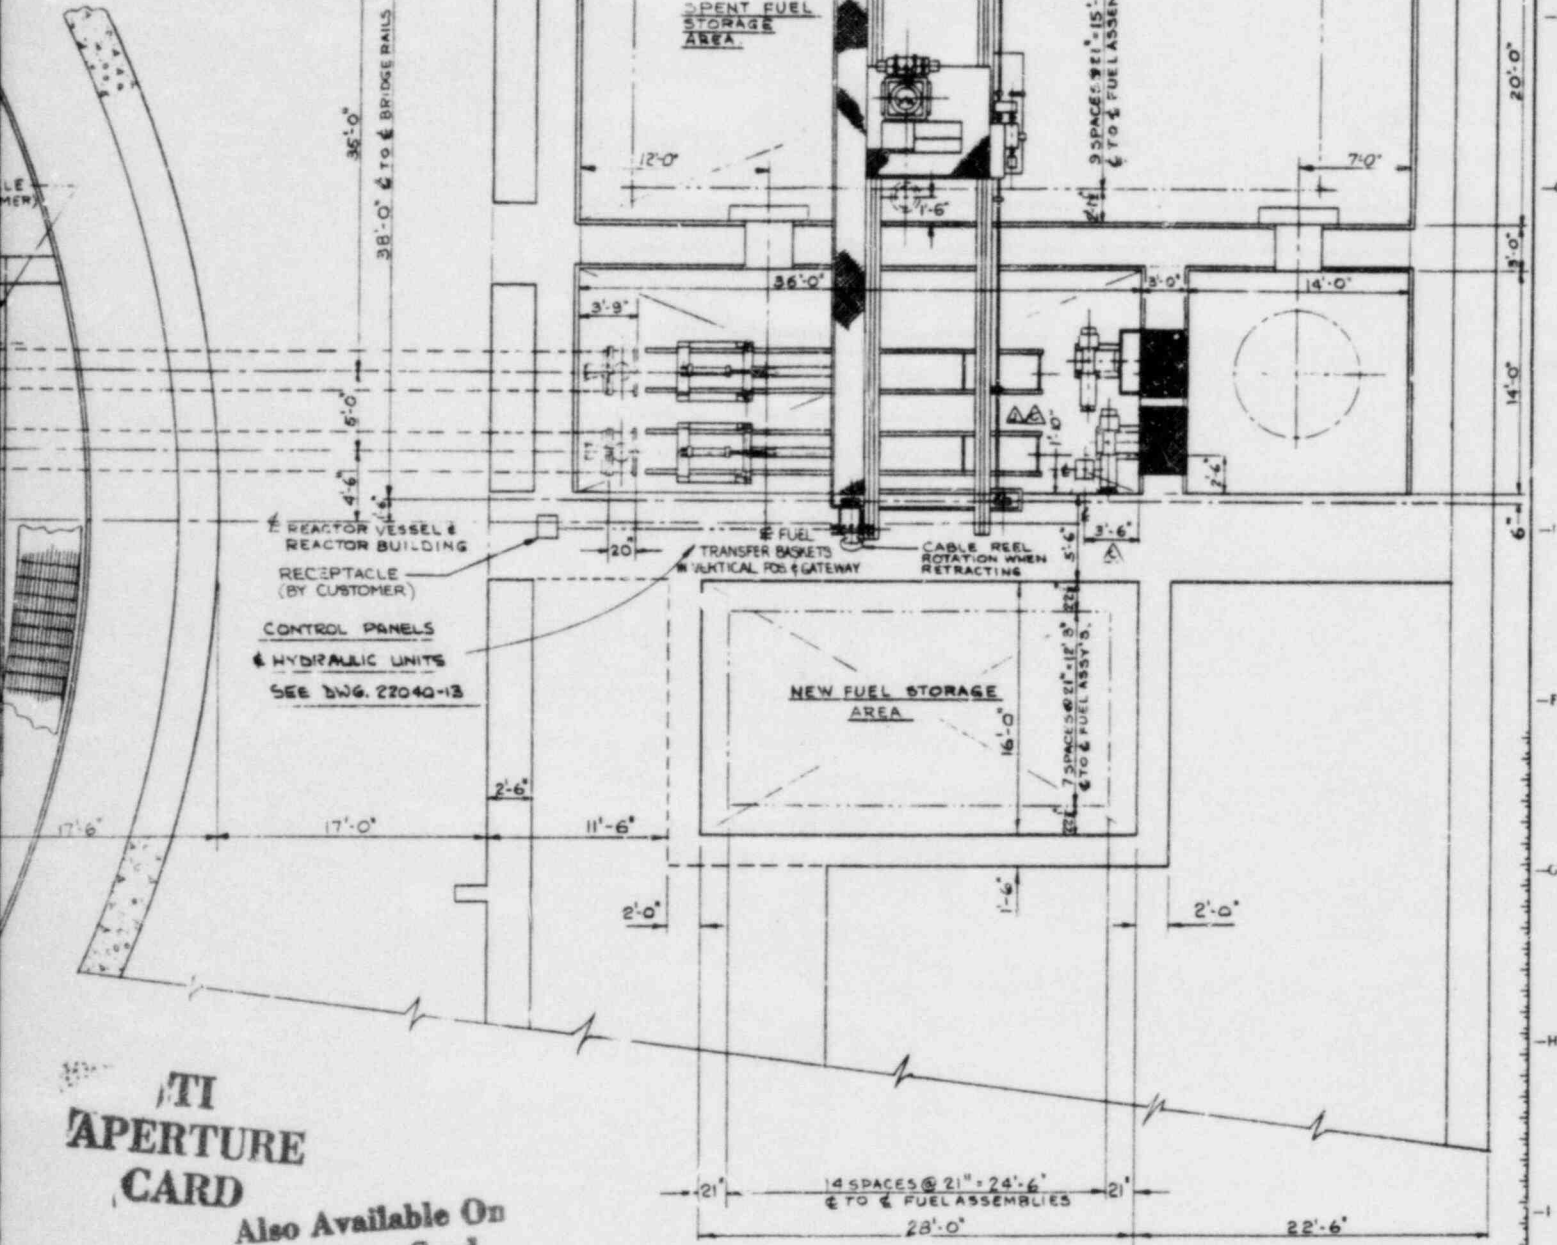
Docket No. 50-346
 License No. NPF-3
 Serial No. 1-466
 September 27, 1984
 Figure 2

Figures 2 and 3 illustrate the configuration of the Davis-Besse Fuel Handling equipment and the areas flooded during fuel handling activities. The refueling canal inside containment is connected to the Auxiliary Building by two fuel transfer tubes. At either end of the transfer tubes are the upender mechanisms for the fuel transfer system. These devices rotate fuel assemblies between the vertical and horizontal positions necessary for fuel handling or fuel transfer between buildings.

In containment, the upender mechanisms are located in the lowered section of the refueling canal, such that the top of a fuel assembly located in an upender mechanism in the vertical position will be approximately level with the vessel flange and main refueling canal floor.

The upender mechanisms in the Auxiliary Building are located in a separate pool area which can be isolated from the spent fuel storage area by a movable gate. Additional isolation between the containment and Auxiliary Building can be provided by large gate valves on the Auxiliary Building end of the fuel transfer tubes. The gate valves are manually actuated from the top of the pool.

During refueling operations, the refueling canal, spent fuel storage area, and the fuel transfer pool in the Auxiliary Building are all inter-connected and flooded to within about two feet of the top of the refueling canal. There are no active components, such as pressurized seals, in this configuration.

If a gross seal ring failure is assumed during refueling activities and no operator action is taken, the refueling canal, spent fuel storage pool, and fuel transfer pool water level would drain to the level of the reactor vessel flange. Fuel assemblies located in the reactor vessel would continue to be cooled by the decay heat removal system.

Any fuel assemblies located in the fuel handling mast of any of the three fuel handling bridges would be completely uncovered and could not be cooled. In such a condition, an estimate of the time to cladding failure, from the time the assembly is exposed, is approximately 30 minutes.

Any fuel assemblies located in the spent fuel storage area, in any of the upender mechanisms, or in the temporary holding racks located in the deep end of the refueling canal along side the upender mechanisms (not shown on drawings), would be immersed in water to a depth of approximately three inches over the top of the fuel pins. Cooling of these assemblies would be limited to heat transfer to the surrounding water.

While Toledo Edison does not believe that gross seal ring failures are a realistic concern, the fuel handling bridge operators have been given instructions to deal with a decreasing refueling canal level. The objective of the instructions is to maximize the level of water over any spent fuel assembly. The instructions include:

Fuel assemblies in the masts of fuel bridges inside containment are to be placed in an upender mechanism or in the reactor vessel.

Fuel assemblies located in the upender mechanisms are to be placed in the horizontal position.

Fuel assemblies located in the temporary racks in the refueling canal are to be moved to the reactor vessel or to the upender mechanism.

Fuel assemblies in the mast of the fuel transfer bridge in the spent fuel area are to be lowered into the spent fuel storage area rack.

The gate between the spent fuel storage area and the adjoining pool in the auxiliary building is to be put in place.

If time permits, the cables which drive the transfer mechanisms are to be removed to allow complete closure of the gate valves on the Auxiliary Building end of the transfer tubes. In any case, the gate valves are to be closed as tightly as possible.
