IE Circular No. 79-02
Date: January 16, 1979
Page 1 of 3

FAILURE OF 120 VOLT VITAL AC POWER SUPPLIES

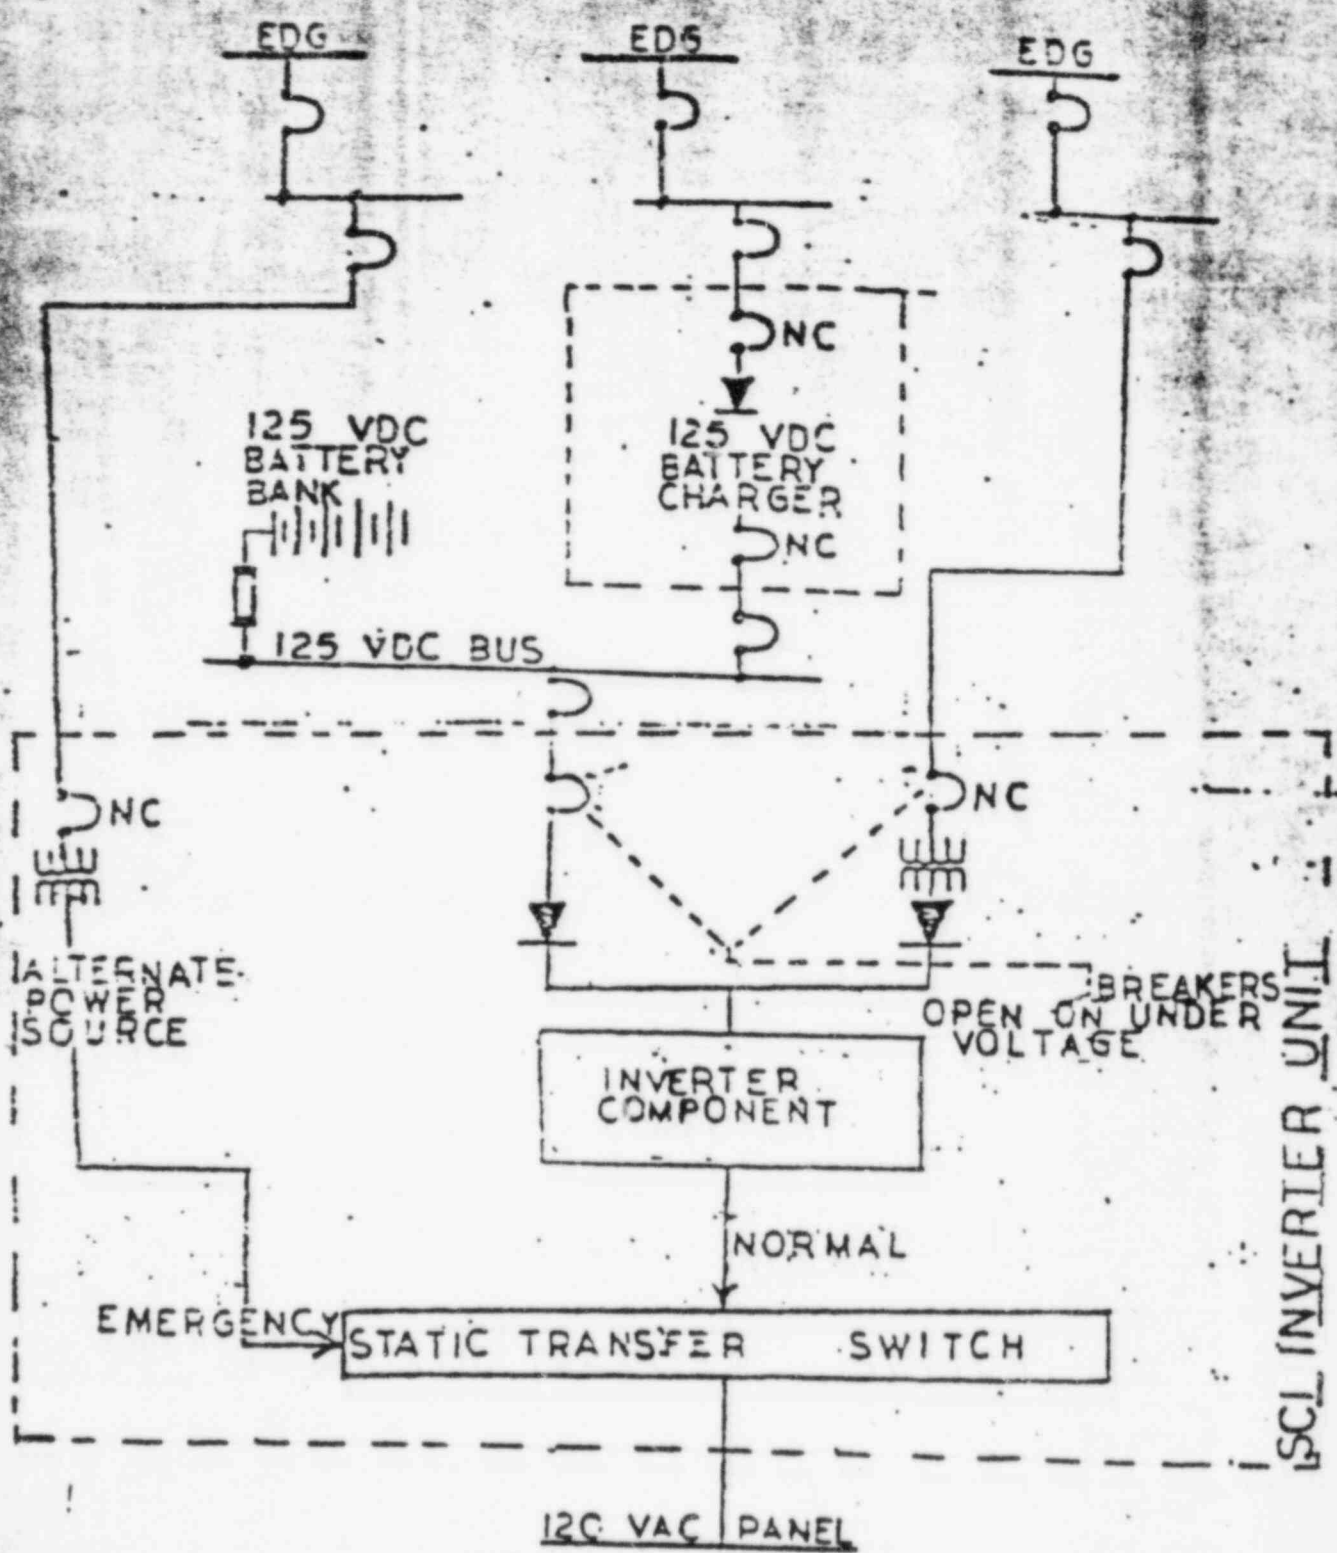
FIGURE 1
SINGLE LINE DIAGRAM - 120 VAC

On September 16, 1978, Arkansas Nuclear One - Unit 2, while in hot functional testing preceding initial criticality, suffered a degradation of both of the independent off-site power sources. This produced an undervoltage condition on the Engineering Safety Features (ESF) Buses and caused an inadvertent ESF actuation. The licensee determined that the ESF actuation occurred on a loss of at least two of the uninterruptible 120 volt vital AC power sources. Immediate investigation revealed that all four of the Solidstate Controls, Inc., (SCI) inverter static switches had automatically transferred to the alternate power supply (the 120 volt AC being supplied by transformers directly off the ESF buses rather than from the inverter output). Figure 1 (attached) shows the functional interconnection of the 120 volt AC power supply system.

A single conclusive cause of the undesired SCI inverter static switch transfer could not be identified. However, the following problems were discovered during subsequent investigation.

- (a) The SCI inverters have circuitry to monitor the incoming DC voltage level which, on sensing a low voltage (nominally 104 DC volts for these inverters) will trip both input breakers to the inverter component after an adjustable time delay.

The settings of these time delay relays were not verified during either preoperational testing or subsequent maintenance. The time delay is necessary in order to accommodate transient loading conditions which may be encountered.

- (b) On one SCI inverter, a DC fuse within the inverter component was found blown. The vendor indicated that this fuse will blow due to an excessive DC voltage to the inverter component caused by a transient on the 480 AC input. The licensee has subsequently reset the taps on the 480V to 120V three-phase AC input transformer to limit the DC voltage to the inverter to less than the nameplate maximum rating in the event of a high AC input voltage transient.

- (c) The SCI inverter static switch is designed to transfer to an alternate source on inverter output overcurrent or undervoltage. Initially, these trips were set at 125 percent overcurrent and 80 percent undervoltage. An explanation for the transfer of two of the inverter static switches is that during one of the transfers of site loads, the instantaneous inductive load caused these trip set points to be exceeded. The licensee has subsequently adjusted the transfer sensing circuitry to higher overcurrent and lower undervoltage trip settings to assure that the inverter will maintain load over the widest possible range of voltage and current. (Note that in this case, once the SCI inverter transfers to the alternate source, it will not automatically transfer back to normal source.)

1. Determine whether or not time delay circuitry is used in your inverter units. If so, have they been adjusted to the appropriate set point as required by equipment and the integrated system designs?

2. Determine if the AC input voltage and transformer tap settings are optimized to prevent exceeding the inverter component name-plate maximum rated DC input voltage in the event of a high AC input voltage transient.

3. If an alternate 120 volt source is used in your design, determine if the protection transfer circuitry of the inverter has been optimized within design limits to ensure maximum possible availability of the inverter system during transient loading conditions. An operating history of inexplicable transfers may be indicative of the above.

4. Determine if the administrative controls employed by your facility ensures operability of safety systems after its subcomponents (e.g., time delay relays, switches, etc.) have been subjected to maintenance or testing.
