UNITED STATES
NUCLEAR REGULATORY COMMISSION
OFFICE OF INSPECTION AND ENFORCEMENT
WASHINGTON, D.C. 20555

IE Circular No. 79-02
Date: January 16, 1979
Page 1 of 3

FAILURE OF 120 VOLT VITAL AC POWER SUPPLIES

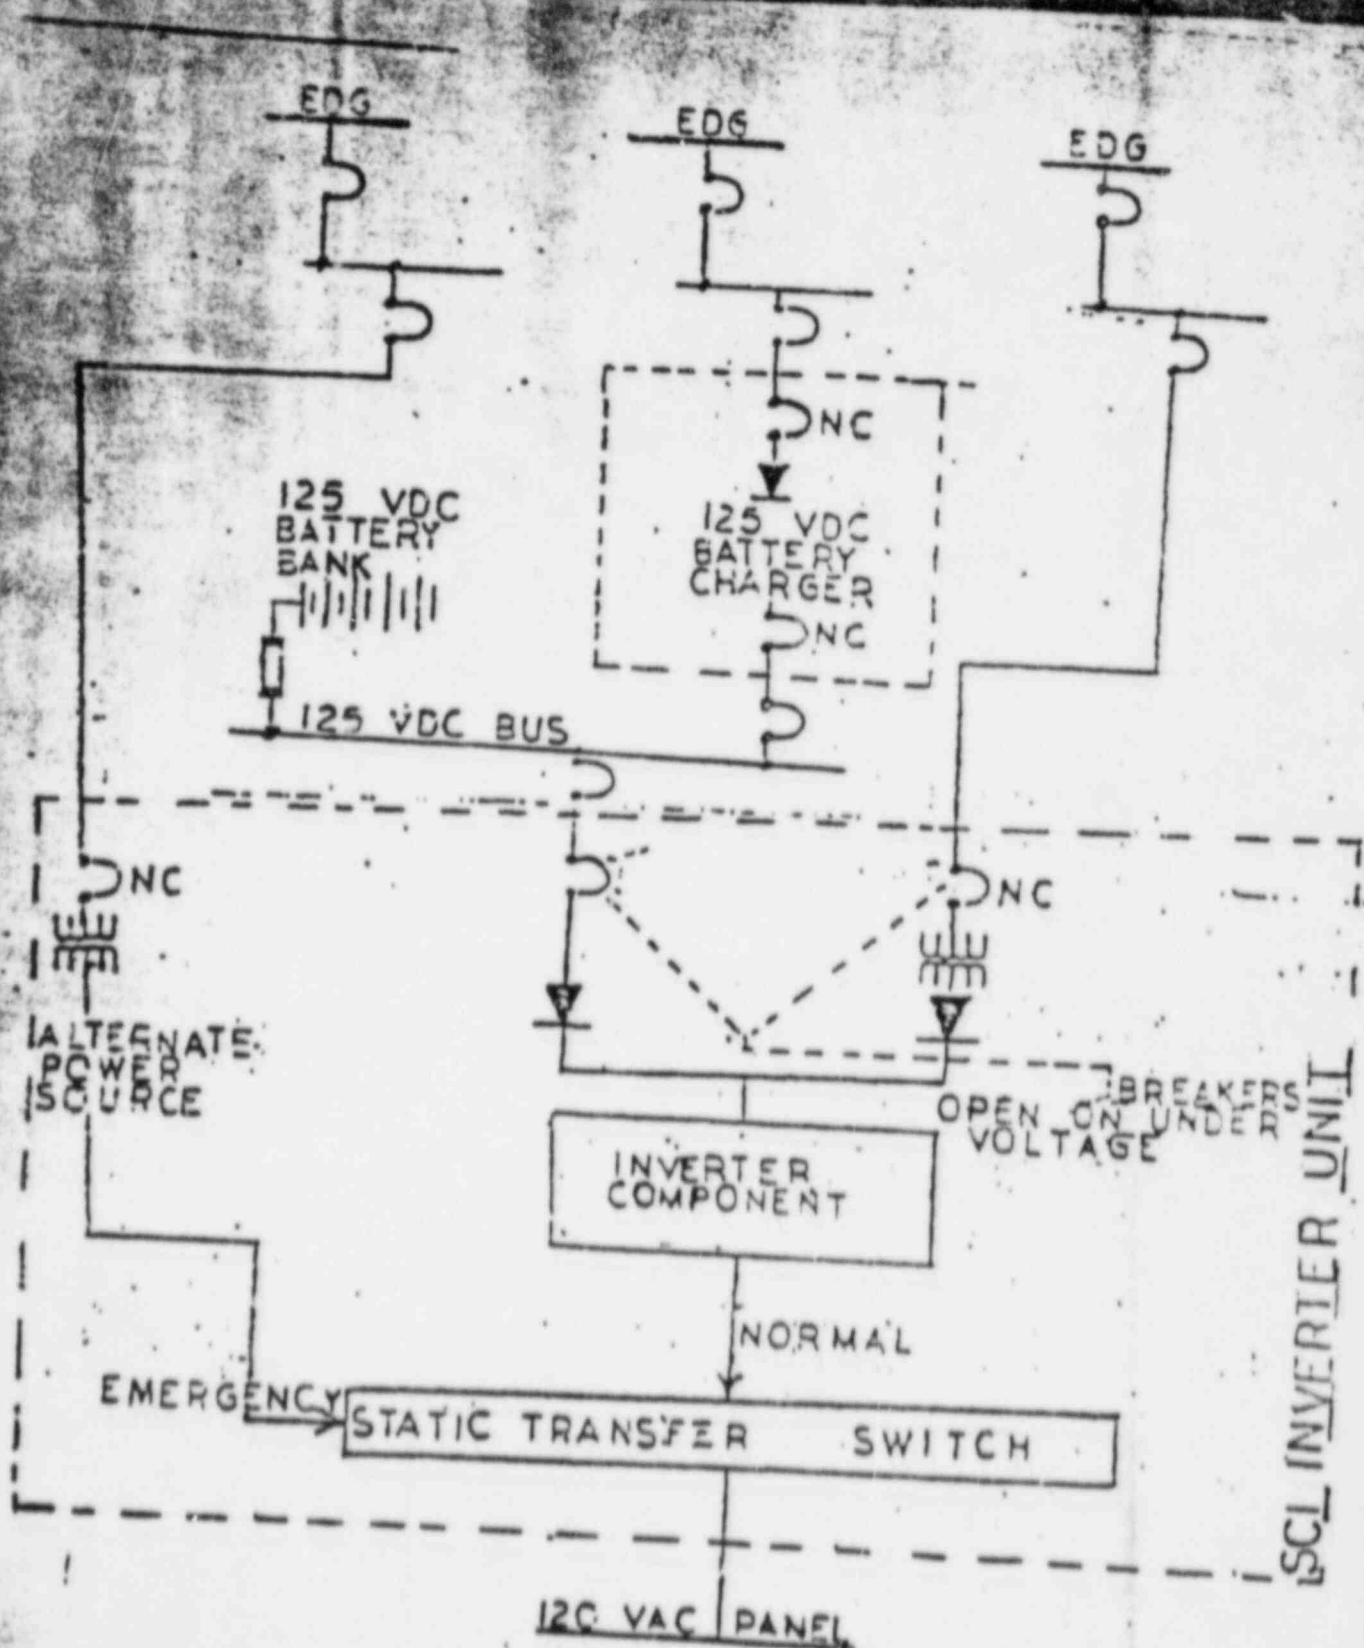
FIGURE 1
 SINGLE LINE DIAGRAM - 120 VAC

On September 16, 1978, Arkansas Nuclear One - Unit 2, while in hot functional testing preceding initial criticality, suffered a degradation of both of the independent off-site power sources. This produced an undervoltage condition on the Engineering Safety Features (ESF) Buses and caused an inadvertent ESF actuation. The licensee determined that the ESF actuation occurred on a loss of at least two of the uninterruptible 120 volt vital AC power sources. Immediate investigation revealed that all four of the Solidstate Controls, Inc., (SCI) inverter static switches had automatically transferred to the alternate power supply (the 120 volt AC being supplied by transformers directly off the ESF buses rather than from the inverter output). Figure 1 (attached) shows the functional interconnection of the 120 volt AC power supply system.

A single conclusive cause of the undesired SCI inverter static switch transfer could not be identified. However, the following problems were discovered during subsequent investigation.

- (a) The SCI inverters have circuitry to monitor the incoming DC voltage level which, on sensing a low voltage (nominally 104 DC volts for these inverters) will trip both input breakers to the inverter component after an adjustable time delay.

The settings of these time delay relays were not verified during either preoperational testing or subsequent maintenance. The time delay is necessary in order to accommodate transient loading conditions which may be encountered.

- (b) On one SCI inverter, a DC fuse within the inverter component was found blown. The vendor indicated that this fuse will blow due to an excessive DC voltage to the inverter component caused by a transient on the 480 AC input. The licensee has subsequently reset the taps on the 480V to 120V three-phase AC input transformer to limit the DC voltage to the inverter to less than the nameplate maximum rating in the event of a high AC input voltage transient.

- (c) The SCI inverter static switch is designed to transfer to an alternate source on inverter output overcurrent or undervoltage. Initially, these trips were set at 125 percent overcurrent and 80 percent undervoltage. An explanation for the transfer of two of the inverter static switches is that during one of the transfers of site loads, the instantaneous inductive load caused these trip set points to be exceeded. The licensee has subsequently adjusted the transfer sensing circuitry to higher overcurrent and lower undervoltage trip settings to assure that the inverter will maintain load over the widest possible range of voltage and current. (Note that in this case, once the SCI inverter transfers to the alternate source, it will not automatically transfer back to normal source.)

1. Determine whether or not time delay circuitry is used in your inverter units. If so, have they been adjusted to the appropriate set point as required by equipment and the integrated system designs?

2. Determine if the AC input voltage and transformer tap settings are optimized to prevent exceeding the inverter component name-plate maximum rated DC input voltage in the event of a high AC input voltage transient.

3. If an alternate 120 volt source is used in your design, determine if the protection transfer circuitry of the inverter has been optimized within design limits to ensure maximum possible availability of the inverter system during transient loading conditions. An operating history of inexplicable transfers may be indicative of the above.

4. Determine if the administrative controls employed by your facility ensures operability of safety systems after its subcomponents (e.g., time delay relays, switches, etc.) have been subjected to maintenance or testing.
