UNITED STATES  
NUCLEAR REGULATORY COMMISSION  
OFFICE OF INSPECTION AND ENFORCEMENT  
WASHINGTON, D.C. 20555

IE Circular No. 79-02  
Date: January 16, 1979  
Page 1 of 3

FAILURE OF 120 VOLT VITAL AC POWER SUPPLIES

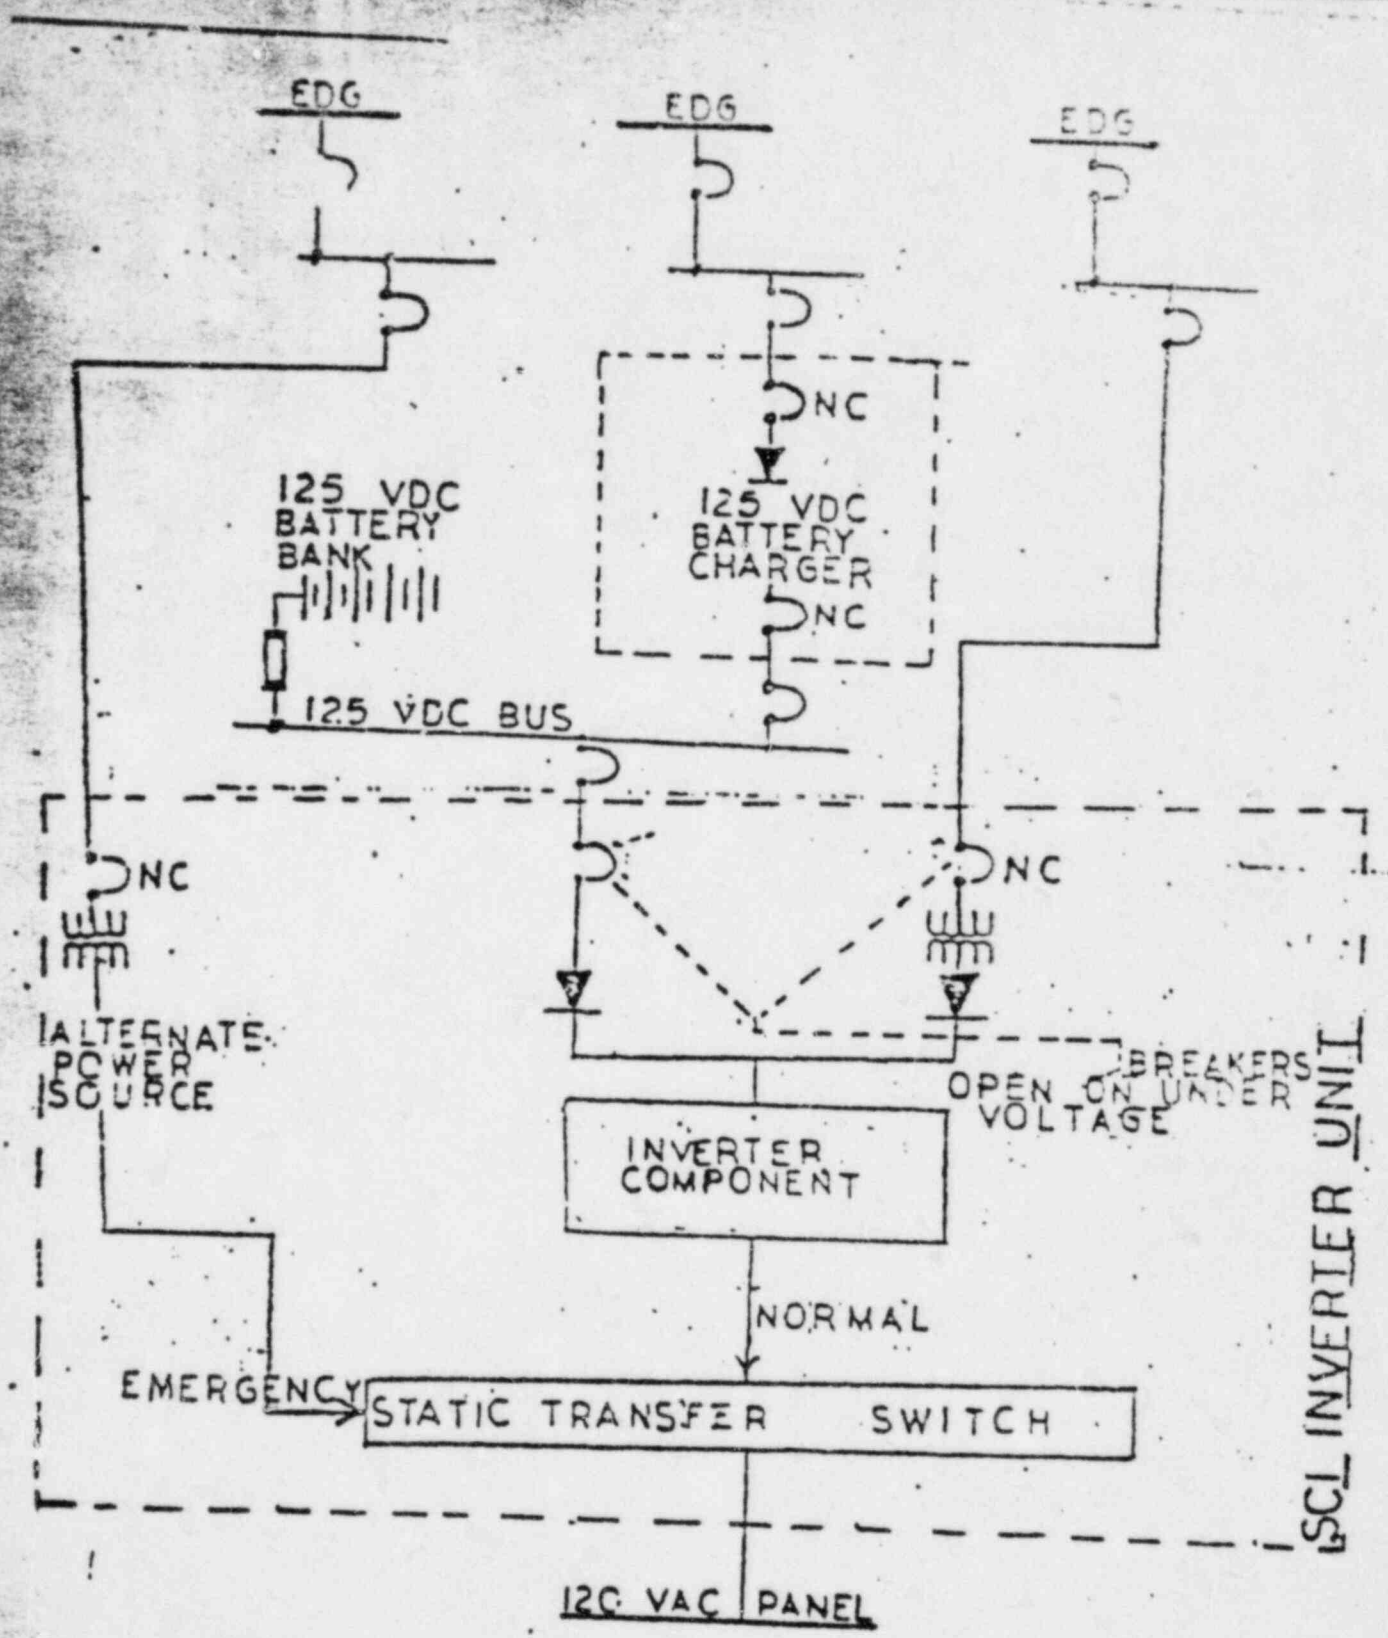
FIGURE 1  
SINGLE LINE DIAGRAM - 120 VAC

On September 16, 1978, Arkansas Nuclear One - Unit 2, while in hot functional testing preceding initial criticality, suffered a degradation of both of the independent off-site power sources. This produced an undervoltage condition on the Engineering Safety Features (ESF) buses and caused an inadvertent ESF actuation. The licensee determined that the ESF actuation occurred on a loss of at least two of the uninterruptible 120 volt vital AC power sources. Immediate investigation revealed that all four of the Solidstate Controls, Inc., (SCI) inverter static switches had automatically transferred to the alternate power supply (the 120 volt AC being supplied by transformers directly off the ESF buses rather than from the inverter output). Figure 1 (attached) shows the functional interconnection of the 120 volt AC power supply system.
