SUBJECT: Calvert Cliffs Nuclear Power Plant  
Unit Nos. 1 and 2; Docket Nos. 50-317 and 50-318;  
License Nos. DPR 53 and DPR 69  
Licensee Event Report 92-004

LICENSEE EVENT REPORT (LER)

TITLE (4) Inoperable Fire Dampers Due to Conflicting Design Information

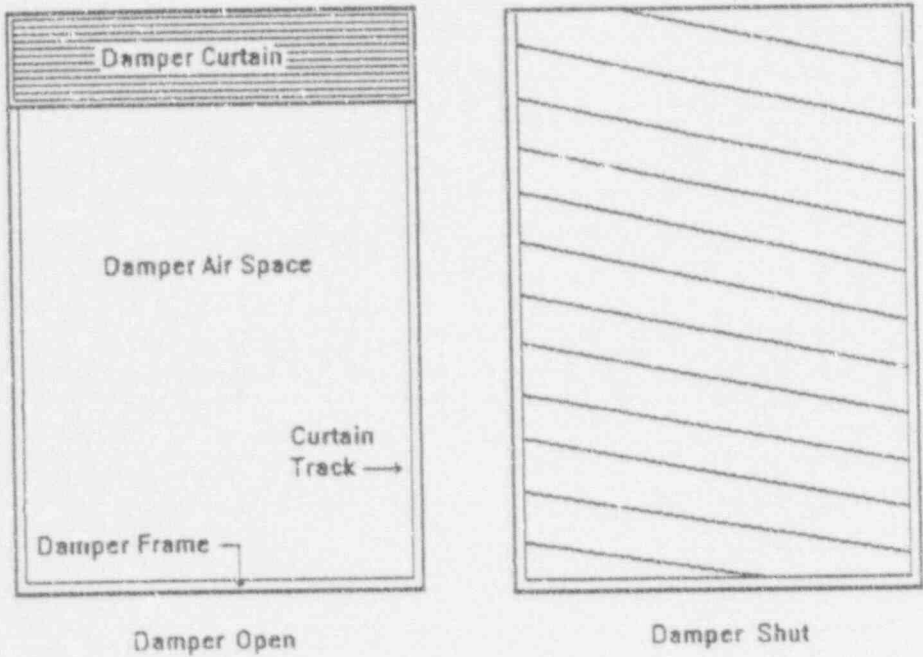
FIGURE 1

These are curtain-type dampers. Several hinged leaves fold and strap securely into the stored position. At high temperatures, a fusible link melts, releasing the straps. This allows the leaves to expand outward, shutting off the duct. Vertically mounted dampers are gravity driven while horizontal dampers are spring loaded. (See Figure 1)

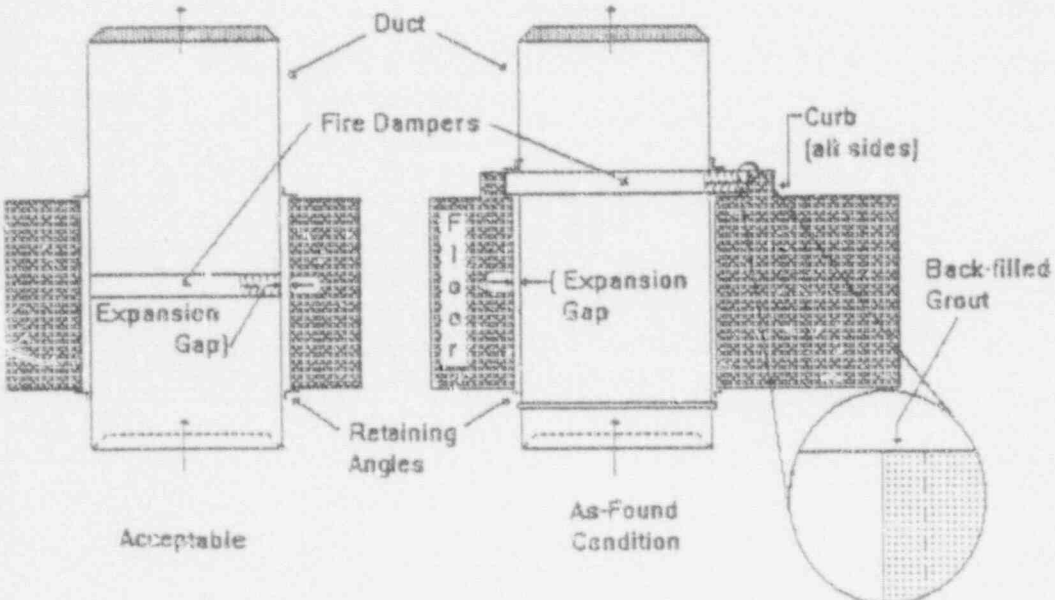
FIGURE 2

During construction, we built up a concrete curb around some dampers to retain their UL listing and rating. When we removed the curbs, we found they had pressed against the dampers, removing the expansion gaps. When we removed the duct retaining angles, we found that critical 1/8 inch expansion gaps had been back-filled with grout. (See Figure 2)

The critical clearance required to ensure proper operation is a 1/4 inch gap between the curtain and its track. The curb grouting constrained the dampers. We also know, from testing, that high duct temperatures thermally affected the dampers. These two elements worked together to reduce the curtain-to-track clearances and resulted in mechanical binding and damper failures. We have concluded that these dampers do not conform to the installation requirements for meeting the UL listing.

The root cause of this event is incomplete and inadequate design information. The Architect Engineer provided design drawings inconsistent in their treatment of the critical clearances. For these dampers, different drawings contradict themselves. One drawing's notes require expansion gap retention. Another's notes has them backfilled.

- A. We declared three fire dampers INOPERABLE, verified automatic fire detection, and established fire-watch patrols in accordance with the TSs.
- B. We investigated similar Unit 1 and 2 fire dampers, declared eight INOPERABLE, and similarly established fire-watch patrols.
- C. We are performing a design review. We will revise drawings, as required, to show proper installation details.

- D. We will repair or replace all failed dampers.
