BRUNSWICK STEAM ELECTRIC PLANT, UNIT 2  
NRC DOCKET NO. 50-324  
OPERATING LICENSE NO. DPR-62  
NUREG-0619 FEEDWATER NOZZLE AND SPARGER EXAMINATION RESULTS

GE-NE-523-112-1191

FEEDWATER SPARGER  
CIRCUMFERENTIAL CRACKING  
EVALUATION FOR  
BRUNSWICK UNITS 1 AND 2

BRUNSWICK STEAM ELECTRIC PLANT UNIT 2  
NINETH REFUELING OUTAGE - OCTOBER, 1991  
INVESSEL VISUAL INSPECTION (IVVI)  
INSPECTION REPORT AND VIDEO REVIEW

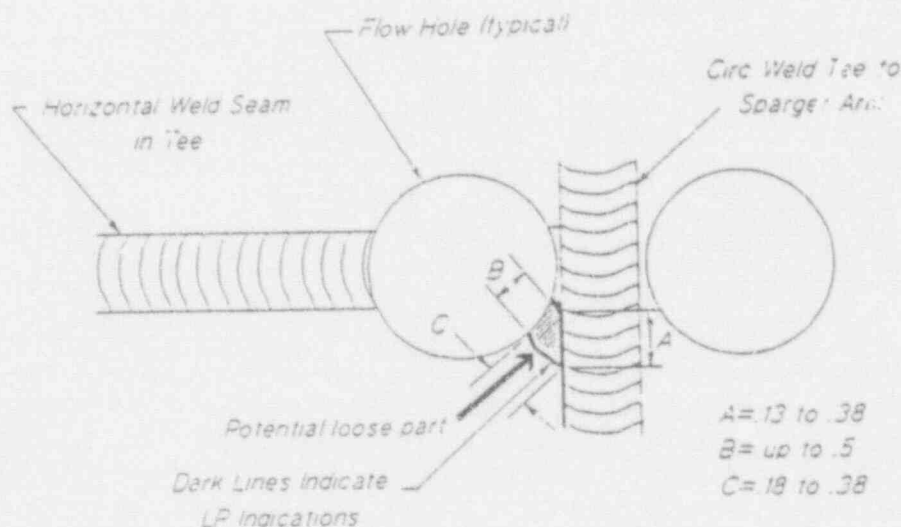
POTENTIAL FEEDWATER SPARGER LOOSE PART

1. No relevant indications were found on the nozzle inner blend radius.
2. Crack growth continues on the flow holes but no pieces have separated. Note: The pieces did not separate during the hydrolase cleaning operation using a 20,000 psi plus hydrolaser unit prior to the examination. In addition to the horizontal piece between the flow holes which has been previously addressed by GE, the size of other potential loose pieces is as shown. The largest of which has also been previously addressed by GE.
