UNITED STATES  
NUCLEAR REGULATORY COMMISSION

Licensee: Omaha Public Power District (OPPD)  
Facility: Fort Calhoun Station  
License No.: DPR-40  
Docket No.: 50-285  
Subject: Management Meeting

## FORT CALHOUN STATION

NRC/OPPD MEETING  
JULY 16, 1992

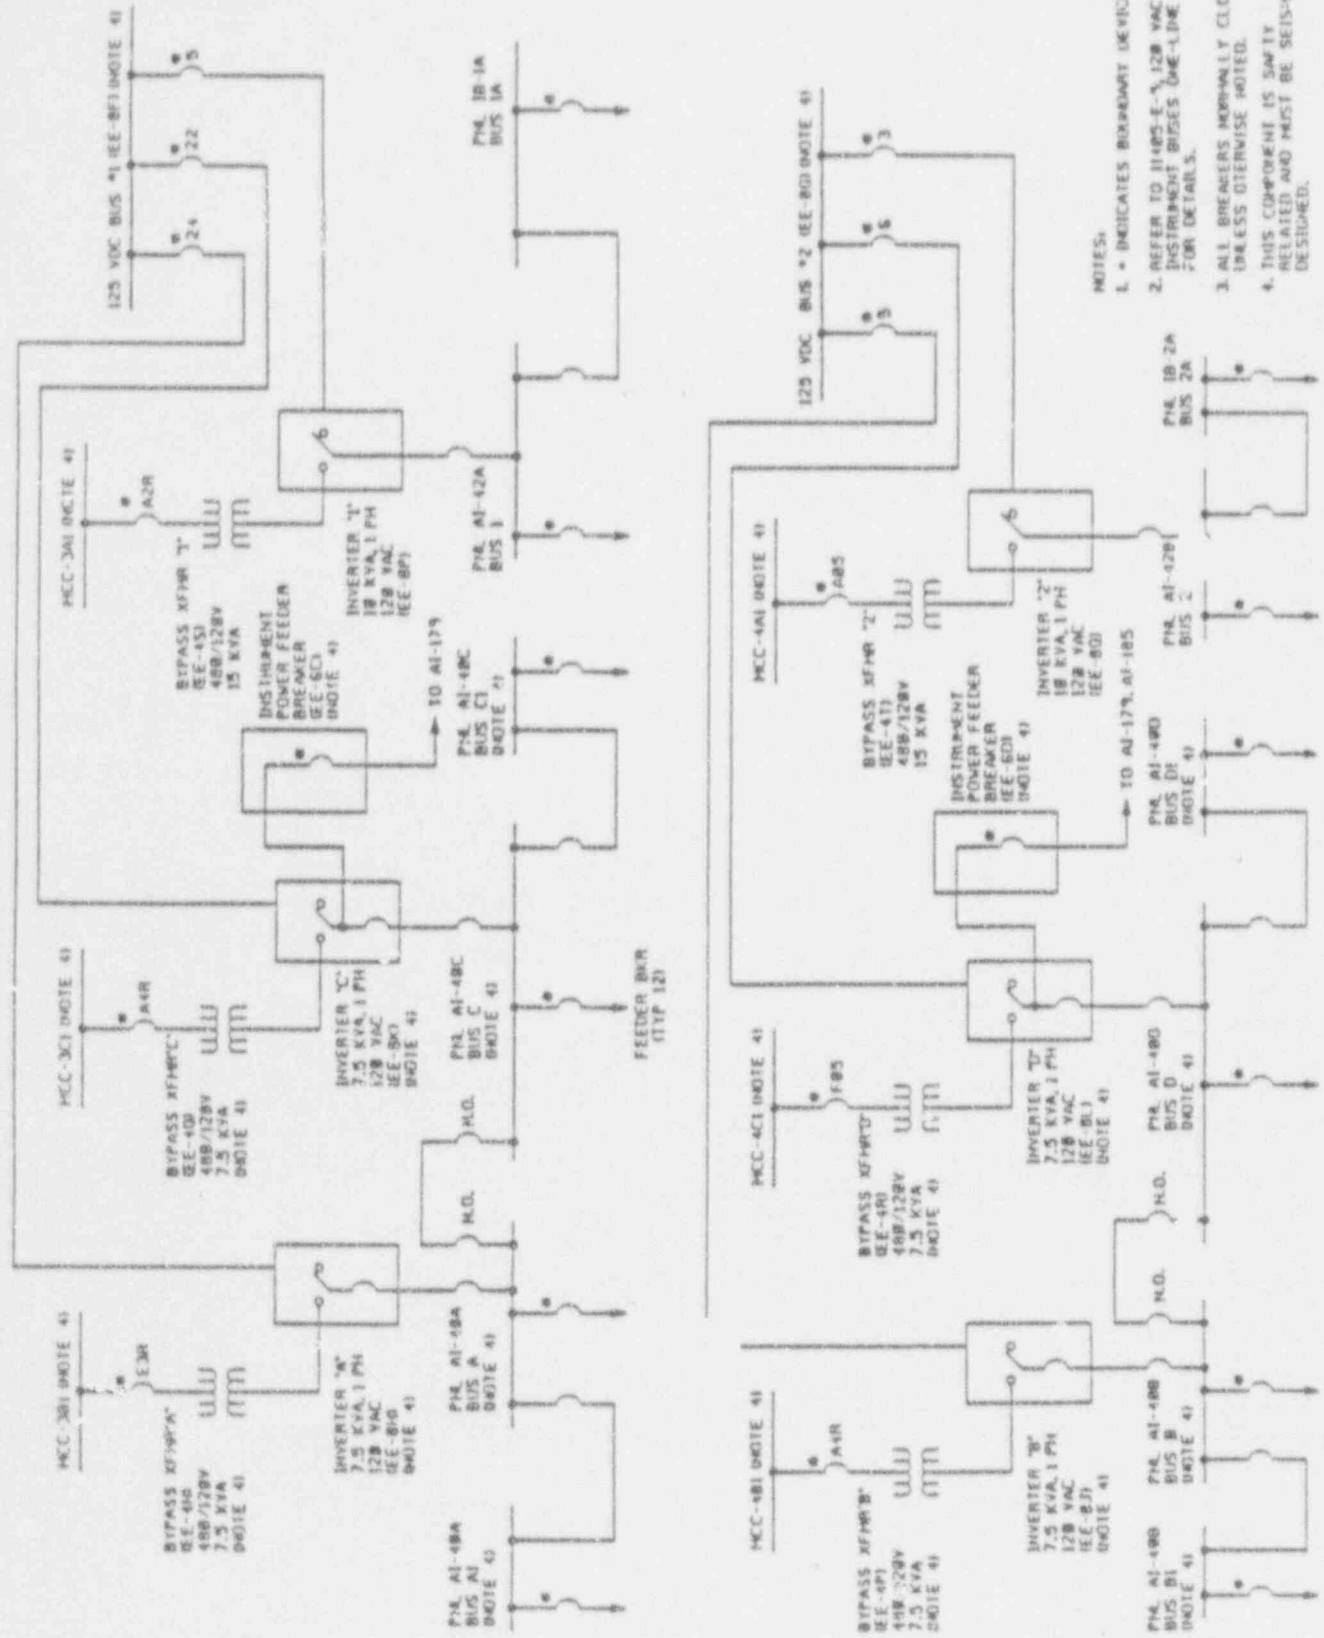
- SYSTEM CONFIGURATION/BACKGROUND
  - SEE FIGURE 1

- ROOT CAUSE
  - INADEQUATE POST MAINTENANCE TESTING AS PROVISIONS WERE NOT MADE TO TEST THE INVERTER OFF-LINE

- 1) REPLACED CIRCUIT BOARDS AND INSTALLED JUMPER.
- 2) MODIFICATION TO PROVIDE OFF-LINE TEST CAPABILITY
- 3) EVALUATION OF INVERTER LOADINGS.
- 4) REVISE PM PROGRAM TO INSPECT SINGLE CLAD BOARD EVERY REFUELING OUTAGE FOR SIGNS OF DEGRADATION.
- 5) MAKE BETTER USE OF VENDOR FIELD SERVICES.
- 6) DEVELOP A TROUBLESHOOTING GUIDE.
- 7) CHANGE METAL JUMPERS ON TERMINAL BLOCKS TO WIRE JUMPERS.
- 8) INSPECT (AND IF REQUIRED) SOLDER WIRES LEADING TO THE GATES AND CATHODES OF ALL ACCESSIBLE INVERTER SCRS.
- 9) SHARED INFORMATION WITH OTHER UTILITIES (NUCLEAR NETWORK).
- 10) INCORPORATE LESSONS LEARNED IN THE TRAINING PROGRAM.
- 11) REVISE VENDOR MANUAL

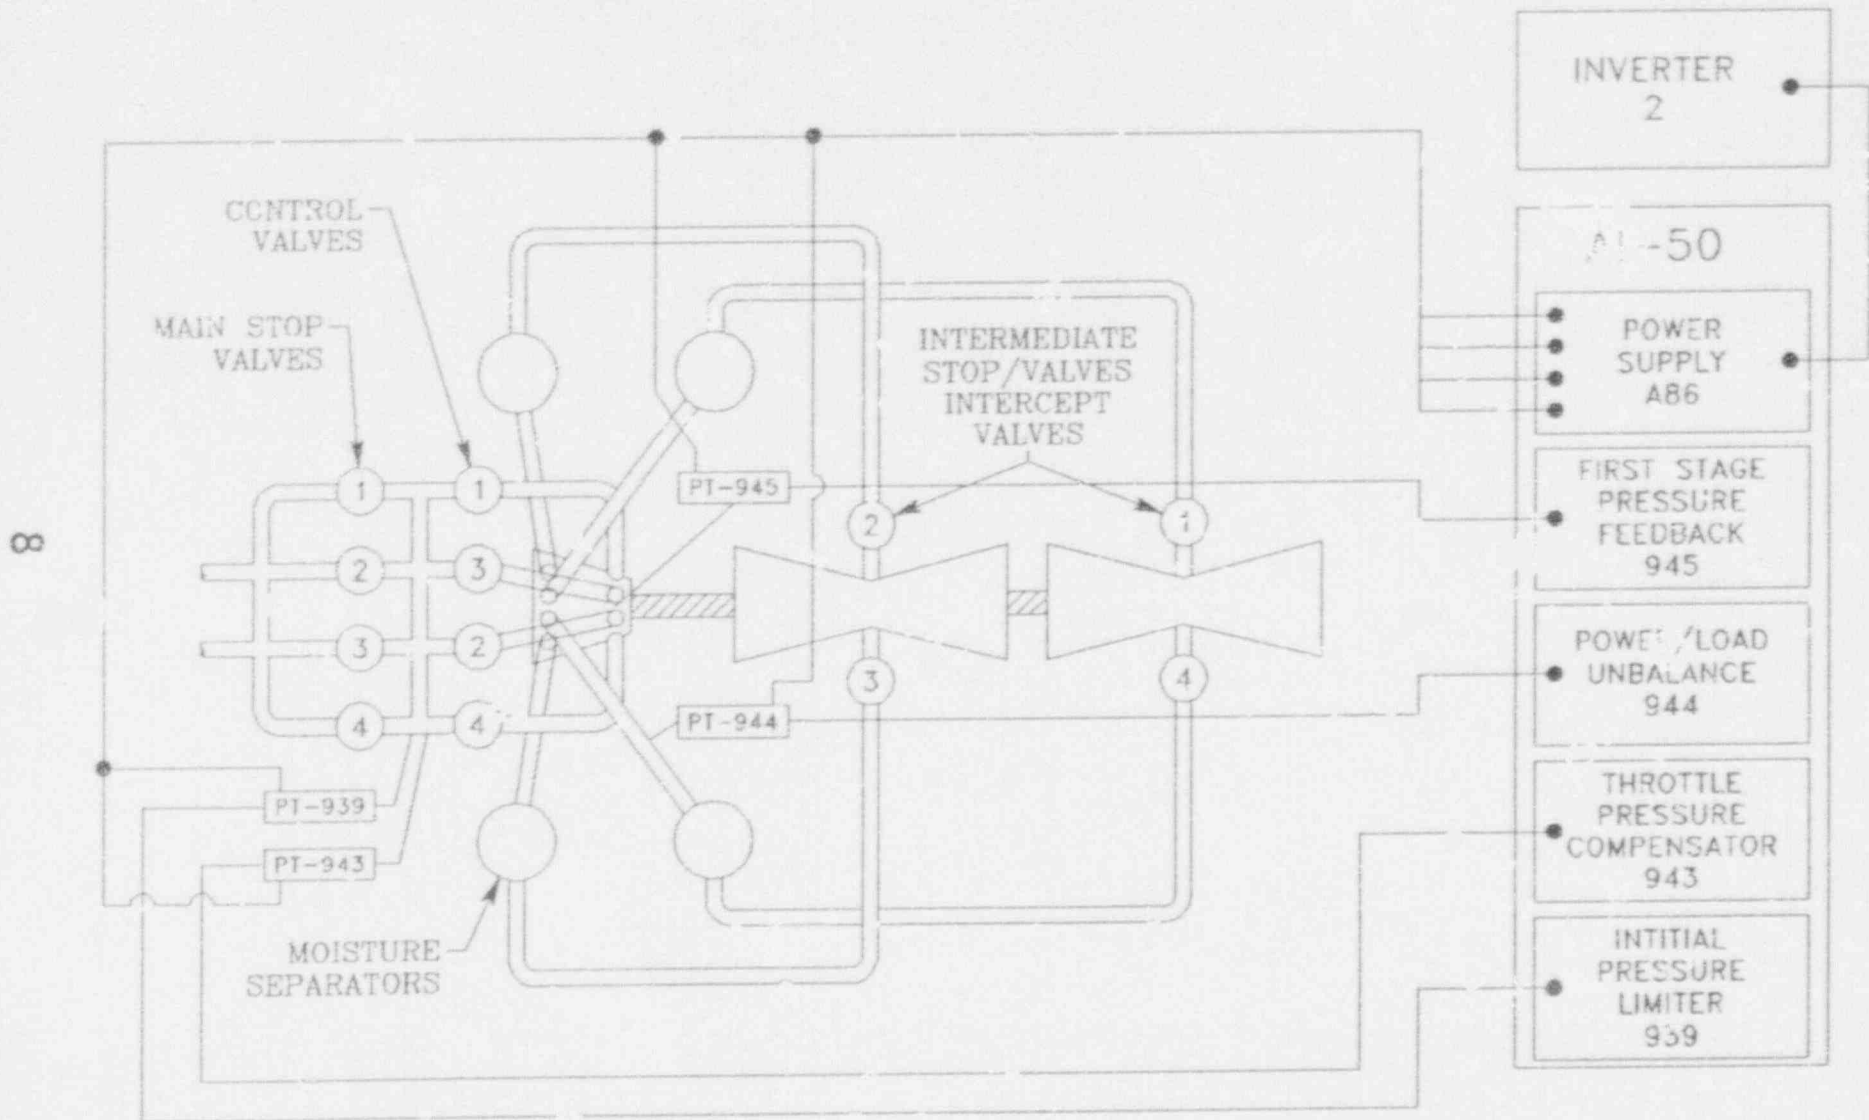
FIGURE 2

- LOSS OF POWER TO AI-50 (EHC PANEL) CAUSED CLOSURE OF TURBINE CONTROL VALVES.

- NO BACK-UP POWER SOURCE FOR PT-939, 943, 944 & 945 (FIGURE 2)

- NO TURBINE TRIP ON LOSS OF LOAD.
- RELIANCE ON SINGLE SOURCE OF POWER FOR PRESSURE TRANSMITTERS.
- FAILURE OF INDIVIDUAL COMPONENTS CAN CAUSE CLOSURE OF TURBINE CONTROL VALVES.

- PROVIDE TURBINE TRIP COINCIDENT WITH LOSS OF POWER TO AI-50 (INTERIM FIX TO BE COMPLETED PRIOR TO POWER OPERATION).

- EVALUATE THE FOLLOWING OPTIONS:
  - PROVIDE TURBINE TRIP COINCIDENT WITH CLOSURE OF TURBINE CONTROL VALVES (EXCEPT DURING START-UP AND SHUTDOWN).

- PROVIDE BACKUP POWER SOURCE (PERMANENT MAGNET GENERATOR) FOR EHC PRESSURE TRANSMITTERS.

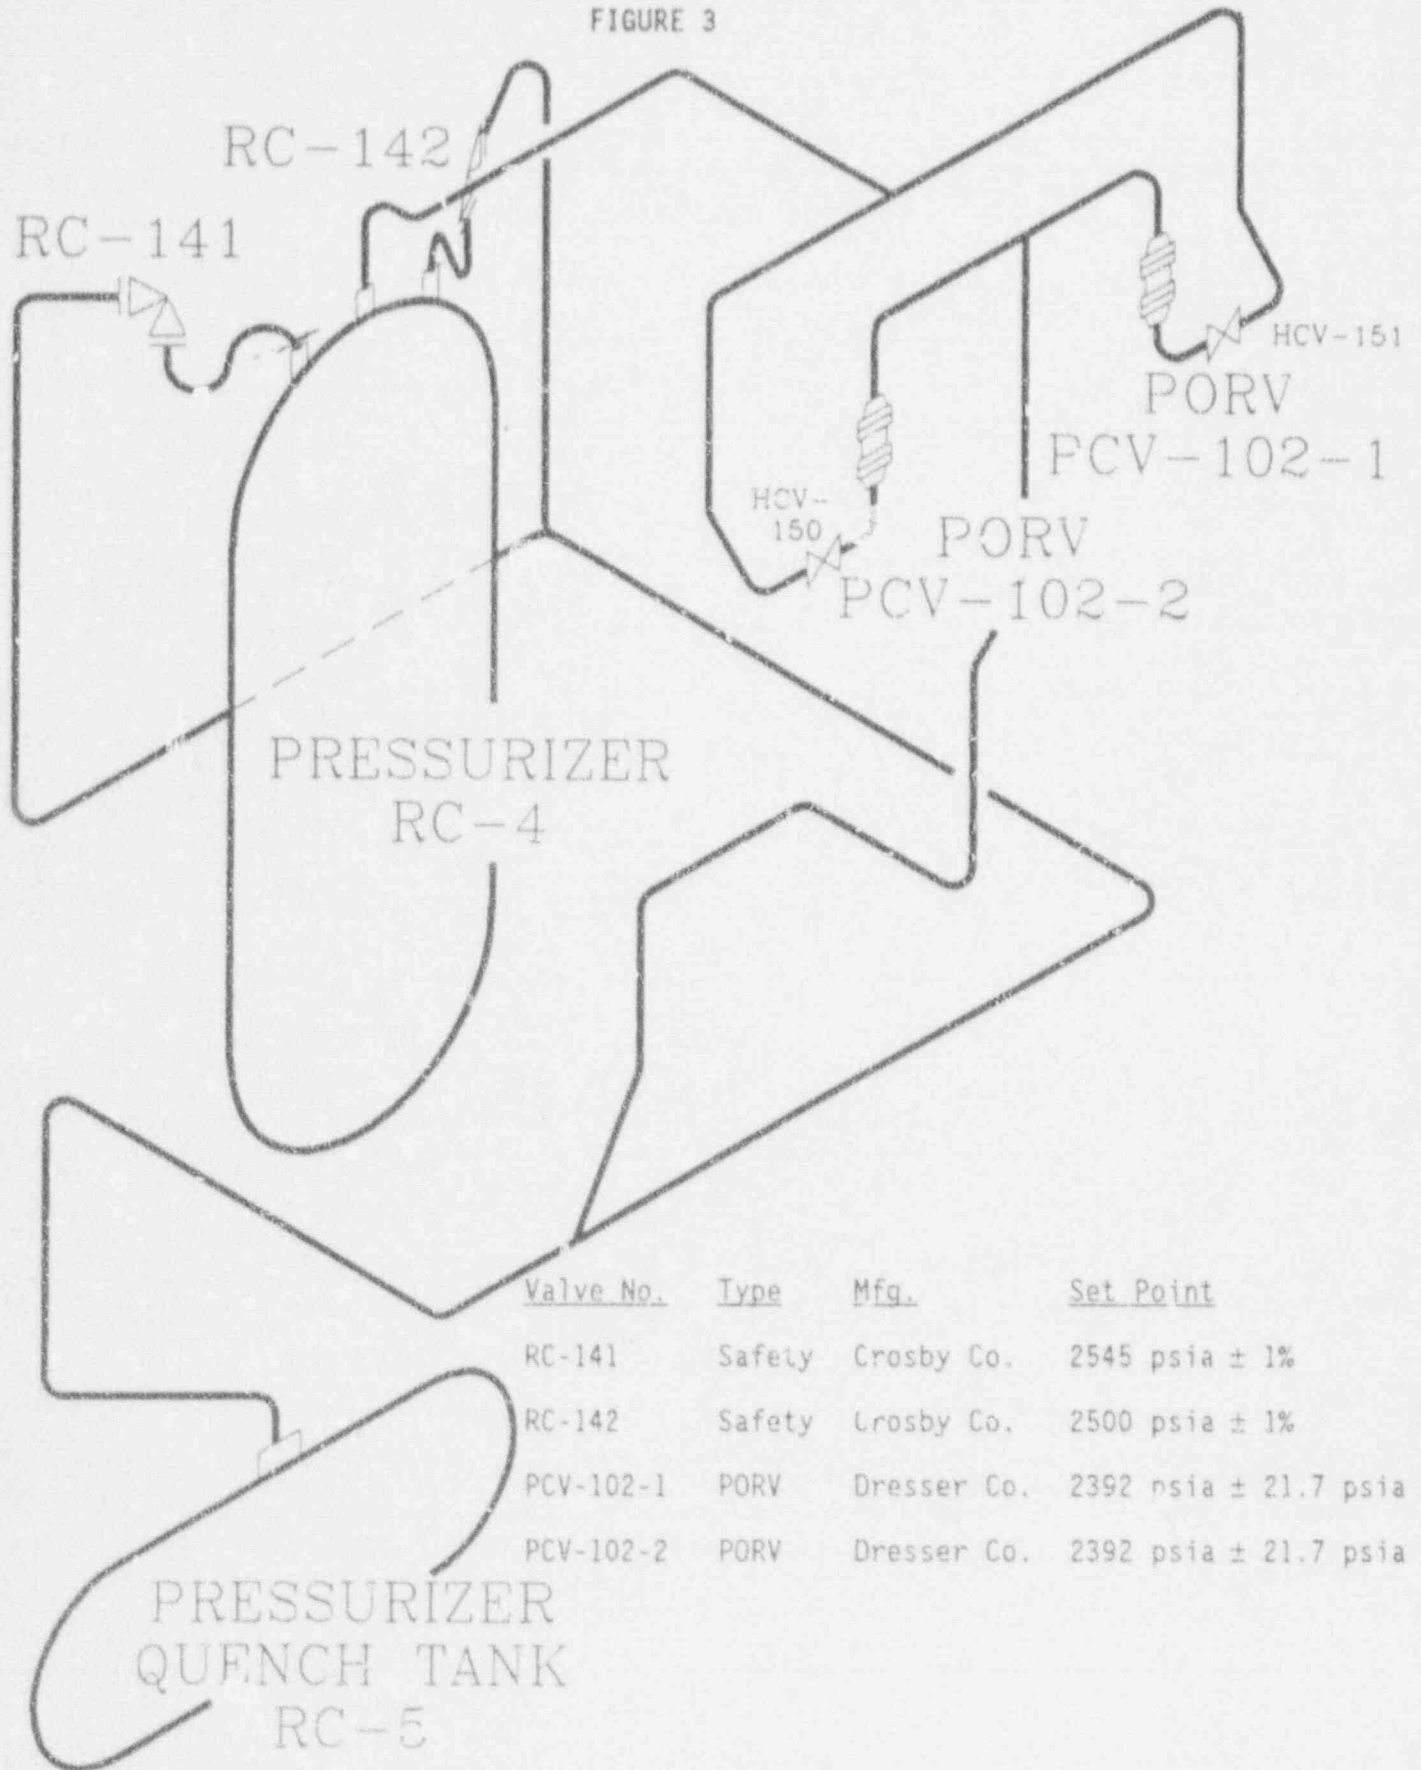
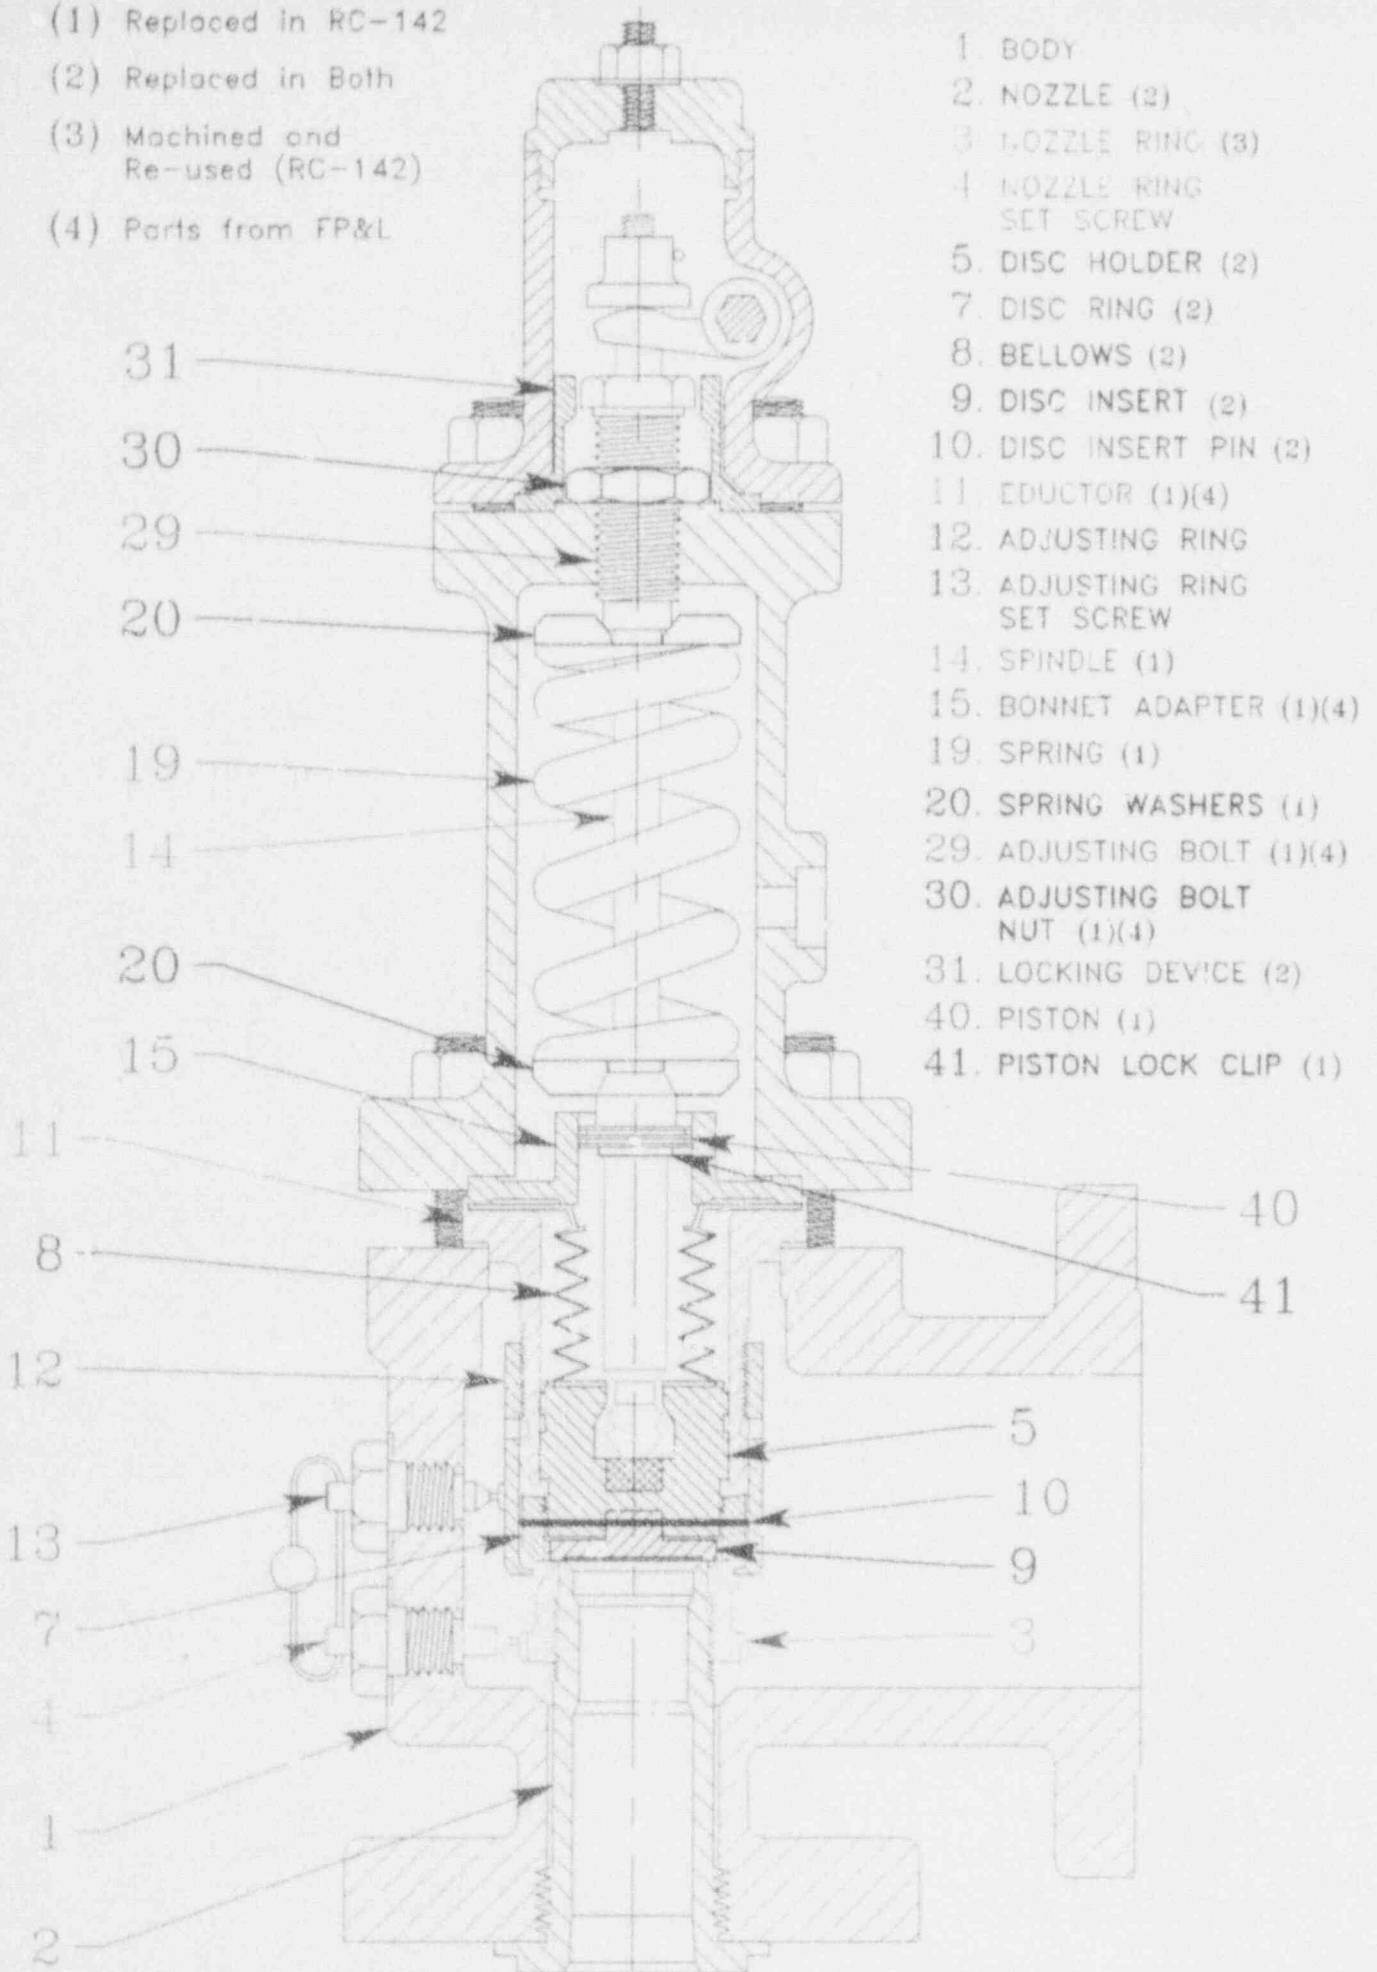
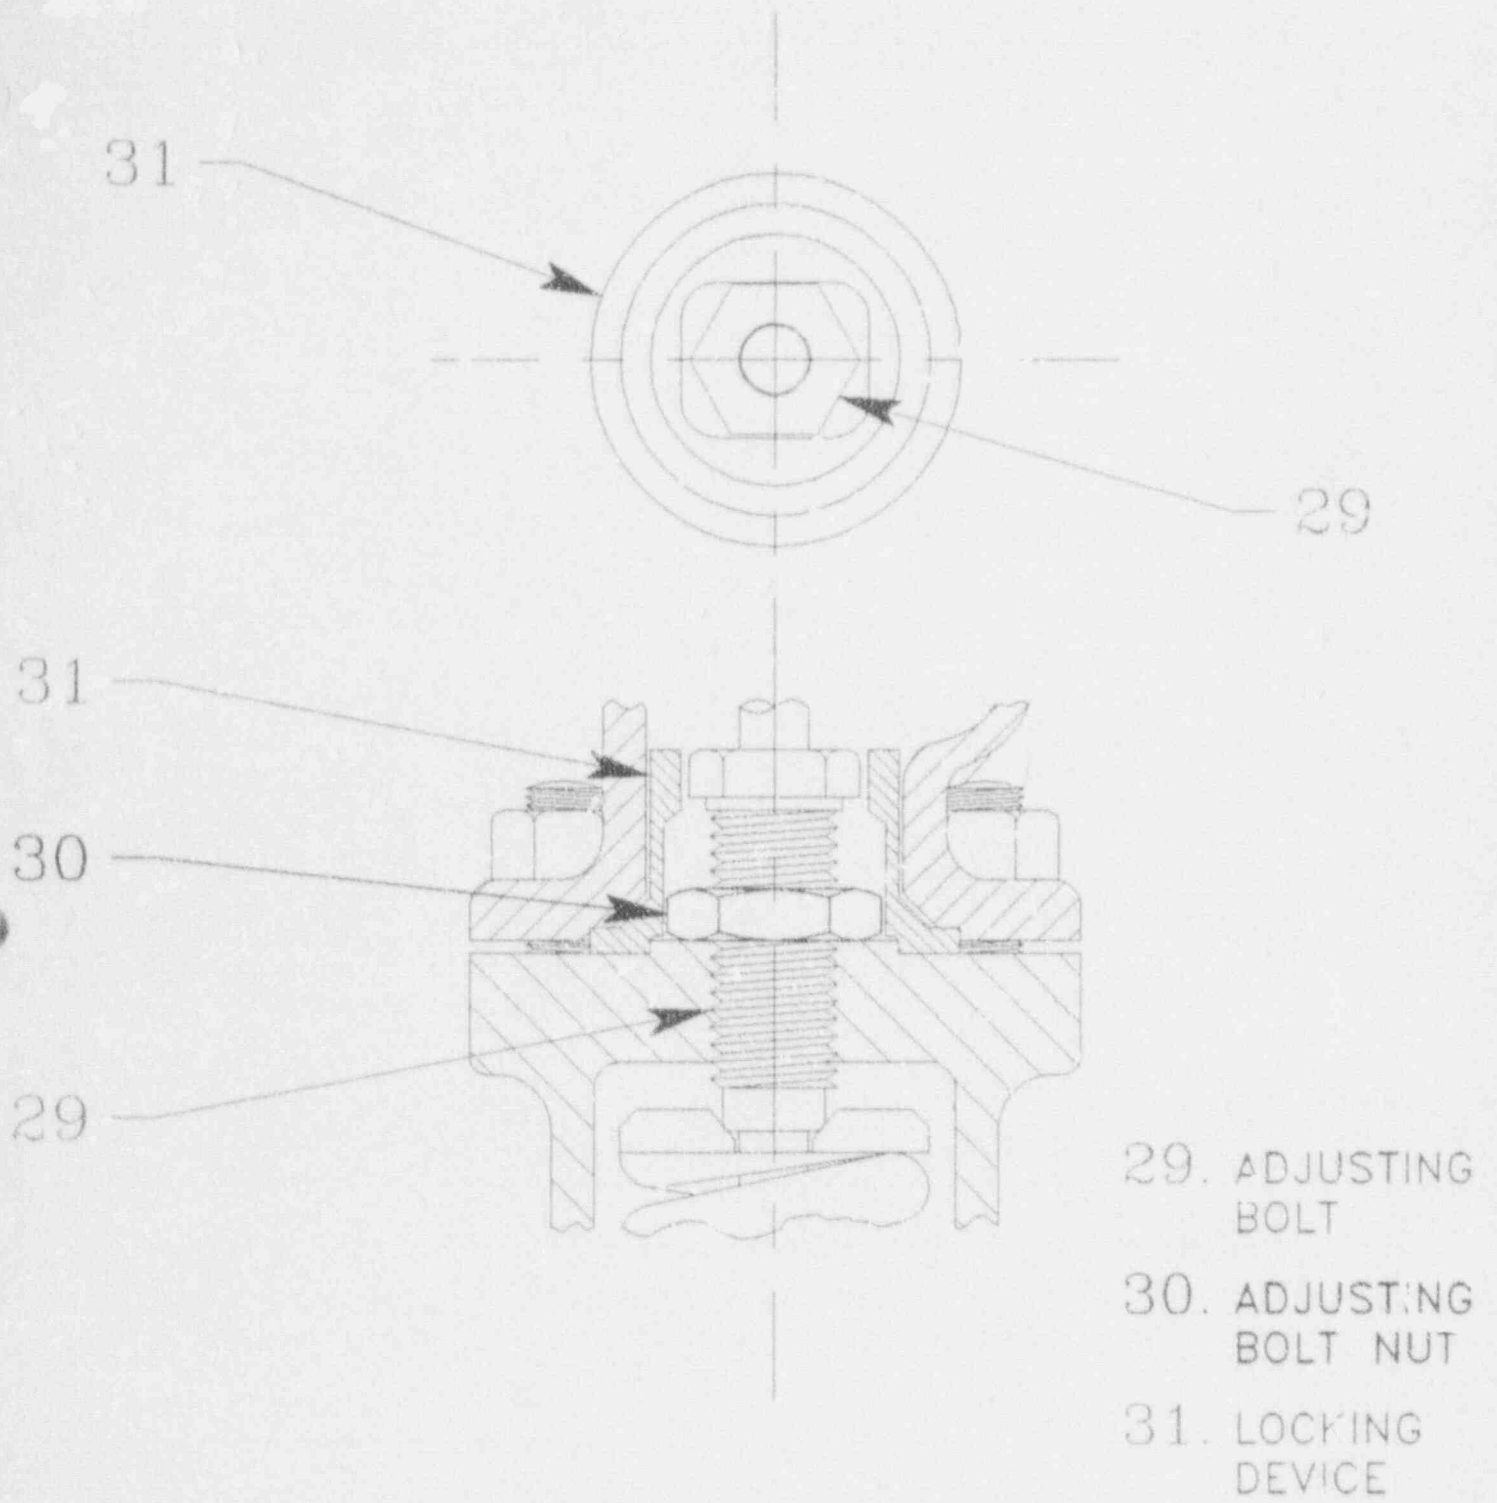
FIGURE 3

- BELLOWS LEAKED AT 2.6 PSIG
- FOUND ADJUSTMENT BOLT BACKED OUT
- SETPOINT CHANGED
- INDICATIONS OF SEVERE CHATTERING (APPENDIX 1)

- ADJUSTING BOLT NUT FAILED TO MAINTAIN THE ADJUSTING BOLT'S POSITION DURING RELIEF

- NO DOCUMENTATION/TORQUE VALUE FOR ADJUSTING BOLT NUT
- LACK OF POSITIVE LOCKING DEVICE

PART NUMBER	COMPONENT	EVALUATION	DISPOSITION
2	Nozzle	Seating surface had chatter indications. No major damage, but met replacement criteria.	Replace
3	Nozzle Ring	Impressions of Disc Ring on top surface	Machine
4	Nozzle Ring Set Screw	No significant damage	Replace
7	Disc Ring	Marks due to impact with Nozzle Ring on top surface	Replace
9	Disc Insert	Disc Insert was mushroomed into the Disc Holder. Seating surface of Disc Insert was 0.002" below the top surface of Disc Ring. The Disc Insert protrusion should have been 0.010" to 0.023" above the top surface of the Disc Ring. Impact marks were visible on the seating surface	Replace
12	Adjusting Ring	A 1/2" circumferential band of minor indentations was observed on the inner vertical surface of the Adjusting Ring. No affect on valve operation.	Use in the "as-is" condition. No machining required
13	Adjusting Ring Set Screw	No significant damage	
10	Disc Insert Pin	Although this pin should be contained within the Disc Holder (5), it was protruding from the Disc Holder by approximately 1/4"	Replace

5	Disc Holder	Disc Insert could not be removed from the Disc Holder. The Eductor guiding surfaces of the disc holder displayed significant wear	Replace
6	Disc Bushing	Uneven wear on the top spherical concave surface	Replace
8	Bellows	The Bellows assembly (Part Number 5, 6, and 8) was found broken into three pieces. The fractures occurred near the upper mounting plate and the top of the Disc Holder	Replace
11	Eductor	Minor wear on the Disc Holder guiding surface of the Eductor	Replace**

PART NUMBER	COMPONENT	EVALUATION	DISPOSITION
14	Spindle	Chatter indications on the lower Spring Washer bearing surfaces of the Spindle. Uneven wear of the bottom spherical surface of the Spindle. This surface is a ball which is pressed into the bottom end of the Spindle. The ball had rolled within the cavity	Replace
40	Piston	Chatter indications on the outer guiding surface of Piston	Replace
15	Bonnet Adapter	Excessive wear on piston guiding surface of Bonnet Adaptor	Replace**
20	Spring Washers	Chatter indications on pressure bearing surfaces of both upper and lower Washers	Replace with new spring assembly
29	Adjusting Bolt	Galling on bearing surface	Replace**
19	Spring	No damage but part of spring assembly with washers	Replace
30	Adjusting Bolt Nut	Nut was found backed off of the bonnet surface approximately 1/4". Loose fit with adjusting bolt	Replace and add locking device**

- REFURBISHED RC-141 AND RC-142 (APPENDIX 1)
- RC-141/142 ADJUSTING BOLT MECHANICAL LOCKING DEVICE
- VERIFIED RING SETTINGS AND LOOP SEAL DESIGN ADEQUACY
- REQUESTED WYLE TO ADVISE THEIR CLIENTS OF POTENTIAL FOR THIS PROBLEM IN OTHER RELIEF VALVES
- INDUSTRY NOTIFICATION (NUCLEAR NETWORK)

- EVALUATE OPTIONS TO ELIMINATE LOOP SEAL DESIGN CONSISTENT WITH INDUSTRY EXPERIENCE
- PERFORM FURTHER ANALYSIS ON BELLOWS AND SPRING REMOVED FROM RC-142
- INCORPORATE LESSONS LEARNED INTO RELIEF VALVE TESTING PROGRAM
