Subject: Clinton Power Station - Unit 1
Licensee Event Report No. 92-002-01

LICENSEE EVENT REPORT (LER)

TITLE (4) Manufacturing Deficiencies and Inadequate Maintenance Procedures Result in Reactor Feed Pump Control Valve Lockup, Feedwater Level Transient, and Low Reactor Water Level SCRAM.

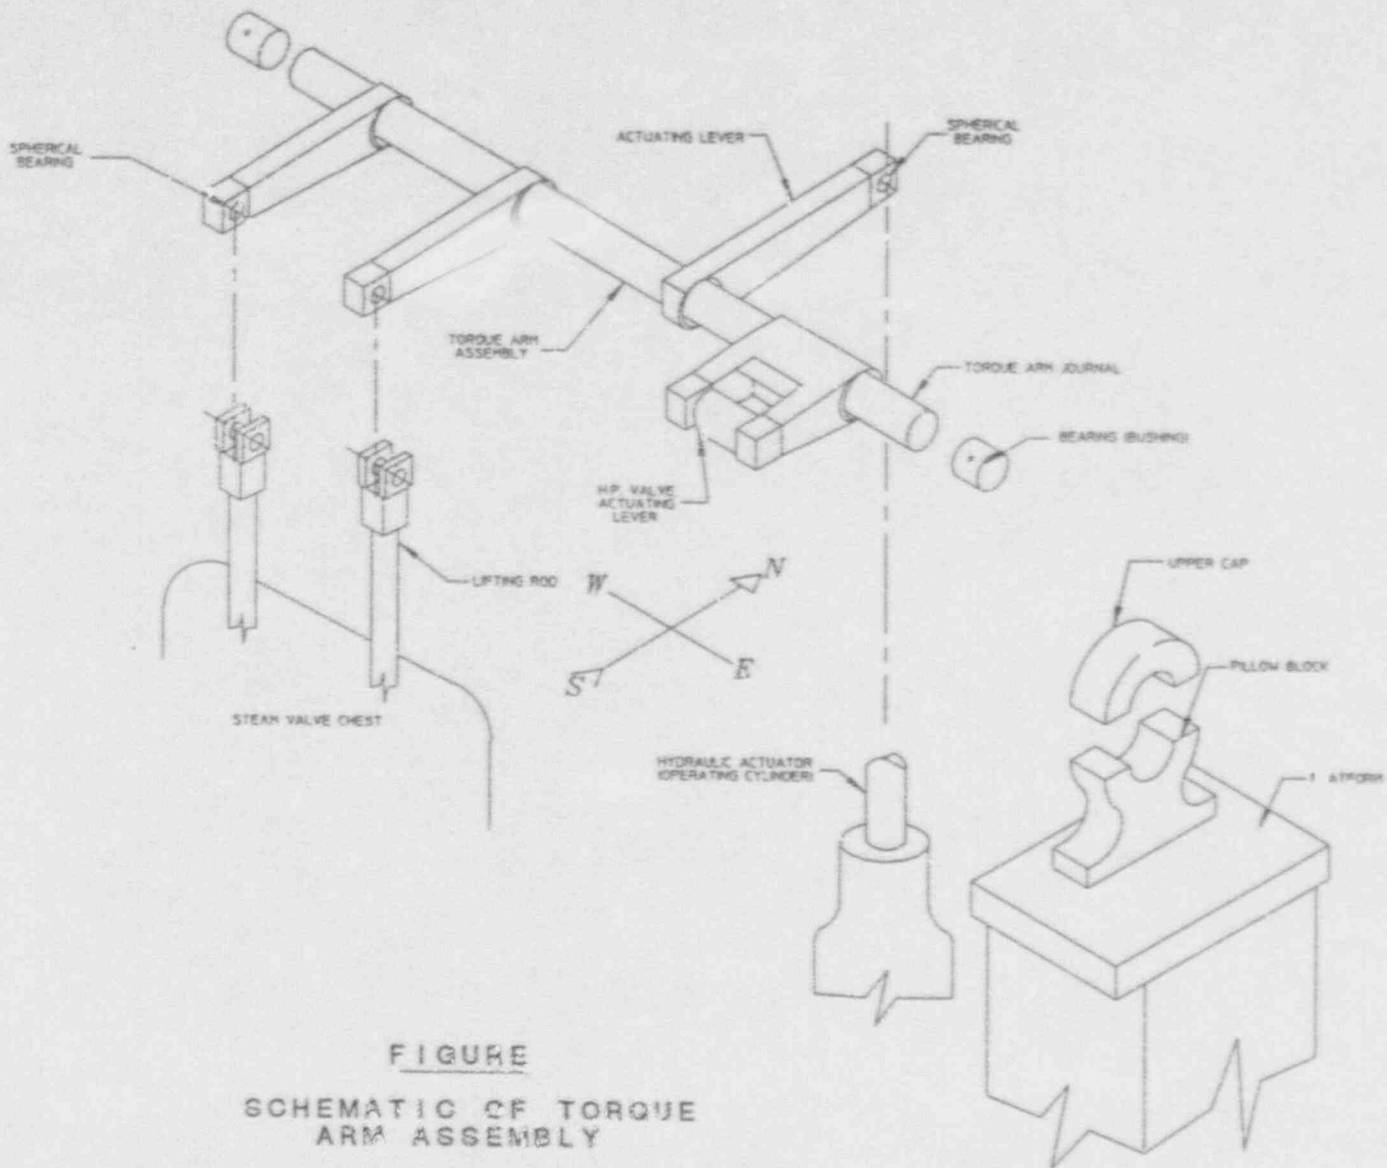
FIGURE
SCHEMATIC OF TORQUE
ARM ASSEMBLY

The lockup of the "B" TDRFP control valve caused the feedwater transient and the low reactor water level scram. The cause of the "B" TDRFP lockup is attributed to manufacturing deficiencies compounded by inadequate procedural guidance for maintenance of the TDRFP turbine actuating linkages. Factors which contributed to the cause of the lockup were application of improper lubrication which was specified by the TDRFP vendor, General Electric; misalignment of pillow blocks; out-of-round torque arm journals; inadequate surface finish on torque arm journals; high spots on the bores of the pillow blocks; reduction of bearing-to-journal clearance when the pillow blocks were tightened to specifications; and lack of periodic maintenance tasks to verify actuator assembly condition. (Reference figure for sketch of TDRFP turbine torque arm assembly components.)

An immediate investigation identified that the cause of the June 13, 1992 occurrence was the lockup or physical binding of the torque arm assembly between the pillow block bearings and the torque arm journal. A detailed plan was developed to investigate the cause of the premature failure of the "B" TDRFP. The investigation found severe galling on both pillow block bearings and significant scoring of the torque arm journals. Further investigation identified the torque arm journals were slightly out-of-round; the pillow block bearings had high spots on the inside wall when the pillow block was in the tightened position; the pillow block bores had high spots; and the pillow block alignment was inaccurate.

An evaluation concluded that these surface imperfections decreased the established clearances of 0.003 to 0.004 inches to virtually zero clearance with the pillow block tightened to specifications. The resulting clearances allowed metal to metal contact between the journal and the bearing causing the surfaces to rub without lubrication and thereby creating metal fragments, increased friction and, finally, bearing failure.

Following the June 13, 1992 occurrence and determination of its cause, the "B" TDRFP actuating linkage was reworked and reassembled. The torque arm journals were machined and ground to a fine surface finish (16 RMS). New pillow block bearings were measured and machined to fit, and the high spots in the pillow block bores were removed. The pillow blocks were aligned using the laser alignment instrument.
