# NORTHEAST UTILITIES

Reference: Facility Operating License No. NPF-49  
Docket No. 50-423  
Licensee Event Report 92-016-00

FACILITY NAME (1) **Millstone Nuclear Power Station Unit 3** DOCKET NUMBER (2) **0 5 0 0 0 4 2 3** PAGE (3) **1 OF 0 6**

TITLE (4) **Both Trains of Auxiliary Building Filters Inoperable**

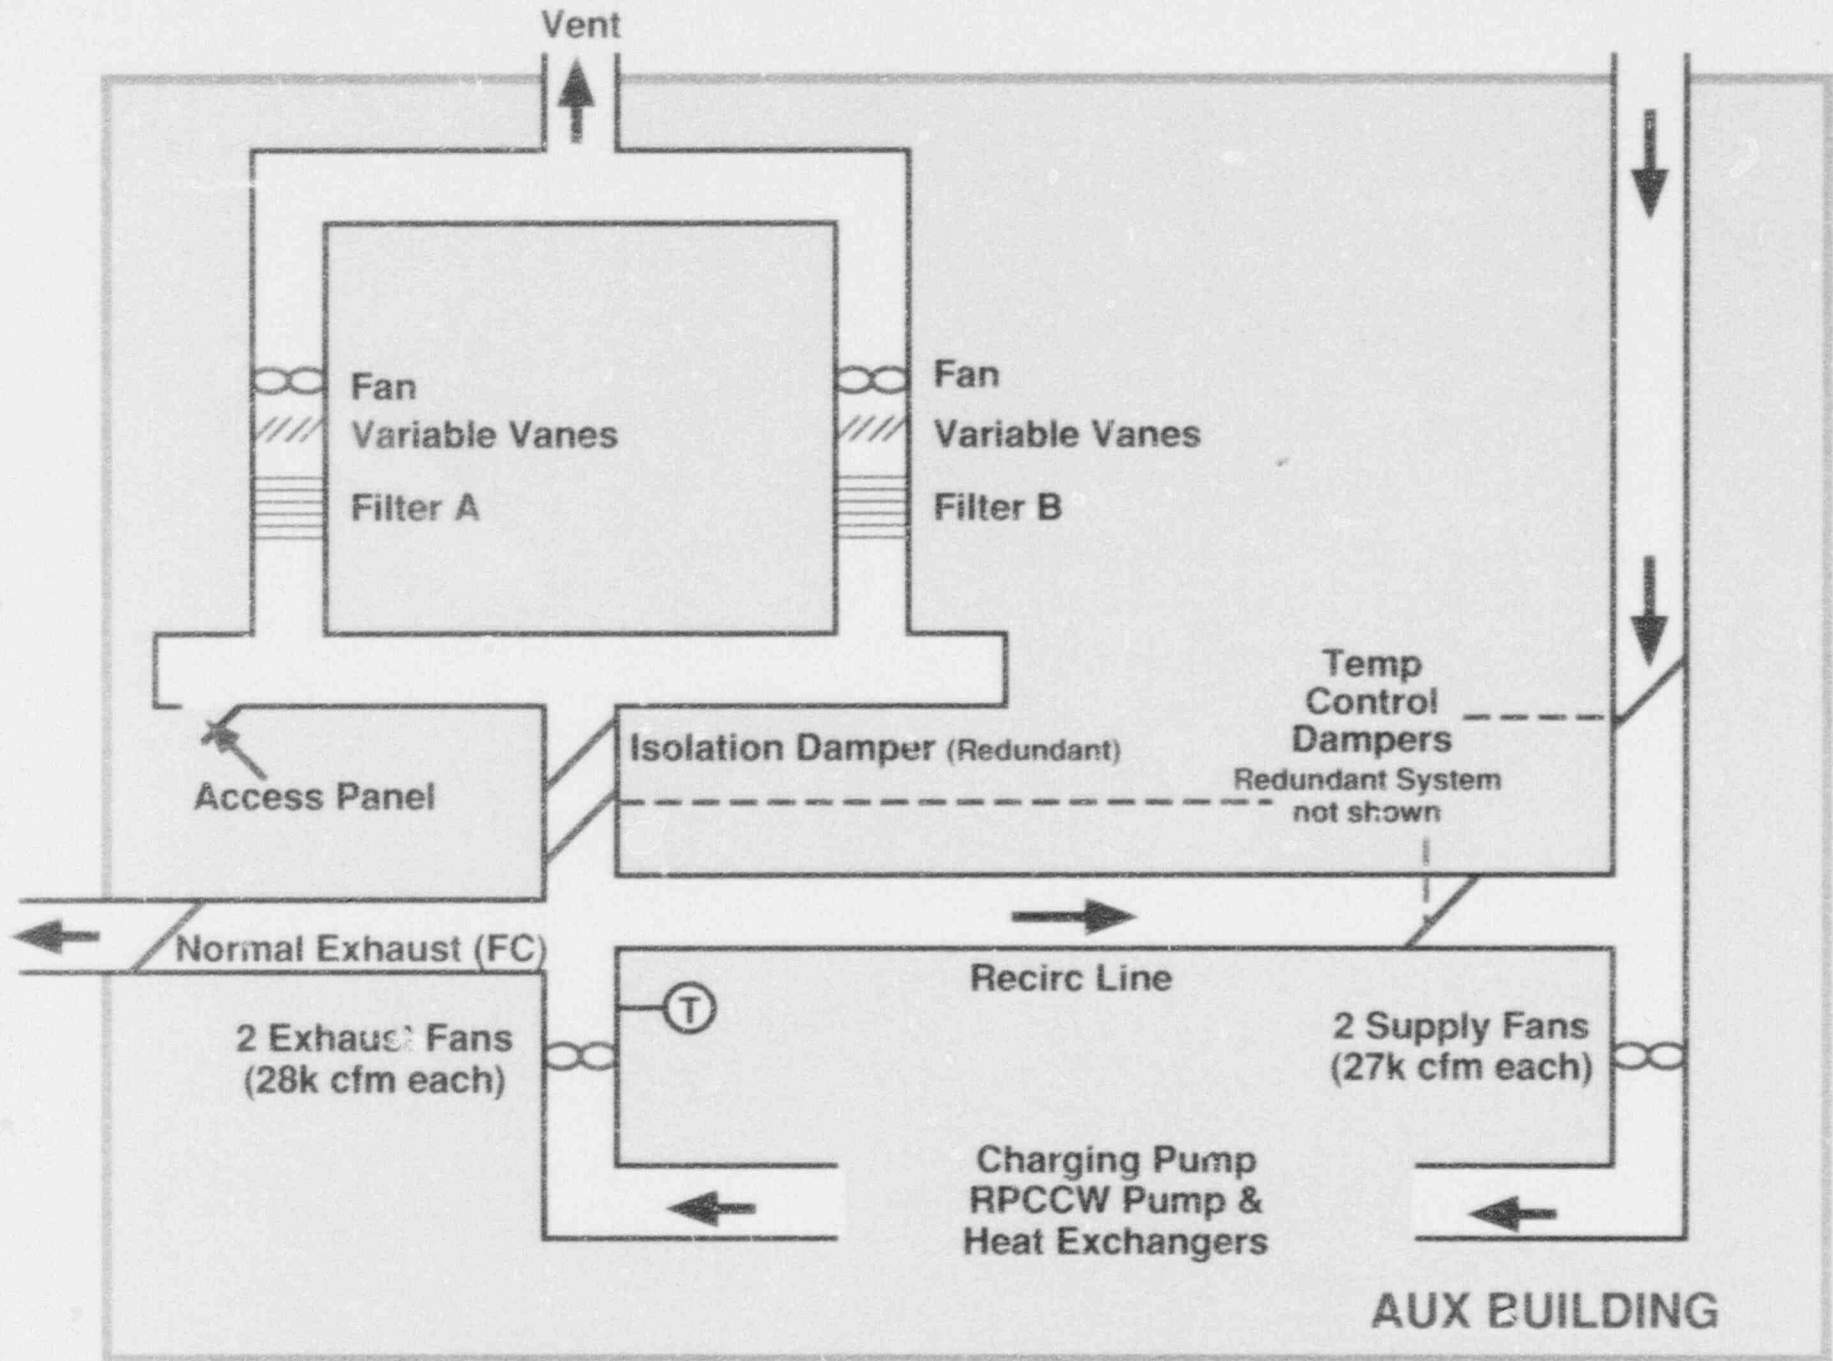
On July 4, 1992, at 1655 with the plant in Mode 1 at 78% power (2240 psia and 577 degrees Fahrenheit), an access door on the common intake plenum for the Auxiliary Building Filter System was found open. The discovery was made by an operator on rounds. The access door provides access to damper 3HVR\*DMPF12. The Control Room staff determined that this may cause both filters to be inoperable and entered the action statement for both trains of ventilation inoperable. In the event of a Safety Injection Signal (SIS), the system is required to

- filter the air in the Auxiliary Building before discharge to the atmosphere. This is accomplished by passing the discharge of the Charging Pump and Component Cooling Water Area Ventilation exhaust fans (see attached drawing) through the filters.
- assist the Supplemental Leak Collection and Release System (SLCRS) in maintaining a negative pressure in the Auxiliary Building. This is accomplished by exhausting more air than is brought into the building by the Charging Pump and Component Cooling Water Area Ventilation supply fans (see attached drawing).

The Auxiliary Building Filter System was last run as required by Technical Specification 4.7.9.a on June 18, 1992. It was most likely at this time that the two closure handles vibrated to the unlatched position. This access door is hinged with two cam type locking devices. This is the only access door in safety related ducting which is believed to have vibrated open. A review of all safety related ducting will be performed and any similar doors will also be lock wired shut. Other access panels in the area are either bolted shut or have sash type locks around the perimeter of the panel.

The open access door is assumed to have a non-conservative effect on the amount of air removed by the Auxiliary Building Filter System. The section of duct where the access door is located is pressurized in the accident alignment. Opening the access door may reduce the inlet pressure to the Auxiliary Building Filter System fans with a subsequent reduction in flow.

To prevent recurrence of this event the door has been lock wired shut.

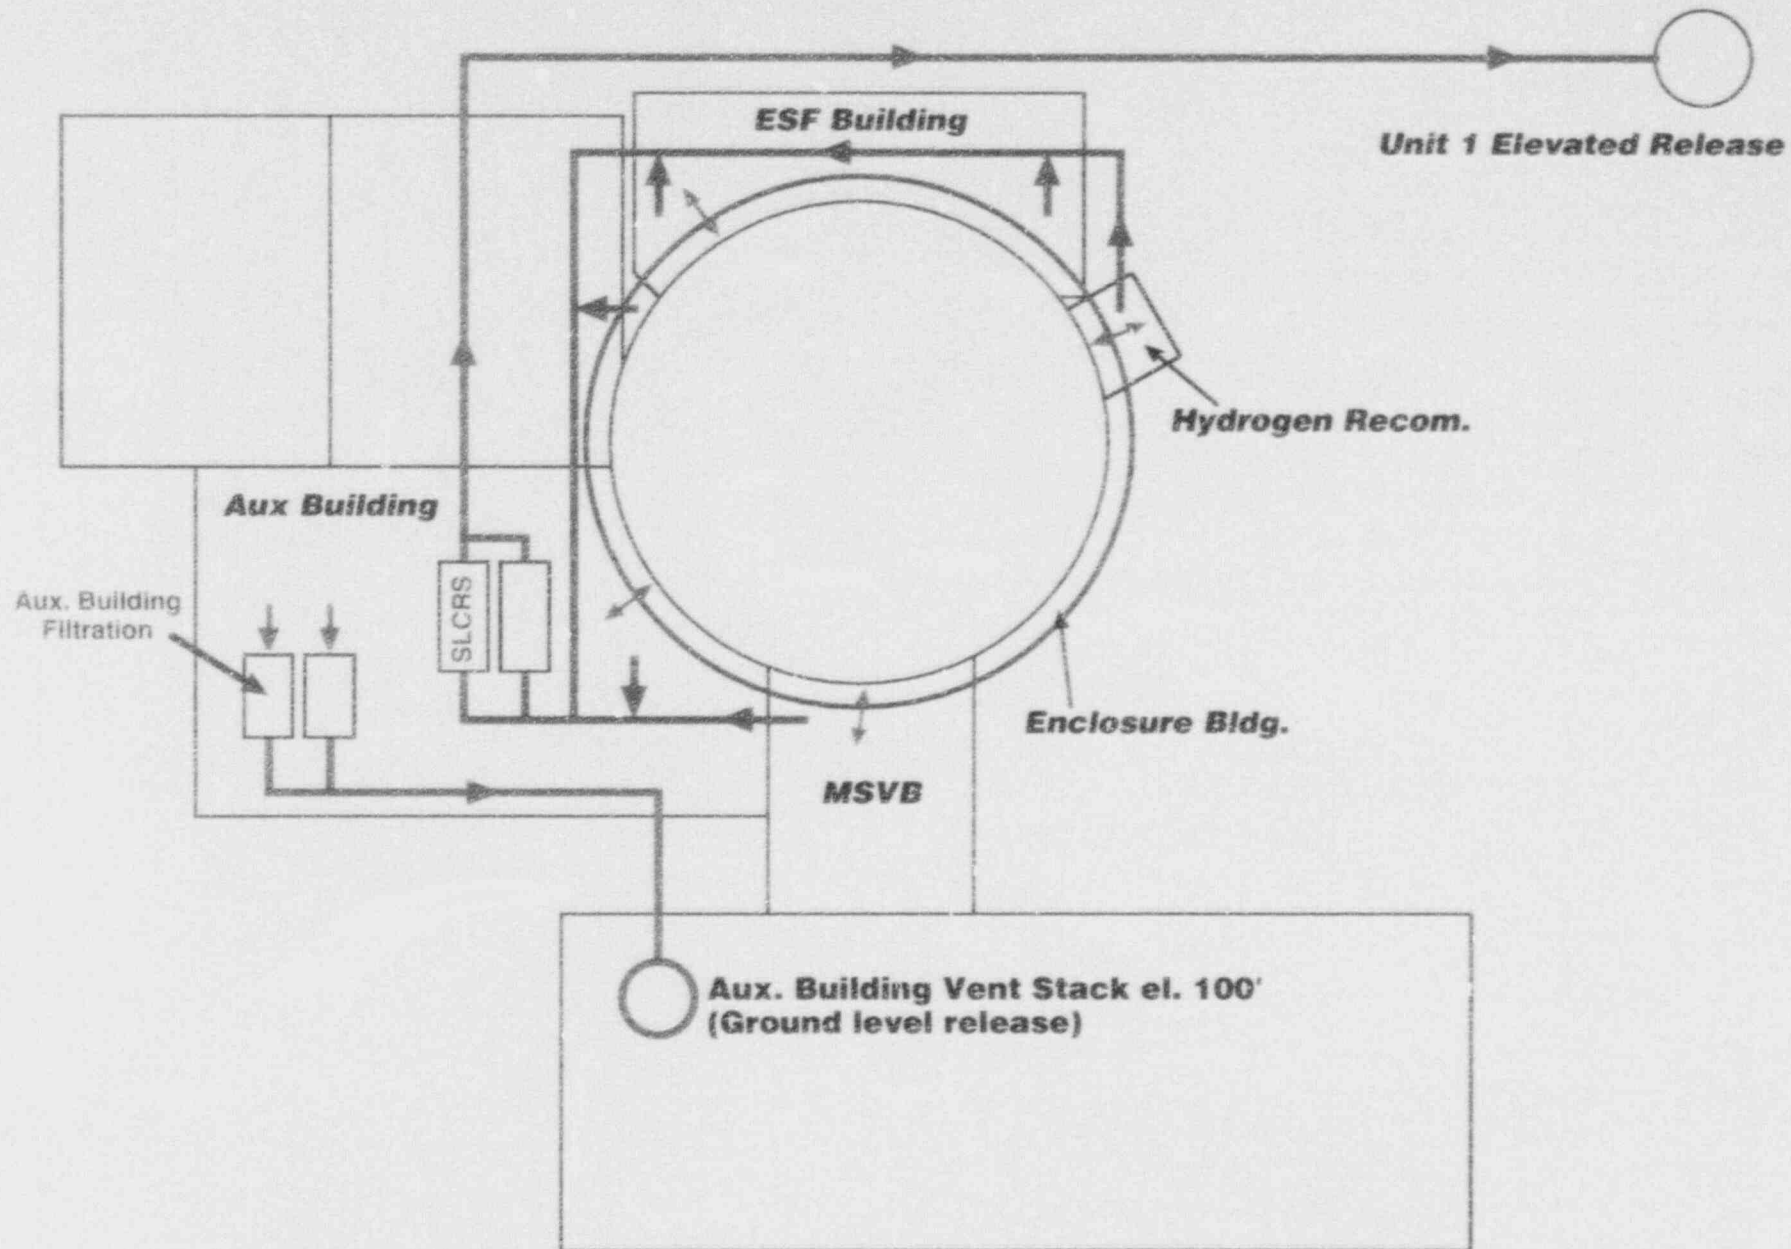
# Secondary Containment Drawdown

The Auxiliary Building Filter System is designed to control the release of radioactive material from the area of the Charging Pump and Plant Component Cooling Water Pumps and Heat Exchangers in the Auxiliary Building during an accident by directing releases through a filtered path and assisting the Supplemental Leak Collection and Release System (SLCRS) in maintaining a negative pressure within the secondary enclosure around containment.

The two systems, Auxiliary Building Filter System and SLCRS, work together to establish the negative pressure. The two systems are tested together to demonstrate the ability to achieve the negative .25 inches water gage pressure within 1 minute inside the secondary containment enclosure during the 18 month secondary enclosure drawdown surveillance.
