LICENSEE EVENT REPORT (LER)

FACILITY NAME (1) Fort St. Vrain, Unit No. 1 DOCKET NUMBER (2) 05000267 PAGE (3) 1 OF 07

TITLE (4) Ultrasonic Detectors Inoperable Due To Instrument Drift

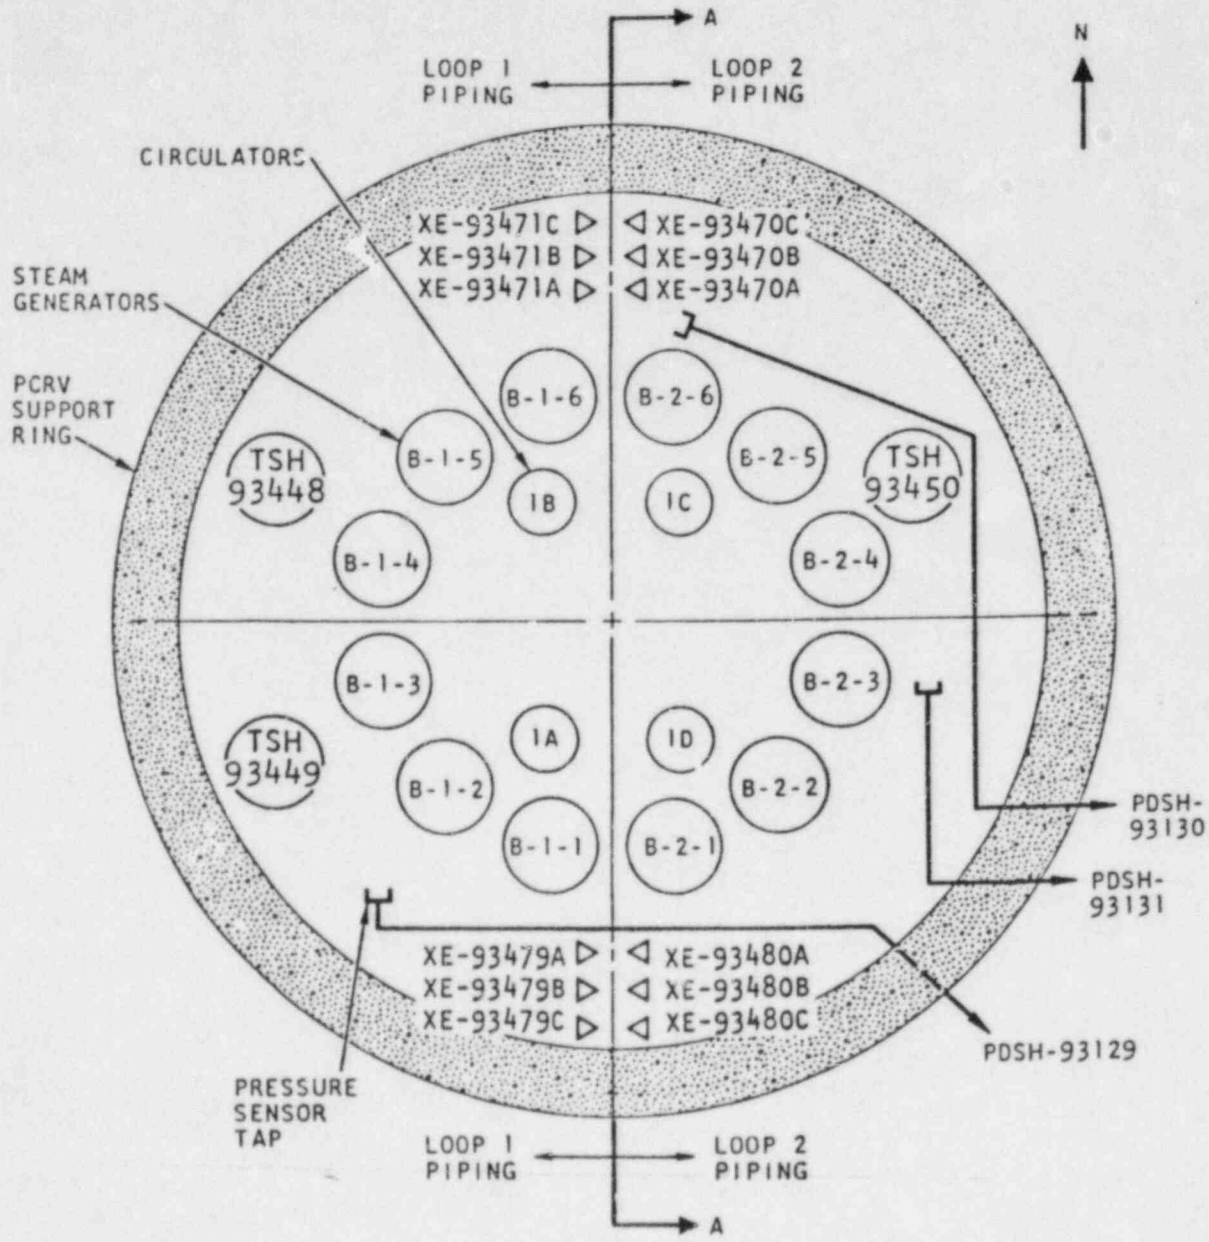
Pipe Rupture Detection System Below PCRV - Plan View

The steam pipe rupture detection system involves a combination of ultrasonic detectors, differential pressure switches, and temperature switches (Figures 1 and 2). The basic system utilizes the ultrasonic detectors to establish in which of two secondary coolant loops a steam leak exists and differential reactor building pressure or temperature switches to confirm that the magnitude of the leak is such that automatic action is necessary. The logic system requires two out of three ultrasonic detectors to trip in the same area plus either a high building pressure or temperature trip.
