SUBJECT: DOCKET NO. 50-333  
LICENSEE EVENT REPORT: 90-025-02  
Service Water Check Valves

LICENSEE EVENT REPORT (LER)

TITLE (4) **FIVE SERVICE WATER TO EMERGENCY SERVICE WATER SWING CHECK VALVES FAIL TO CLOSE DURING TESTING**

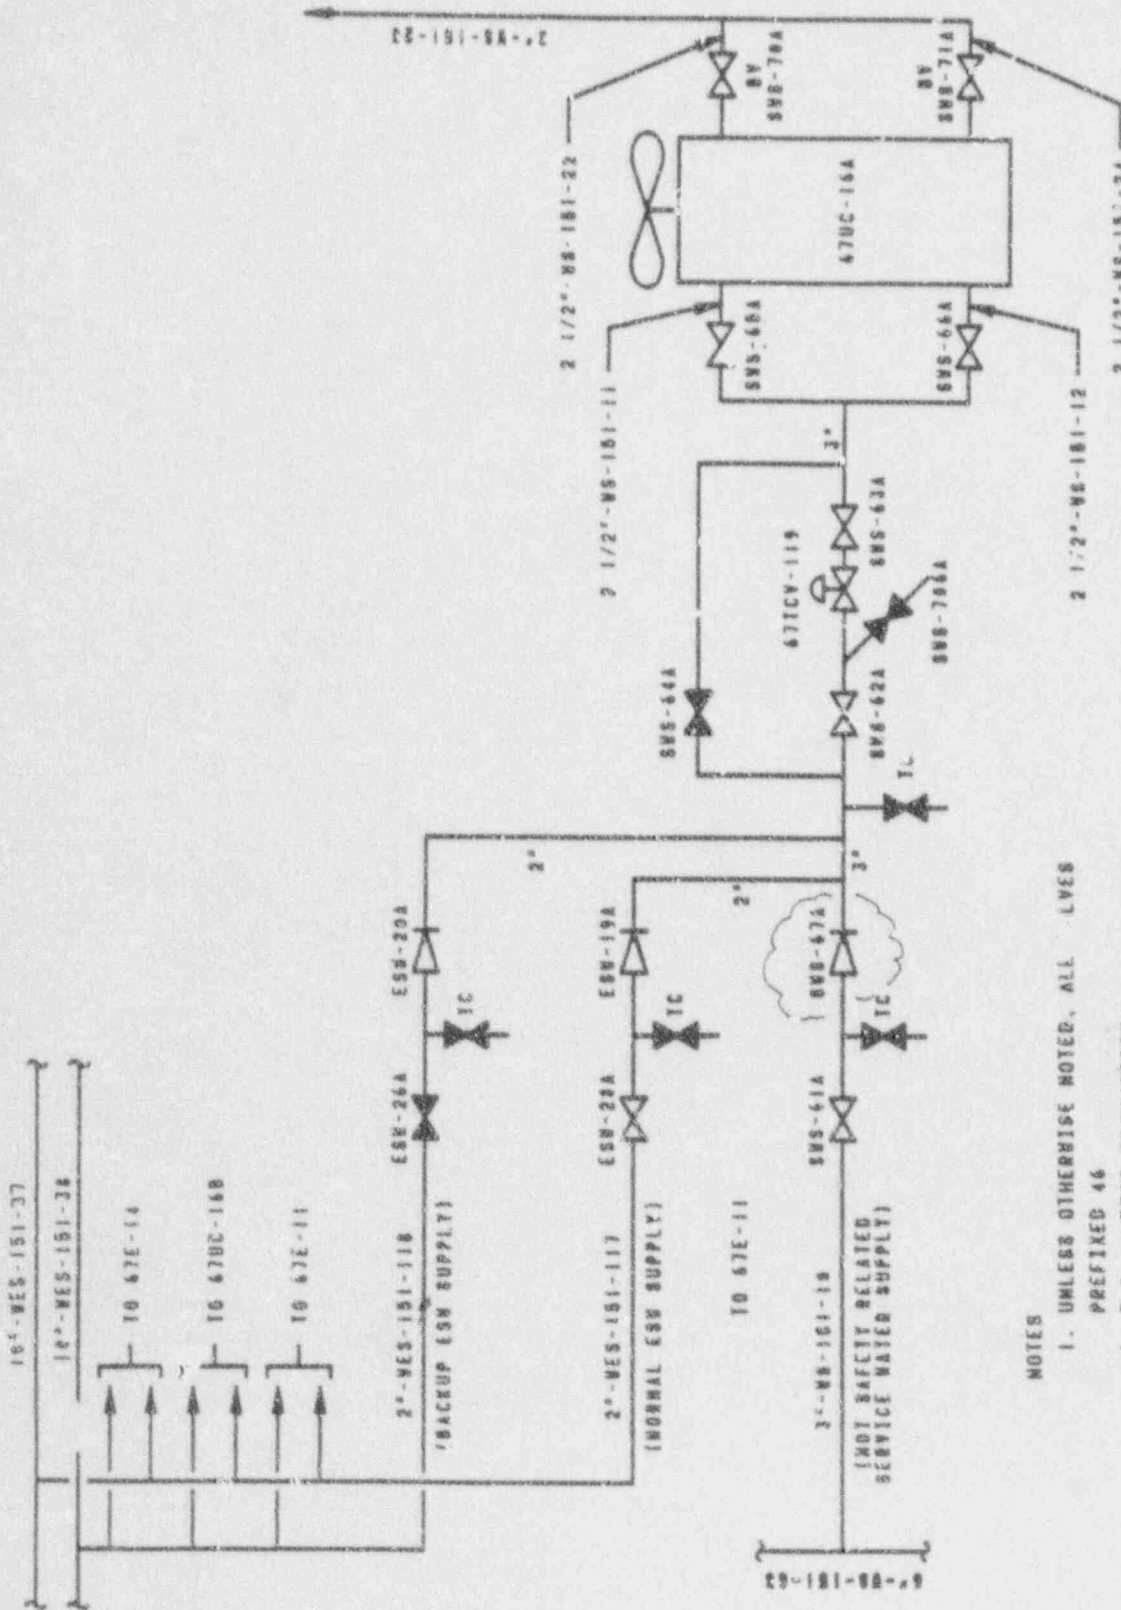
ELECTRIC BAY UNIT COOLERS

Flow diagrams showing the SWS and ESW supply to each heat exchanger are attached as Pages 8 through 11. The tube side of each heat exchanger is normally provided with service water from a 3-inch line that branches off the SWS main header. Teeing into this line, just downstream of the 3-inch swing check valves (which failed to close in this event), are two 2-inch ESW supply lines. One of these supply lines is normally valved-in and is considered safety-related. The other line is normally valved-out and is not safety-related.

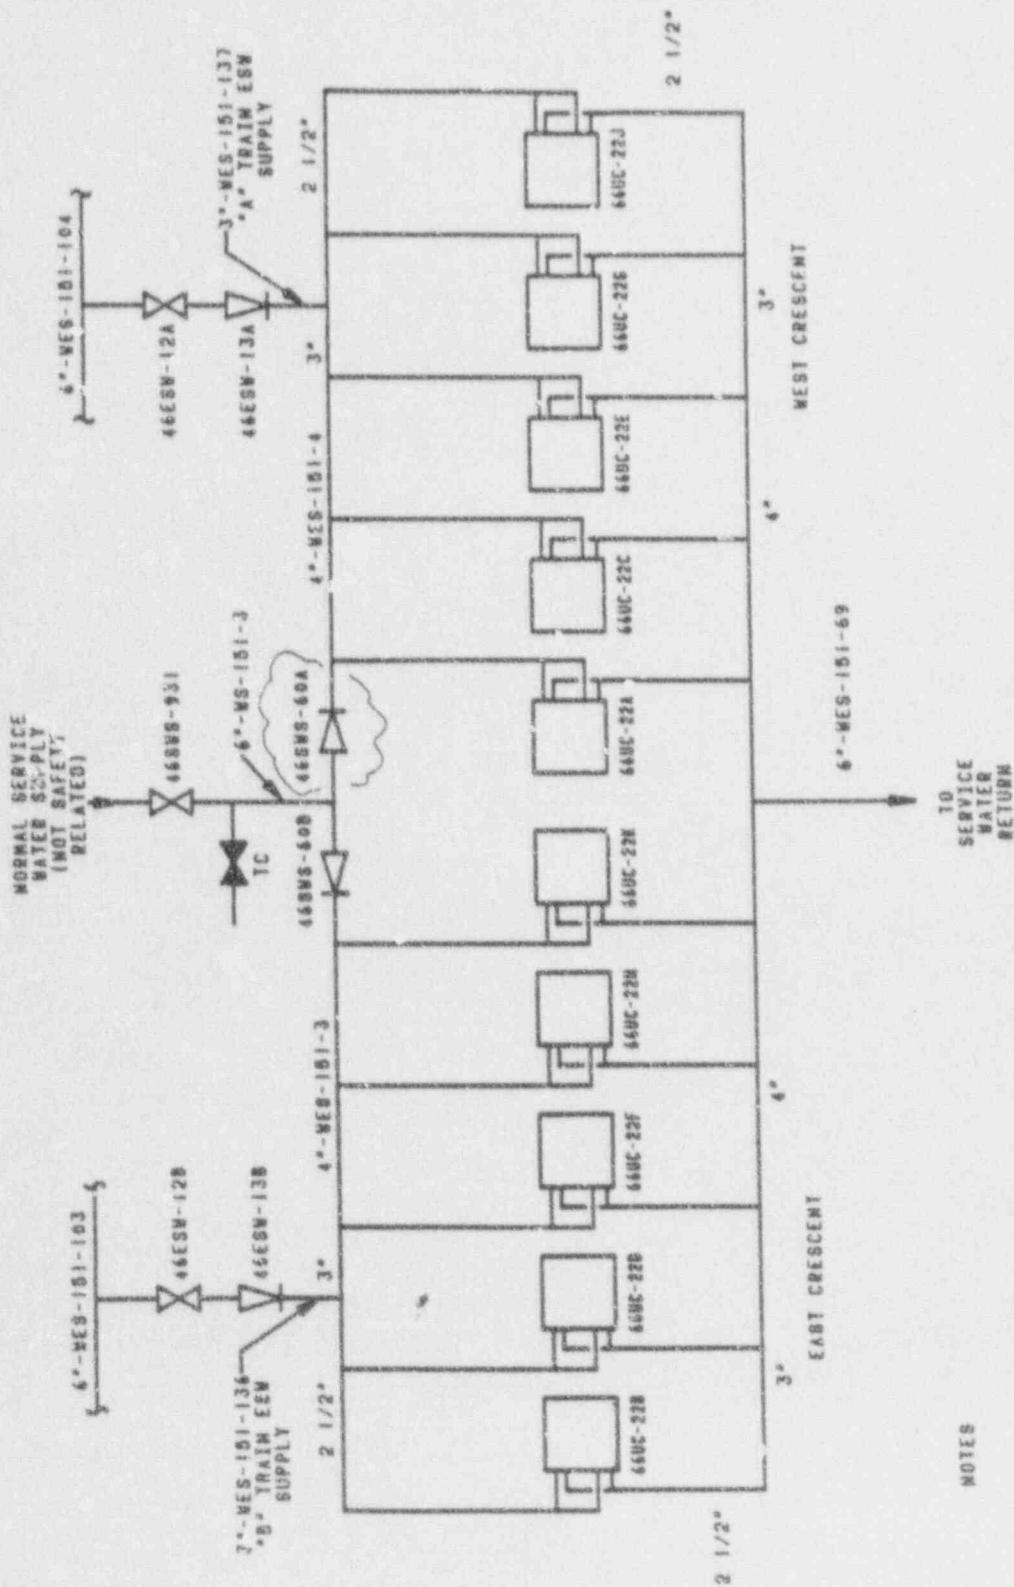
CRESCENT UNIT COOLERS

The crescent area unit cooler heat exchangers provide cooling for portions of the emergency core cooling system (ECCS) [BJ, BM, BN, BO] equipment located in the reactor building west crescent (Safety Division 1) (see Page 12). The coolers are arranged in a bank of five (5).

Each cooler approximates a counterflow air to water heat exchanger. The tubes of each heat exchanger are normally provided with service water through a 6-inch header that tees off in two 4-inch headers (1 per division). The 4-inch header contains the 4-inch swing check valve (46SWS-60A) which initially failed to close under test conditions. Downstream of this valve the header has five tee connections into 2-1/2-inch supply lines to each cooler. The ESW supply also ties into the same header downstream of the failed check valve. Upon initiation of the ESW, the service water check valve 46SWS-60A is designed to close to prevent diversion of ESW from the unit coolers.
