NORTHEAST UTILITIES

LICENSEE EVENT REPORT (LER)

FACILITY NAME (1) **Millstone Nuclear Power Station Unit 2** DOCKET NUMBER (2) **0 5 1 0 0 0 3 3 6 1** PAGE (3) **OF 0 4**

TITLE (4) **Combined Leakage Rate Exceeded**

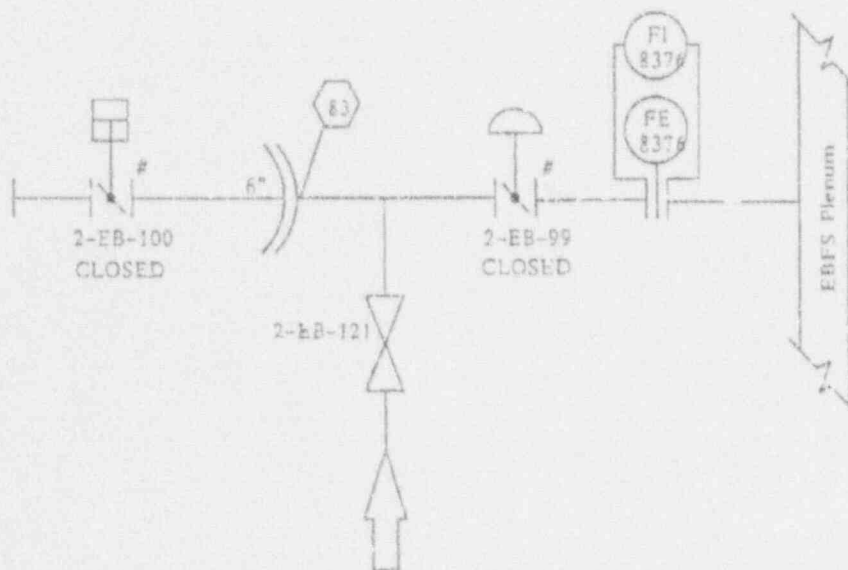
| P&ID 26026 | Figure 9.8 |

The outer isolation valve was disassembled. Inspection revealed that the keys connecting the hand operator and the air operator to the valve shaft had been sheared off. The key connecting the air operator to the shaft became wedged so that the valve still operated, but caused improper seating of the valve disc. Repairs were completed and subsequent valve cycling resulted in failure of the keys again. Investigation of the cause is ongoing.

The root cause of the leakage through the outer isolation valve is due to failure of the key connecting the air operator, which allowed slight misalignment of the valve disc/seat interface.

The root cause of this event is failure of the key connecting the air operator to the valve shaft, which allowed slight misalignment of the valve disc/seat interface, resulting in excessive leakage.

The suspected causes of the failure are either over-tightening of the air operator return spring or improper engagement of the manual operator disengaging lever while positioning the valve with the air operator. It is believed that either of these could cause the damage to the valve operator connecting key and subsequent misalignment of the valve disc. The manual operator disengaging lever only applies to valve 2-EB-99, as valve 2-EB-100 has no manual operator.

Valve 2-EB-99 was disassembled and inspected. The inspection revealed the keys connecting the manual and air operators to the valve shaft had been sheared off. The air operator connecting key was wedged such that the valve still operated but the valve seat was misaligned. The damaged keys were replaced and the air operator linkage was properly adjusted. Valve cycling subsequent to repair has again resulted in shear of the keys. Investigation of the cause continues. Result will be addressed in the supplemental report.
