U.S. NUCLEAR REGULATORY COMMISSION  
REGION IV

NRC Inspection Report: 50-285/92-18      Operating License: DPR-40

Facility Name: Fort Calhoun Station

Inspection Conducted: July 4-11, 1992

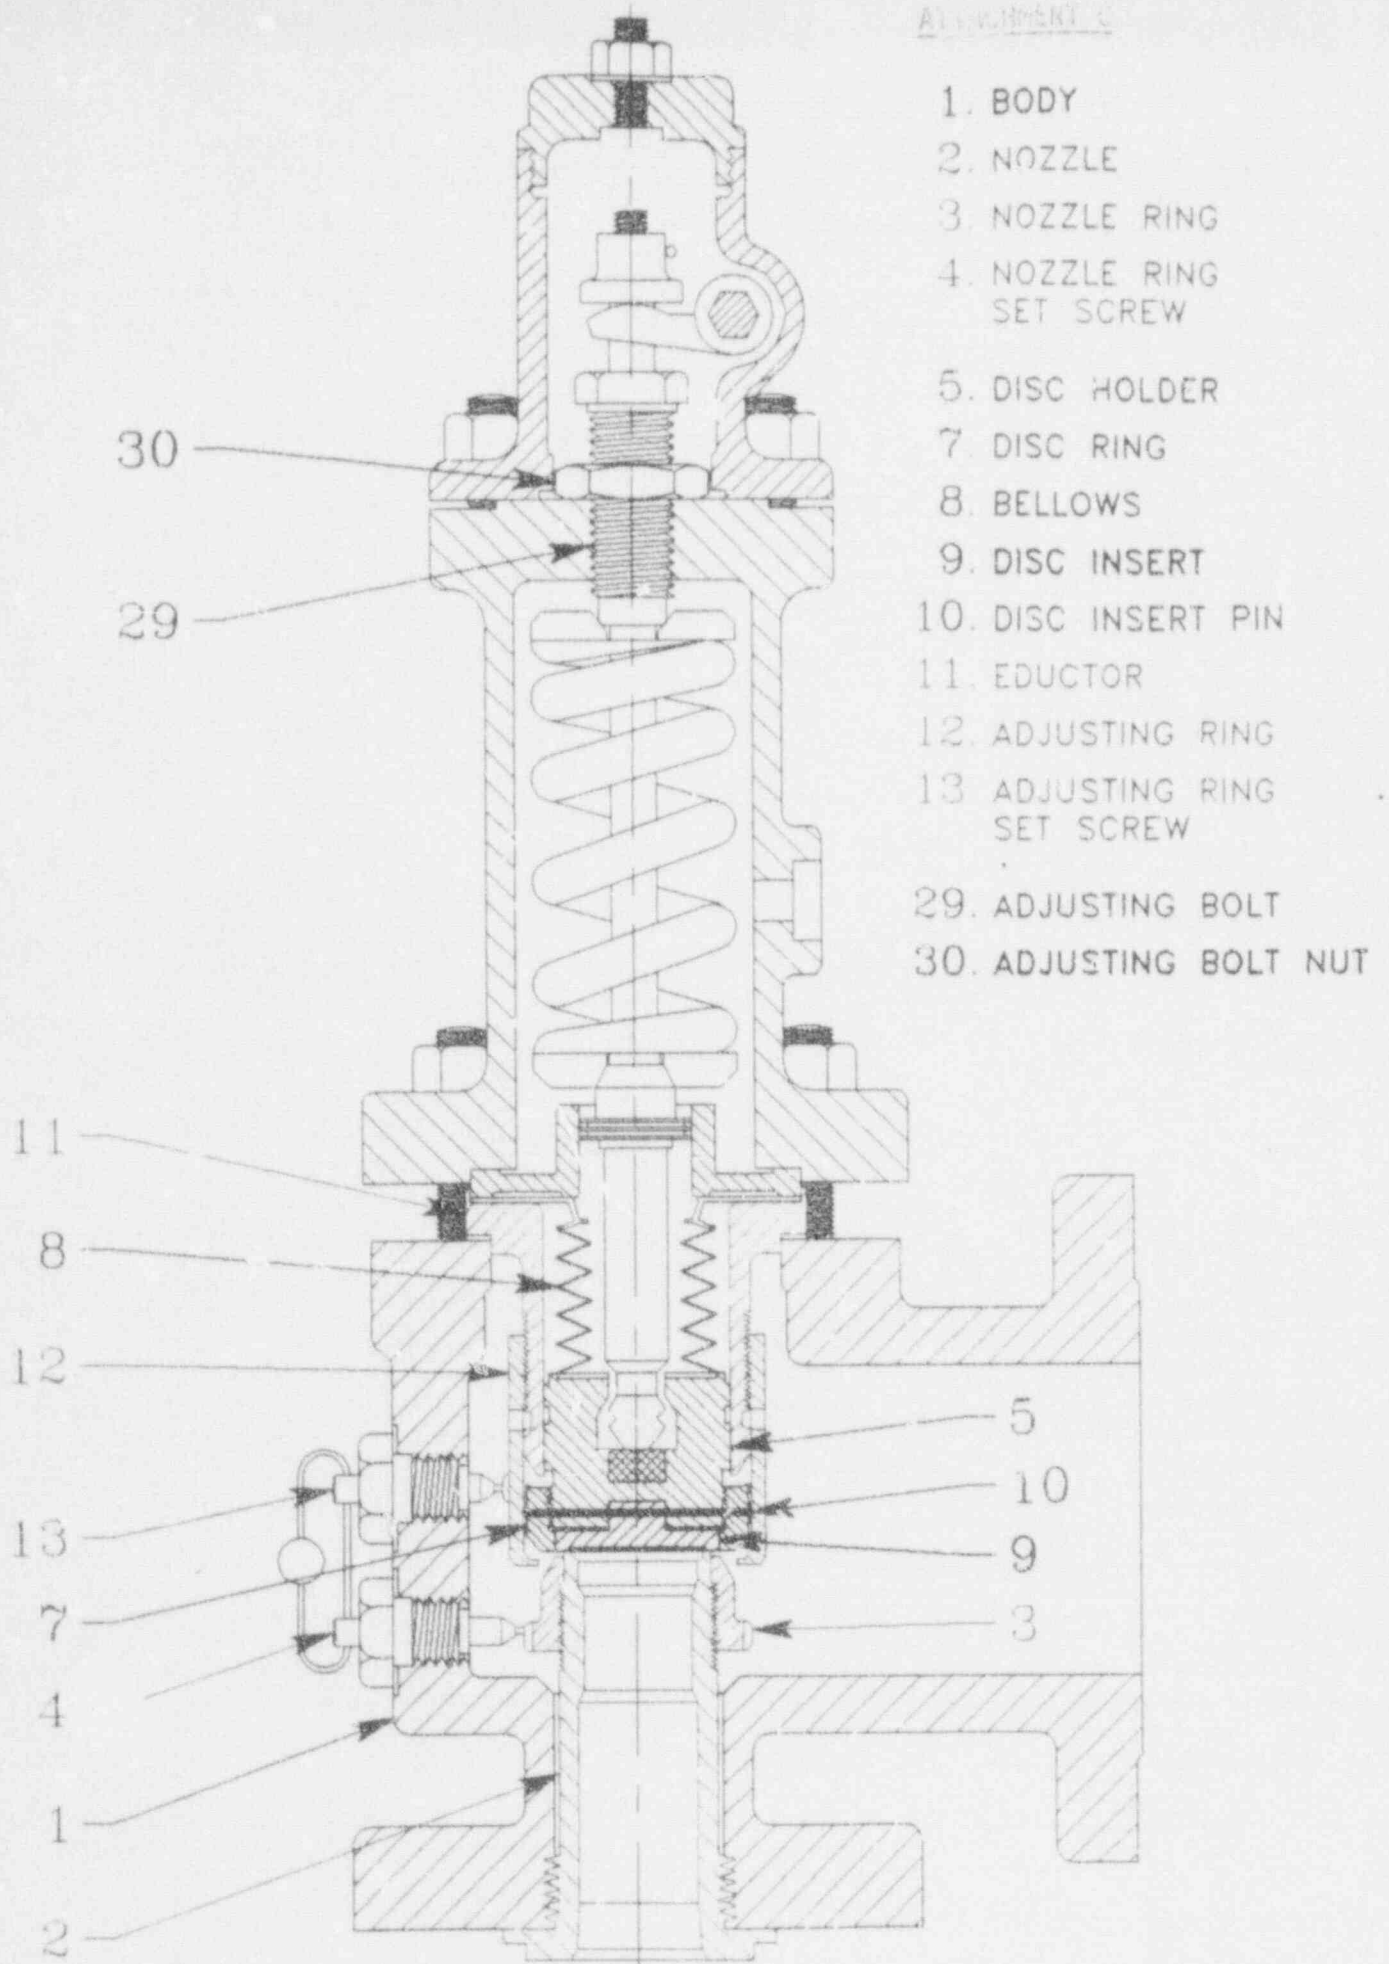
On initial inspection of Pressurizer Code Safety Valve RC-142 (see Attachment C for a diagram of the valve), water (about 3 tablespoons) was found inside the discharge flange of the valve when the temporary outlet cover was removed. To check for possible bellows (Part 8, Attachment C) failure, it was decided to perform a pressure test on the valve through the discharge port, using 15 psig compressed air. At 2.6 psig, the duct tape over the bonnet vent ballooned, indicating significant bellows leakage. As a result of the test, the AIT, in consultation with Region IV and the Office of Nuclear Reactor Regulation, determined that leak testing and verification of the valve setpoint should not be performed with a failed bellows. The decision was based on the potential for causing additional damage to the internals of the valve and possibly destroying evidence of what may have caused the failure of the valve.

During the removal of the valve cap for Pressurizer Code Safety Valve RC-142, approximately 3/4 cup of borated water was removed from the upper valve internals. On inspection, it was noted that the adjusting bolt nut (Part 30, Attachment C) had backed off approximately 1/8 to 1/4 inch and could be turned by hand. Subsequently, on removal of the adjusting bolt (Part 29, Attachment C), it was noted to be 19.5 flats from the zero compression position of the spring. Crosby representatives calculated this position to correspond to a setpoint of approximately 1477 psia. The valve, prior to the

event, was set at  $2500 \pm 25$  psia. The adjusting bolt appeared to have backed out enough, during the event, to lower the setpoint by approximately 1000 psia. During removal of the valve internals, the bellows was found to have catastrophically failed at both ends. The bellows (Part 8, Attachment C) is designed to prevent steam on the discharge side of the valve from entering the upper portion of the valve and leaking out through the hole in the valve cap. The failures occurred at the first weld after the transition weld in both ends of the bellows. The bellows is a welded assembly made of Inconel-X750 and the failures occurred in Inconel-to-Inconel welds. The transition welds, at the upper end of the bellows where the bellows connects to the top flange and at the lower end of the bellows where the bellows connects to the disc holder, are a stainless steel-to-Inconel weld. No problems were noted with the transition welds.

As disassembly continued, there was considerable evidence of valve damage. It was concluded that valve chatter was the major cause of the damage to Pressurizer Code Safety Valve RC-142. Attachment B provides a detailed evaluation of the valve parts and the damage that occurred to each part. Attachment B also provides a list of the parts that are being replaced in Pressurizer Code Safety Valve RC-142. Of significance was that the disc insert (Part 9, Attachment C) was jammed into the disc holder (Part 5, Attachment C) and the disc insert was approximately 0.002 inches below the top surface of the disc ring (Part 7, Attachment C). The disc insert should have been 0.010 to 0.023 inches above the surface of the disc ring. This is an indication of the force that occurred as a result of valve chattering. The disc ring was seated on the nozzle ring (Part 3, Attachment C), as indicated by the nozzle ring not being able to be turned until the spring tension was released. This indicated that the valve was not seating properly and subject to leakage. The nozzle ring and adjusting ring (Part 12, Attachment C) were considered to have been set properly with allowance for the distortion noted above.

30	Adjusting Bolt Nut	Nut was found backed off of the bonnet surface approximately 1/4 inch of bonnet bearing surface. Sloppy fit with adjustment bolt.	Replace and add locking device
