REFERENCE COPY NONCONFORMANCE REPORT

1. ITEM DESCRIPTION BEAM ANGLES	2. PROJECT NO. 8031	12. REPORTED BY <i>M. G. ...</i>	DATE 10-22-76
3. SERIAL NUMBER 232B7 + 232B9	8. ITEM LOCATION <i>See below AREA 19, elev. 253'</i>	13. VALIDATED BY <i>T. H. Brown</i>	DATE 10-22-76
4. PURCHASE ORDER NO. N/A	9. STARTUP SYSTEM NO. N/A	14. REPLACEMENT PART NO.	REASON X
5. CONTRACTOR/LOCATION N/A	10. QC FIELD INSPECTION PLAN NO. C-201-W-1-7 + C-201-W-1-8	15. REPLACEMENT SERIAL NO.	DATE 11-26-76
11. ASME CODE ITEM	<input type="checkbox"/> YES <input checked="" type="checkbox"/> NO	16. SOURCE CONSTRUCTION	DATE 11-17-76
18. ROUTING INSTRUCTIONS:	<input checked="" type="checkbox"/> ROUTE TO FIELD ENGINEERING	<input type="checkbox"/> ROUTE TO MATERIAL SUPERVISOR	DATE 12-2-76

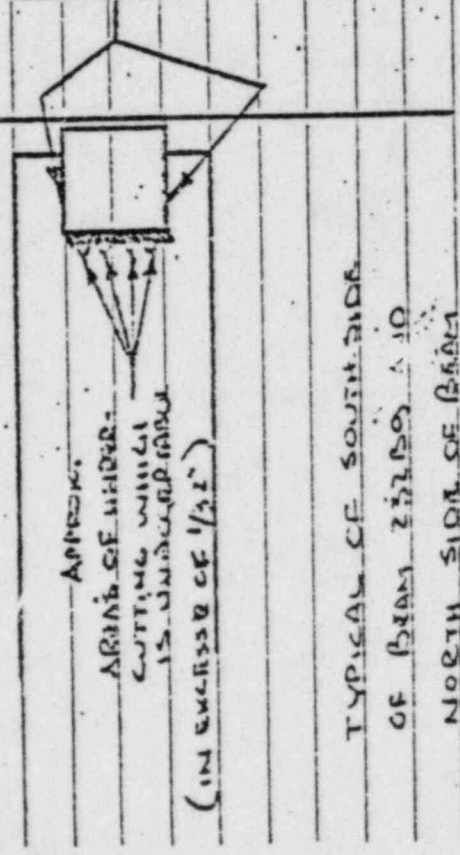
Block #19 CONT. AND UNACCEPTABLE DUE TO EXCESSIVE UNDERCUTTING AND INCOMPLETE WELDING OF THE CONNECTION ANGLE TO THE BEAM WEB. THIS IS CONTRARY TO THE 1970 EDITION OF THE AISC CODE - PART 4 REVISED 6-73 AND AWS D1.1-72, RI-73 AND RB-74 EDITIONS.

AREAS UNDER WELDS IS INCOMPLETE AND OUT OF SPKS. AS OUTLINED IN THE REQUIREMENTS SUPPLIED DATA AND THE AISC REQUIREMENTS.

APPROX. 1 PASS (1/2" OF WELD) VS. REQ'D 7/16" WELD

TYPICAL OF SOUTH ENDS OF BEAM ZHODS AND NORTH ENDS OF BEAM ZHODS

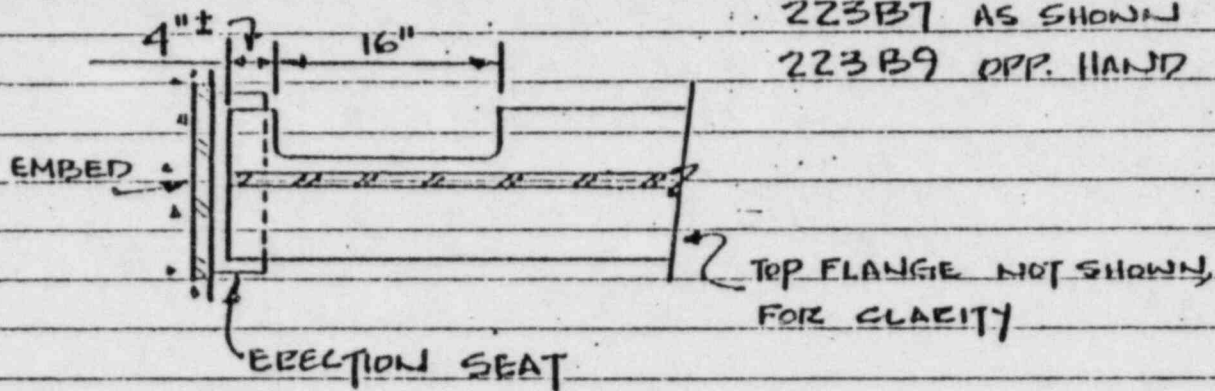
WHILE REPAIRING THE TWO BEAMS, COPES WERE MADE INTO THE BOTTOM FLANGES AS SHOWN.

FIELD RECOMMENDATION TO LEAVE BEAMS AS IS.

REPAIR: rationale: proposed repair procedure will not impair structural capacity of steel. Copies required to make repair may be left as is.
