LICENSEE EVENT REPORT (LER)

FACILITY NAME (1) Robinson Nuclear Project Department, Unit No. 2	DOCKET NUMBER (2) 0 5 0 0 0 2 6 1	PAGE (3) 1 OF 0 3
--	--	----------------------------

TITLE (4)
Loss of MCC-5

H. B. ROBINSON STEAM ELECTRIC PLANT, UNIT NO. 2
DOCKET NO. 50-261
LICENSE NO. DPR-23
LICENSEE EVENT REPORT 85-008

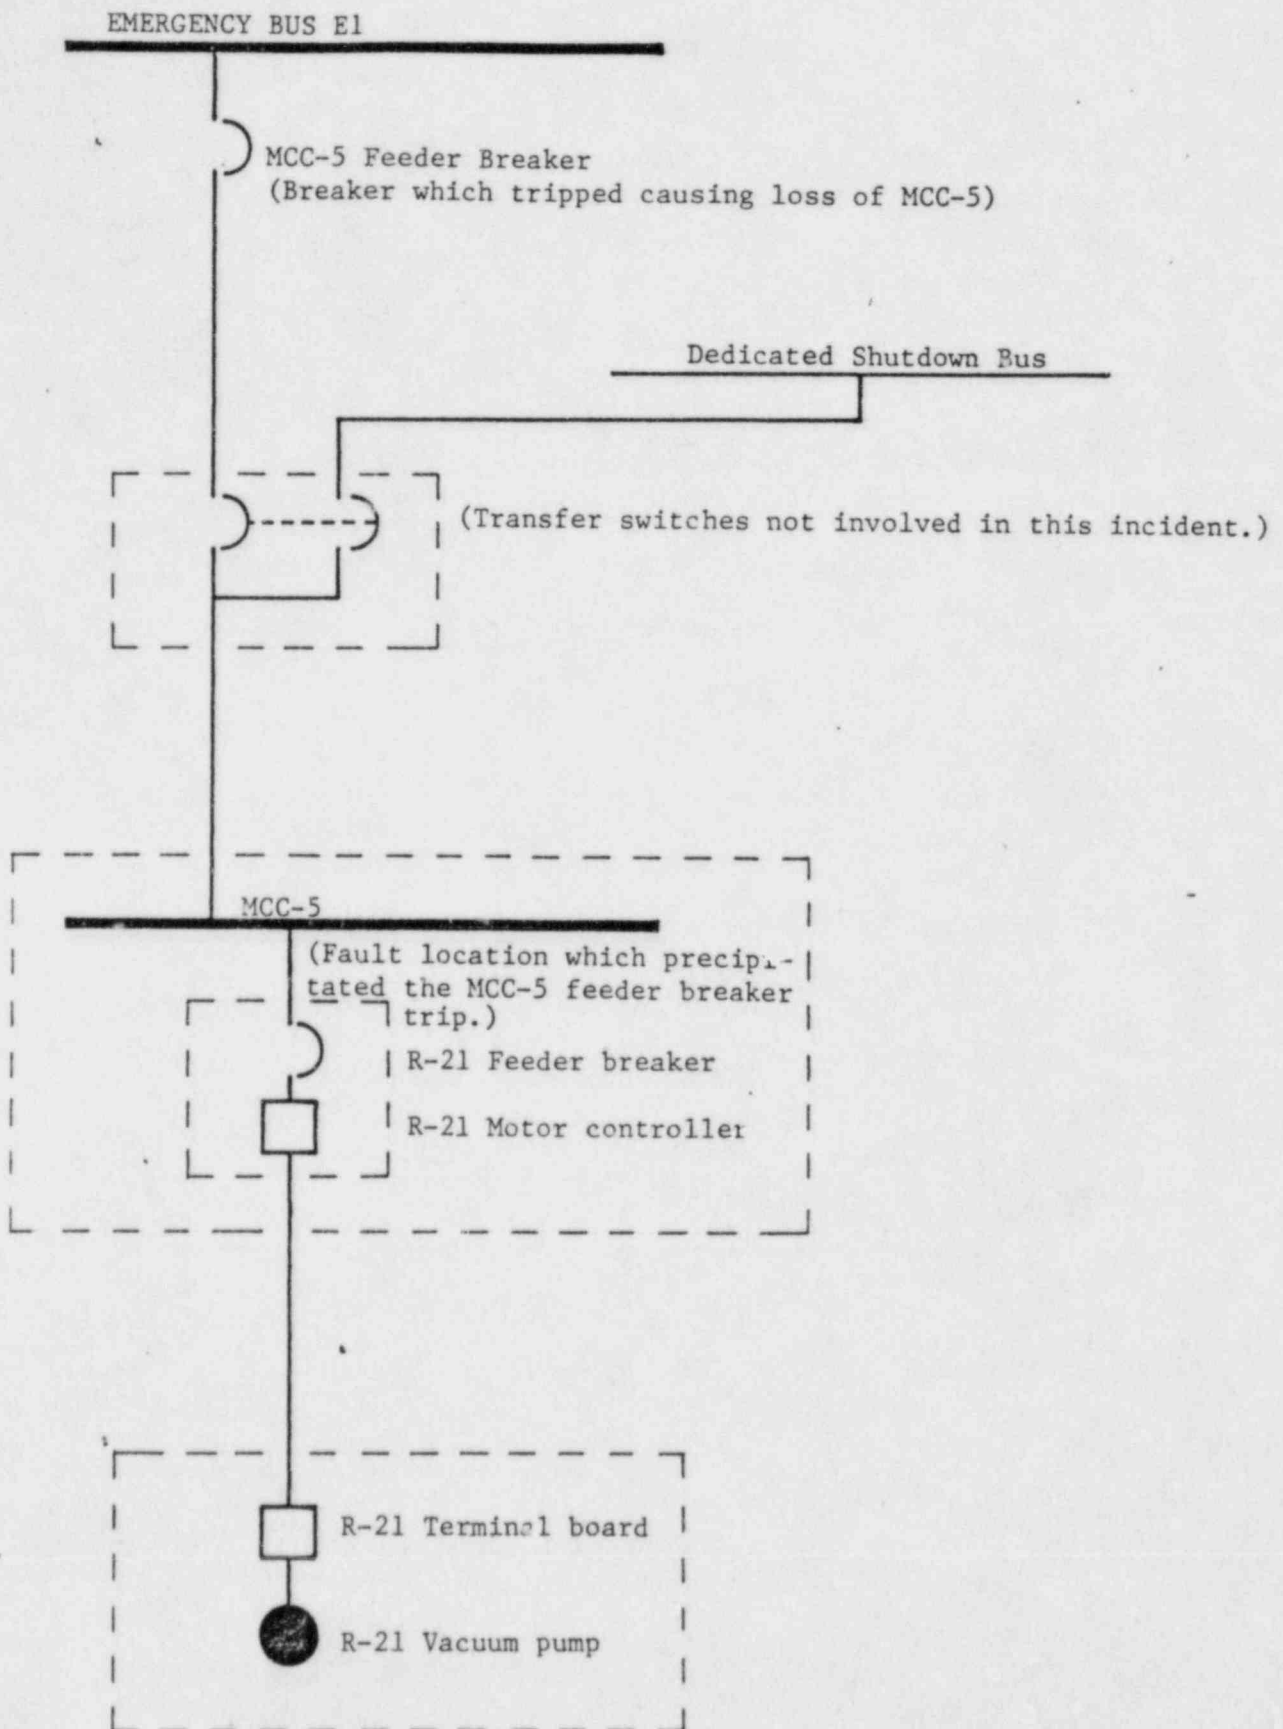
FIGURE 1

Evaluation of this event determined that the R-21 motor feeder breaker instantaneous overcurrent trip device was oversized and unable to adequately protect the R-21 motor controller. The overcurrent condition caused a supply side breaker (MCC-5 feeder breaker) to trip on overcurrent.

Detailed Electrical Description of Incident (Refer to Figure 1)

Water was inadvertently sprayed into the terminal board for the 2 horsepower vacuum pump motor for R-21 (name plate full load running current 3.1 amps). This caused a short circuit between two phases. The high current generated by this fault caused the immediate failure of one phase of the motor starter overload. The current in the other two phases was in excess of the maximum interrupting capacity of the motor controller contactor, caused a flash in the motor controller cubicle and caused failure of the contactor. The motor controller contactor having failed resulted in a short circuit on the line side of the motor feeder breaker. Short circuit protection for the R-21 motor circuit was now bypassed, and fault current from the additional short circuit rose to the overcurrent trip point of the MCC-5 feeder breaker (2800 amps). This device tripped, deenergizing MCC-5.

The magnetic instantaneous trip feature of the 100 amp R-21 breaker was ineffective below 1200 amps (low value of trip band). The 27 amp R-21 motor controller contactor was incapable of interrupting current in excess of 300 amps. Therefore, it has been concluded that no protection was provided by these trips. Additionally, the event was too short in duration for the inverse time protective trip available from the motor feeder breaker to function. The R-21 feeder breaker was found in the tripped position following the incident; however, this could have been from heat generated from the short circuit in the cubical or from the inverse time trip.

The R-21 motor circuit was analyzed, and a more suitable overload size for the motor circuit was established. A 20 amp overload breaker was installed which will provide an interrupt at 240 amps. This breaker also provides a more favorable inverse time characteristic for the motor circuit.

All three improperly sized motor controllers were changed to the 20 amp overload breaker.
