U.S. NUCLEAR REGULATORY COMMISSION
REGION I

Report Nos. 92-17
92-17

Facility Name: Limerick Generating Station, Units 1 and 2

Inspection Period: June 7 - July 18, 1992

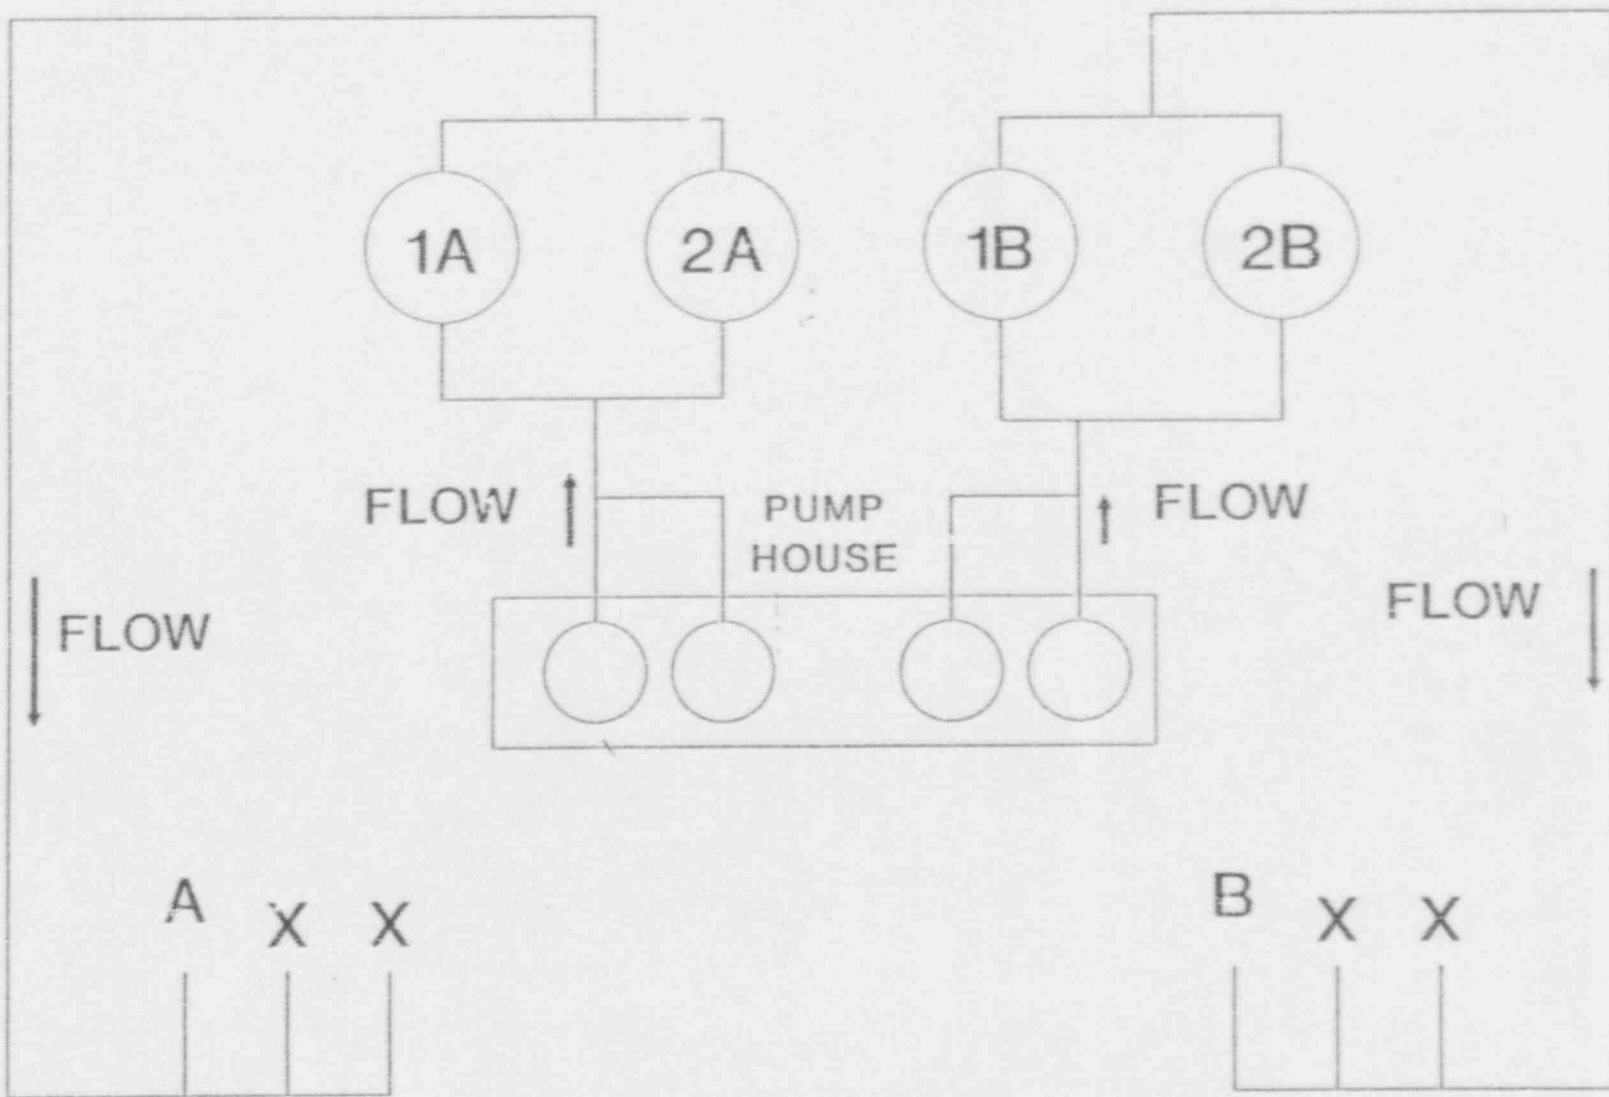
RHR HEAT EXCHANGER

- 3/18 HEAT TRANSFER TEST - INVALID
MISMATCH BETWEEN HEAT TRANSFER RATES
- 3/21 UNIT 1 FOURTH REFUEL OUTAGE COMMENCED
- 3/27 HEAT TRANSFER TEST - INVALID
S/D CLG. ABILITY PREVIOUSLY DEMONSTRATED
- A RHR SYSTEM OUTAGE
- 5/04 HEAT TRANSFER TEST - VALID FAILURE (.0039)
TESTED WITH ADDITIONAL INSTRUMENTATION

5/08 HEAT TRANSFER TEST - VALID FAILURE (.0039)
INSTRUMENTED TO DETERMINE BYPASS FLOW
AND TEMPERATURE STREAMING
PERFORMED AT VARIOUS FLOW RATES

5/24 HEAT TRANSFER TEST - VALID FAILURE (.0037)

6/02 EDDYCURRENT TESTED
 SIGNIFICANT PITTING SHOWN

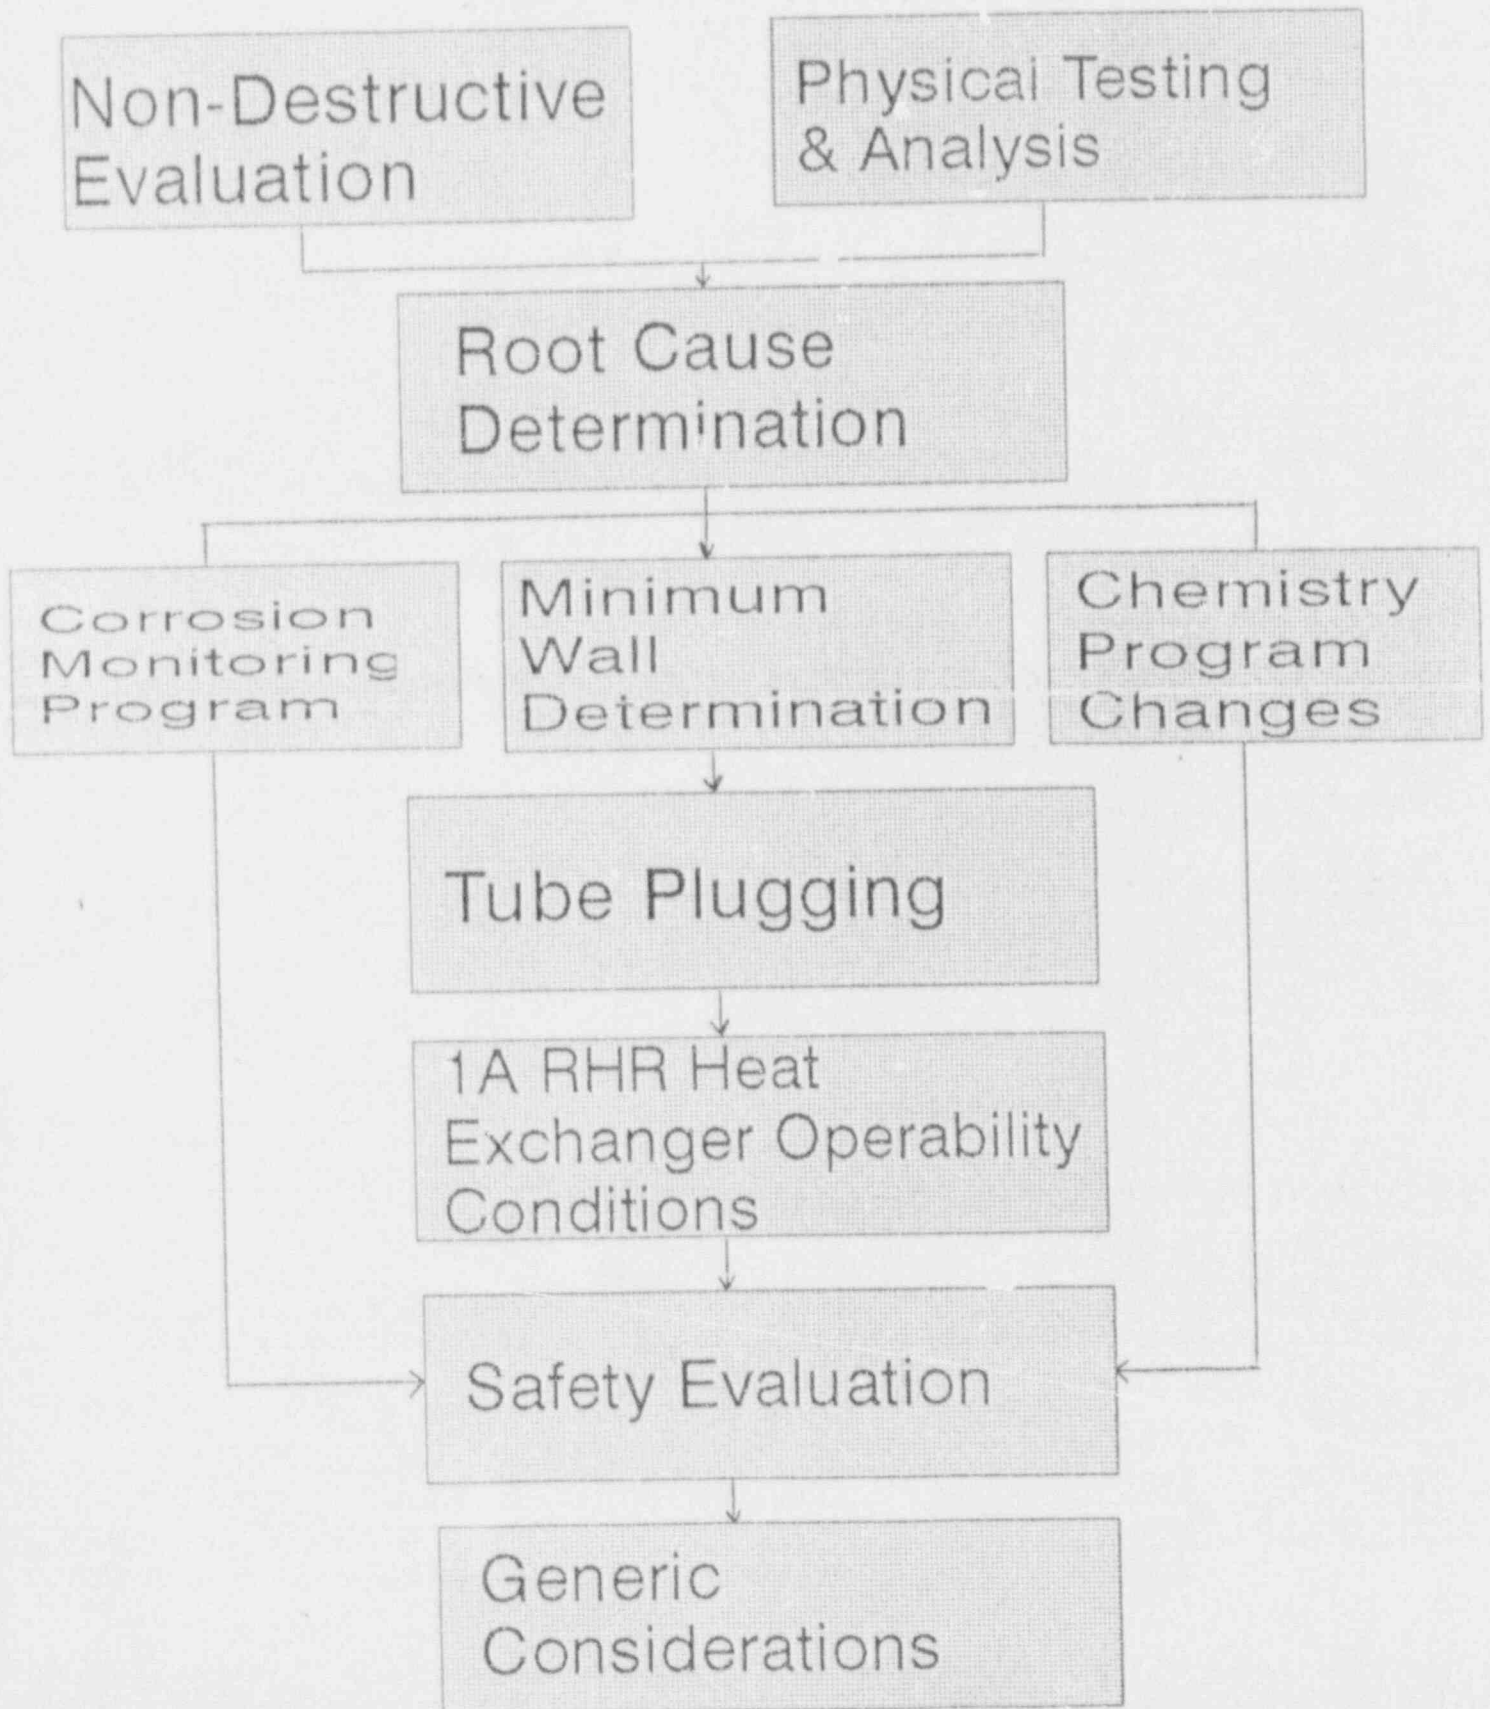
PITTING ROOT CAUSE DETERMINATION

■ ROOT CAUSES

- Underdeposit corrosion caused by
 - Manganese deposition caused by oxidizing environment, microbes, and heat transfer surface
 - Oxygen concentration cells under manganese-rich deposits
 - Aggressiveness of environment increased by sodium hypochlorite

- Microbiologically Influenced Corrosion (MIC)
 - Microbes increase aggressiveness of underdeposit environment

- Eliminated use of oxidizing biocide
- Eliminated corrosion cells (hydrolyzing)
- Increased Spray Pond chemistry monitoring and control
- Implementing use of non-oxidizing biocide
- Evaluating use of dispersant

- Establish improved layup practices
- Implement non-oxidizing biocide treatment during extended pump runs
- Establish chemistry controls for Spray Pond
- Establish procedures for post-LOCA Spray Pond treatment
- Installation/Operation of corrosion monitoring equipment
- Establish appropriate heat transfer test frequency
