U.S. NUCLEAR REGULATORY COMMISSION  
REGION I

Report No. 85-04

Facility Name: Three Mile Island, Unit 1

Inspection Summary: Inspection on January 29, 1985 (Report No. 50-289/85-04)

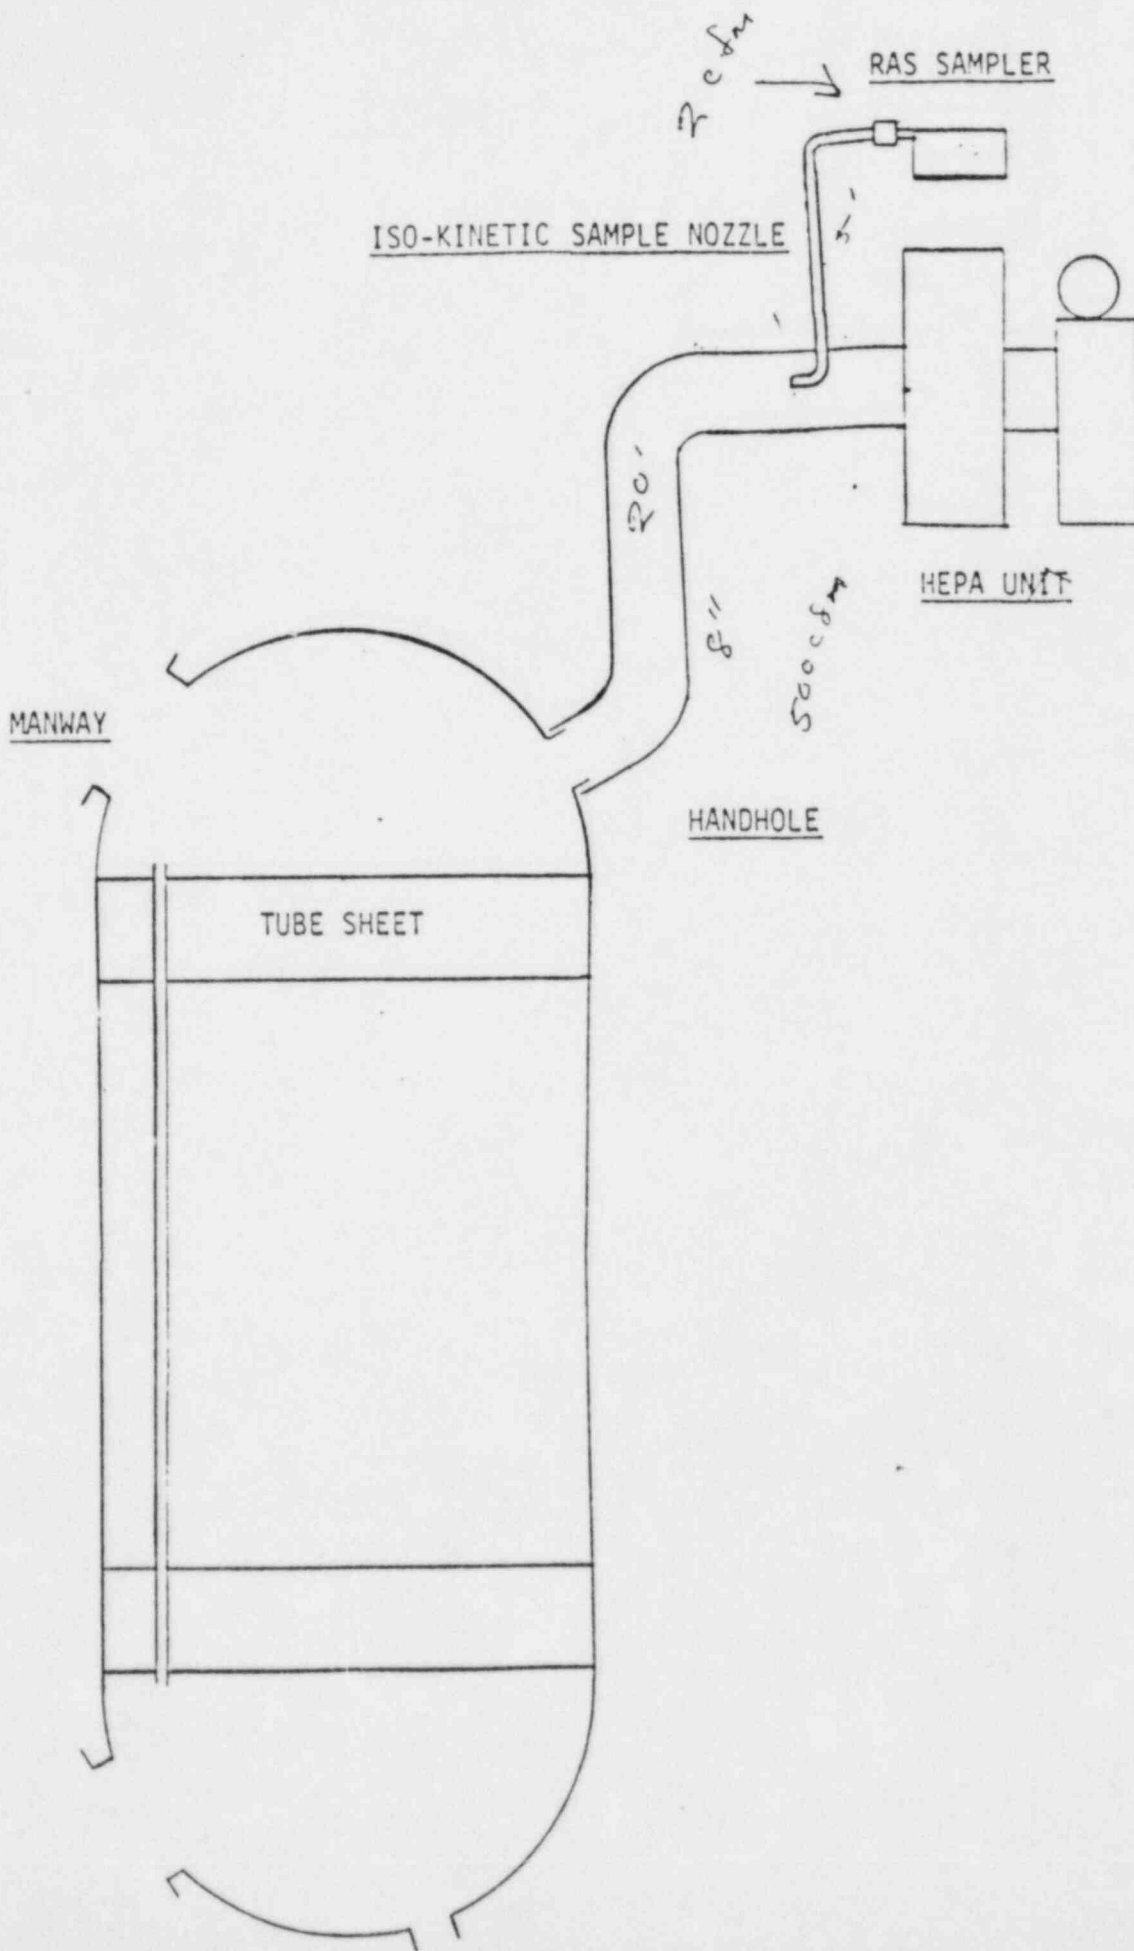
"B" OTSG AIR SAMPLING ARRANGEMENT

In conducting the ALARA/Radiological Review, the cognizant radiological engineer considered previous radiological surveillance data. Normal samples of airborne radioactive material, collected by the means depicted in Figure 1, and conducted while the most energetic work was being done in the steam generators (i.e., extensive eddy current testing of 6000 tubes in the period between November 14 and December 9, 1984) indicated that airborne activity was consistently less than the values specified in 10 CFR 20, Appendix B, Table 1, Column 1, for the predominant isotope identified, Co-60. The radiological engineer also considered loose surface contamination surveys performed inside the steam generators on December 12, 1984, which indicated only moderate activity (5000 to 20,000 dpm/100 cm<sup>2</sup>).

1. The licensee in an effort to reduce personnel exposure by elimination of encumbering respiratory protection equipment, failed to realize that the normal air sampling arrangement did not provide representative indication of workers breathing zone. This deficiency in air sampling was never recognized since all other previous entries were made with respiratory protective devices which afforded a protection factor of at least 2000.
2. The licensee failed to fully realize and understand the nature of the work that was performed, and that radiological conditions might be subject to change as a result of task performance.
3. The licensee failed to evaluate actual air activity and surface contamination in the head area under conditions similar to what the workers were expected to encounter.

1. Radiological Engineering will ensure that in-head air samples, representative of worker breathing zones, are collected to support future OTSG entries by February 15, 1985.
2. Radiological Engineering will re-evaluate past OTSG entries and determine if the respirator protection afforded was commensurate with measured concentrations, considering past sampling techniques by March 1, 1985.
3. Radiological Engineering will have OTSG samples analyzed for alpha emitters and adjust "MPC-Hour" assignments as appropriate by March 31, 1985.
4. Radiological Engineering will re-assess the validity of the  $2.0E-12$  uCi/cc, alpha permissible concentration value as it pertains to the assignment of personnel "MPC-Hours" by March 31, 1985.
