PACIFIC GAS AND ELECTRIC COMPANY

PGandE Letter No.: DCL-84-186

Re: Docket No. 50-275, OL-DPR-76
Docket No. 50-323
Diablo Canyon Units 1 and 2
Responses to SSER 22

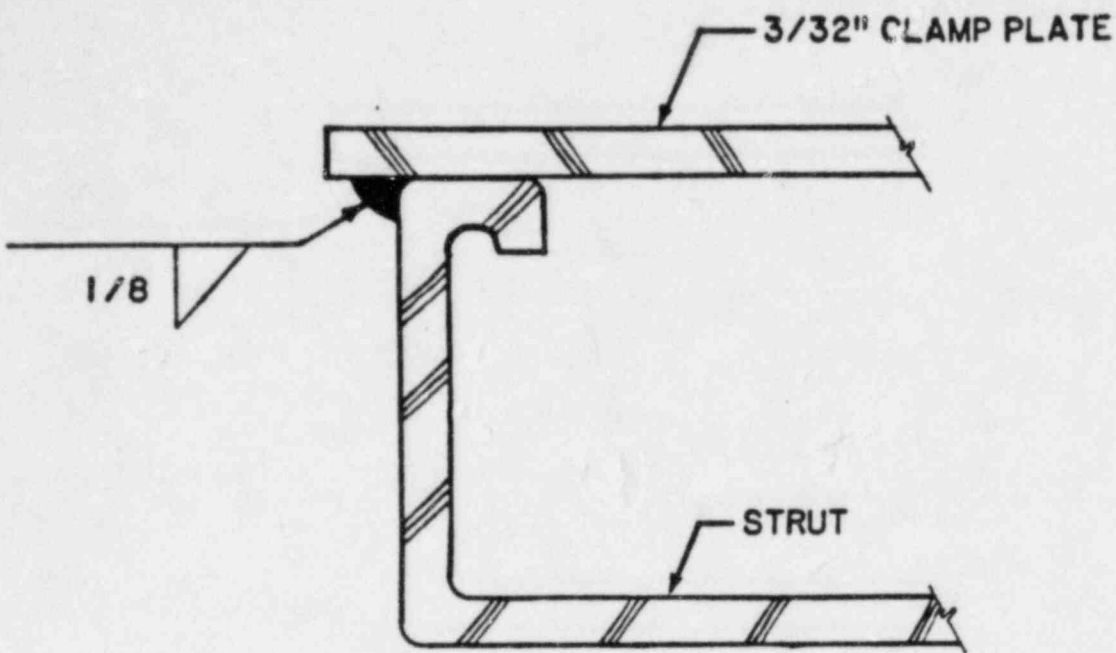
FIGURE 1

actual condition. Engineering then revised the design. The existing clamp plates were replaced with wider clamp plates, restoring the Figure 1 joint configuration. Proper welds were then made. Alternately, in a few cases, the clamp was replaced with a clip angle that bolted to both the tray and the strut, thus eliminating the need for welding.

CORRECT WELDING

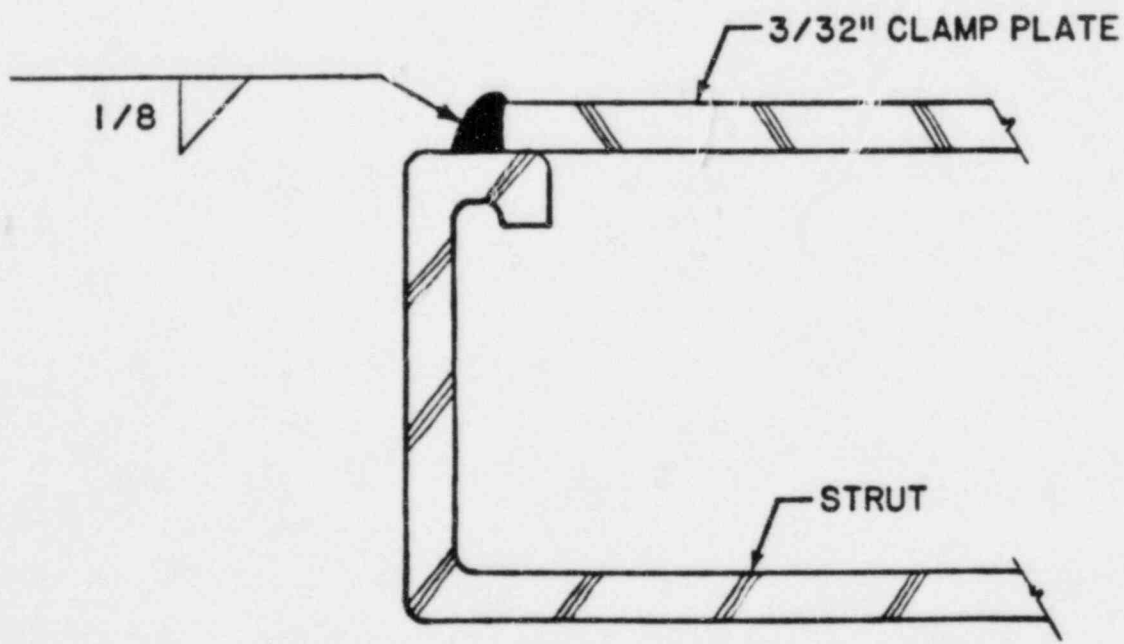
FIGURE 2

This clamp modification was specified for only a few raceway cable tray supports in Unit 2. When Foley began construction of these modifications, they found that the existing clamps were not wide enough to place the specified weld as the joint configuration shown in Figure 2 of Exhibit 2, attached, actually existed. For the Figure 2 joint configuration, placement of a 1/8" weld on the end of the 3/32" clamp plate would have been inappropriate. However, in the course of the normal DCN review process, Foley initiated an Engineering Disposition Request, notifying Engineering of the

INCORRECT WELDING
