LER 92-006
Davis-Besse Nuclear Power Station, Unit No. 1
Date of Occurrence - July 23, 1992

LICENSEE EVENT REPORT (LER)

FACILITY NAME (1) Davis-Besse Unit No. 1 DOCKET NUMBER (2) 0 5 0 0 0 3 4 6 PAGE (3) 1 OF 0 4
TITLE (4) Deficient RPS Calibrating Procedures

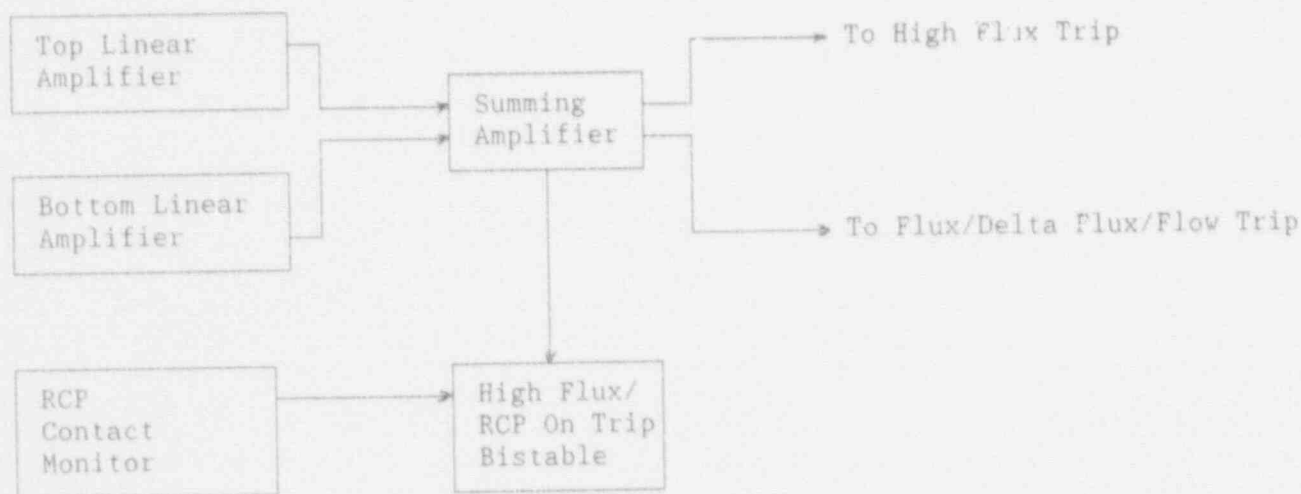
Common circuitry, consisting of the Top Linear Amplifier, the Bottom Linear Amplifier, and the Summing Amplifier provides input to the High Flux/Number of RCPs On trip function, the TS Table 2.2-1, Item 2, "High Flux" trip function, and the TS Table 2.2-1, Item 4, "Flux/Delta Flux/Flow" trip function. Figure 1 provides a simplified schematic of the affected circuitry.

TS Table 4.3-1 requires quarterly calibration of the High Flux and the Flux/Delta Flux/Flow trip functions and an 18-month calibration of the High Flux/Number of RCPs On trip function. The existing procedures require the circuitry common to all three trip functions to be calibrated quarterly. The High Flux/Number of RCPs On trip function is not functionally tested during the quarterly tests. This testing scheme may allow non-conservative values of the High Flux/Number of RCPs On trip setpoint to go undetected.

The apparent cause of this event can be attributed to deficiencies in the procedures used for calibrating the High Flux, the Flux/Delta Flux/Flow, and the High Flux/Number of RCPs On trip functions. These procedures do not properly account for the impact that adjustments and instrument drift of the circuitry common to all three trip functions may have on the High Flux/Number of RCPs On trip function setpoint.

In addition, the acceptance criteria for the Contact Monitor output voltages in DB-MI-03025 through DB-MI-03028 do not properly account for instrument drift which may occur in the Top Linear Amplifier, the Bottom Linear Amplifier, the Summing Amplifier, and the High Flux/RCP On Trip Bistable. Had a proper Contact Monitor setpoint been established, none of the four identified non-conservative setpoints would have occurred.

Plant procedures DB-MI-03057 through DB-MI-03060, governing quarterly calibration of the High Flux and the Flux/Delta Flux/Flow trip functions, will be revised to incorporate calibration of the High Flux/Number of RCPs On trip function and procedures DB-MI-03025 through DB-MI-03028 will be canceled. The High Flux/Number of RCPs On trip function will be calibrated quarterly in conjunction with calibration of the other two trip functions. These procedure revisions will be completed prior to the next required quarterly calibration for each channel. In addition, to properly account for instrument drifts, the Contact Monitor output voltages acceptance criteria will be revised.
