Public Service Company of Colorado

November 8, 1984
Fort St. Vrain
Unit #1
P-84460

Docket No.: 50-267

SUBJECT: Status of Fort St. Vrain
Control Rod Refurbishment

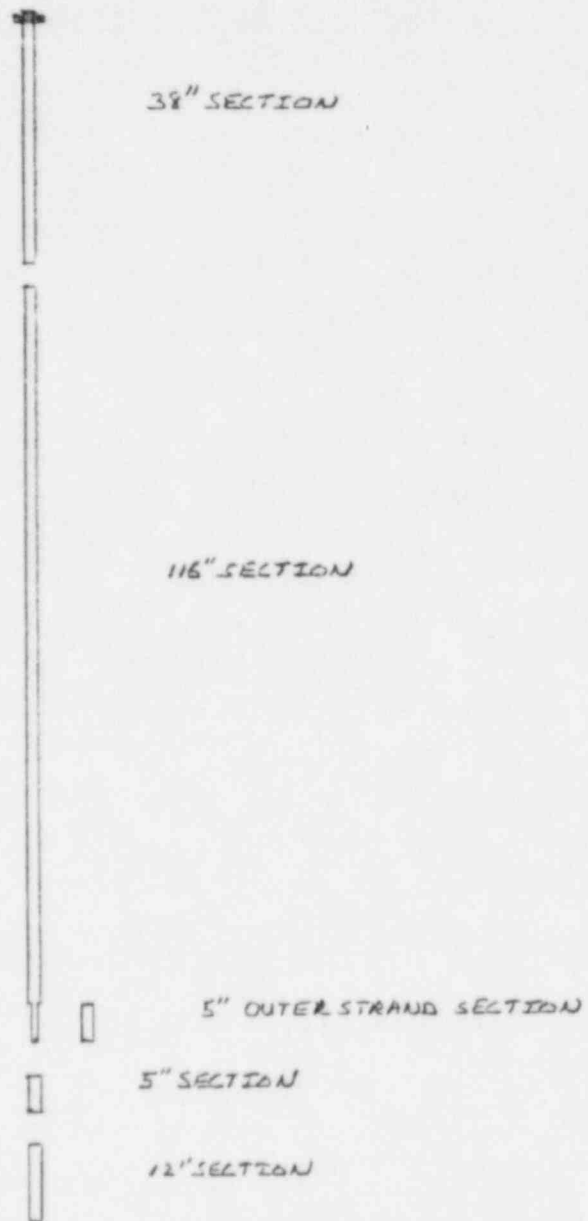
FIGURE 1

Upon removal of the cable seal a single strand of the cable (7 wires per strand, 19 strands per cable) was found to have failed and become entangled around the cable in the cable seal area. Apparently, as the control rods were being retracted in the mechanism, the failed strand became jammed in the seal, thus increasing the tension on the cable and causing it to fail approximately one foot above the seal. The upper portion of the failed cable then became entangled between the cable drum and gear train housing causing it to sever into five separate sections when the drive system was later activated.

Starting from the end of the cable, attached to the cable drum, a 38 inch section (including the anchor) was found to be wrapped around the drum. The next section, 116 inches in length, was entangled around the drum and jammed in the cable channel at the bottom of the drum. It was observed that one end of this long section matched to the 38 inch section. The other end of the 116 inch section had a 5 inch section of the outer strands missing. The inner strands were still intact. A 5 inch section, which had fallen while the 200 Assembly was raised, consisted of the outer strands and fit around the inner strands of the 116 inch section. Another 5 inch section, fully intact but slightly distorted, matched the end of the inner strands from the 116 inch section and the outer strands of the other 5 inch section. Finally a 12 inch section, found on the orifice motor plate, matched the end of the 5 inch section. The other end of the 12 inch section matched the end of the remaining cable stuck in the cable seal. Figure 1 shows the five different sections and the manner in which they were pieced back together. Including the remaining cable still attached to the control rod, all cable has been accounted for.

SEVERED CABLE FROM CDDA #25

The discovery of a second strand failure initiated an extensive investigation into the possible mechanisms causing the failures. In addition to the removal of the failed cable, the sister cable of CRDOA #25 was also removed for detailed testing and examination. CRDOA #25 was then reassembled using new cable that was swaged onto the remaining cables attached to the control rods. This enabled the two absorber strings to be fully retracted for removal from the hot service facility and temporarily stored in an equipment storage well. Refurbishment of the CRDOA will be completed at a later date in order to expedite additional cable examinations.
