Docket No. 50-289

SUBJECT: TMI-1 REACTOR COOLANT PUMP REPAIR/TESTING

SAFETY EVALUATION BY THE OFFICE OF NUCLEAR REACTOR REGULATION  
OPERABILITY OF REACTOR COOLANT PUMPS  
GPU NUCLEAR CORPORATION, ET. AL.  
THREE MILE ISLAND NUCLEAR STATION, UNIT 1  
DOCKET NO. 50-289

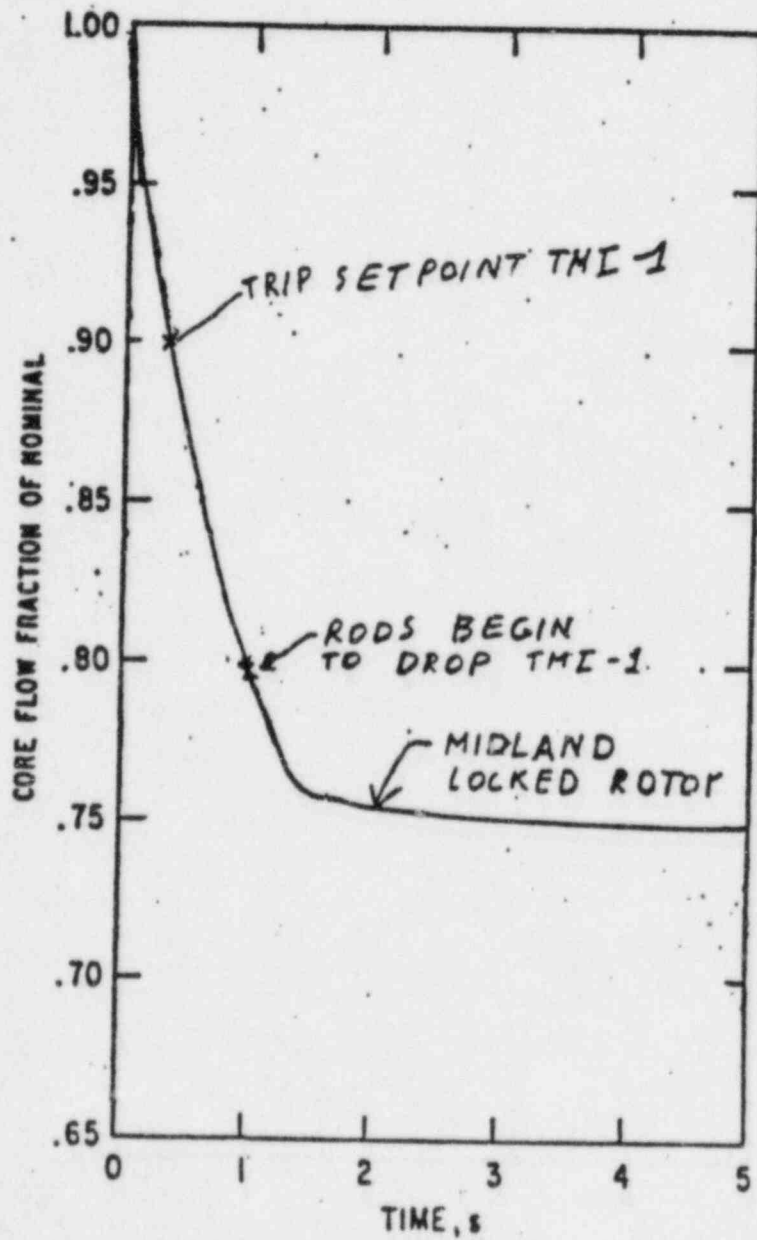
FIGURE 1

The TMI-1 FSAR does not provide a flow coastdown curve for a locked rotor accident. The licensee referenced the flow coastdown curve in the Midland FSAR. Midland has an identical loop arrangement to TMI-1. When TMI-1 is at full power the reactor will trip when the core flow decreases to 90% of its initial value. The trip delay time is 650 milliseconds. As may be seen from the attached Midland flow vs time curve, the control rods would enter the core during the flow coastdown period when the locked rotor case would have the lower flow and therefore be limiting. Based on the Midland analysis and the TMI-1 trip delay time we conclude that the locked rotor case bounds the free spinning shaft case for TMI-1, and therefore the locked rotor evaluation bounds the pump shaft failure with respect to RCS flow and DNBR.
