**Plant Vogtle**

**Diesel Generators  
Airstart Cap Evaluation**

**Log No. 95-MT-039**

**Southern Company Services  
Stress and Metallurgy**

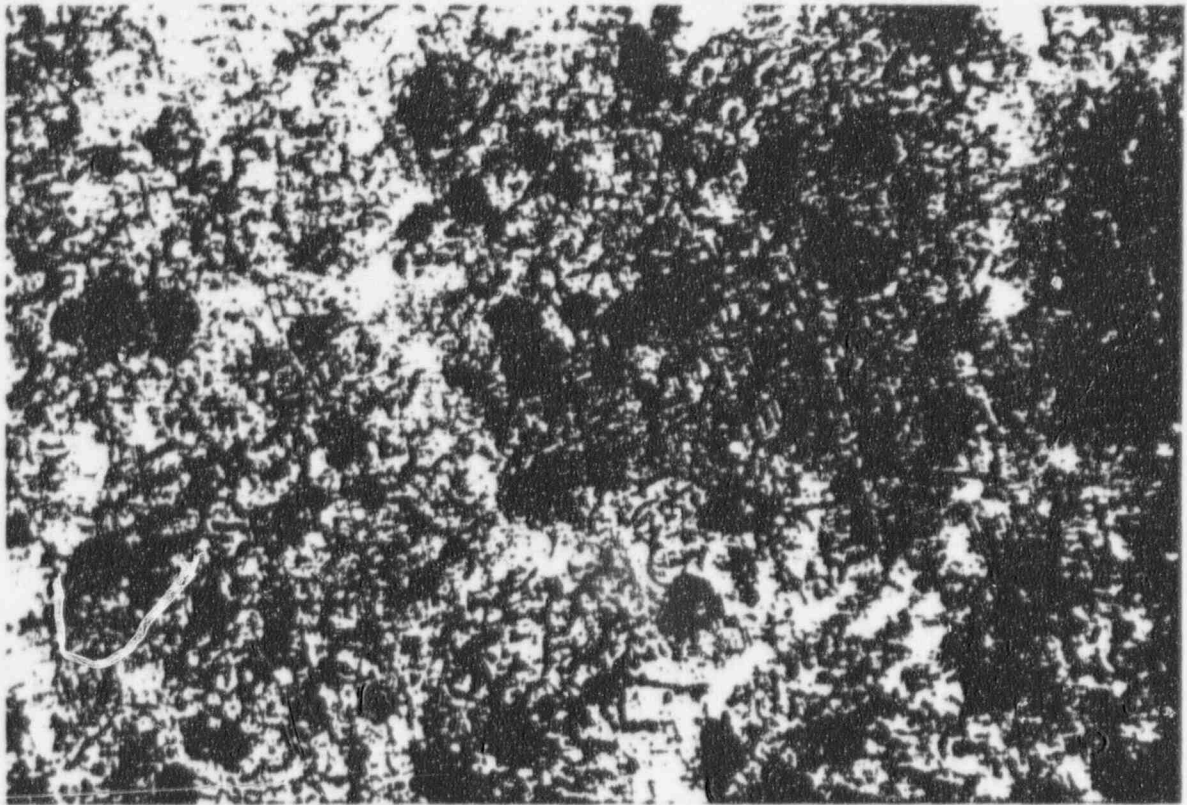
After the chemical analysis a sample was polished and etched to reveal the microstructure. A photomicrograph of the sample is located in Appendix A. The microstructure is indicative of a gray cast iron. The additional amount of manganese present in the sample could cause the amount and configuration of the flake graphite to differ slightly from that of a normal gray cast iron.

Figure 1. View of the microstructure of the airstart cap 100X

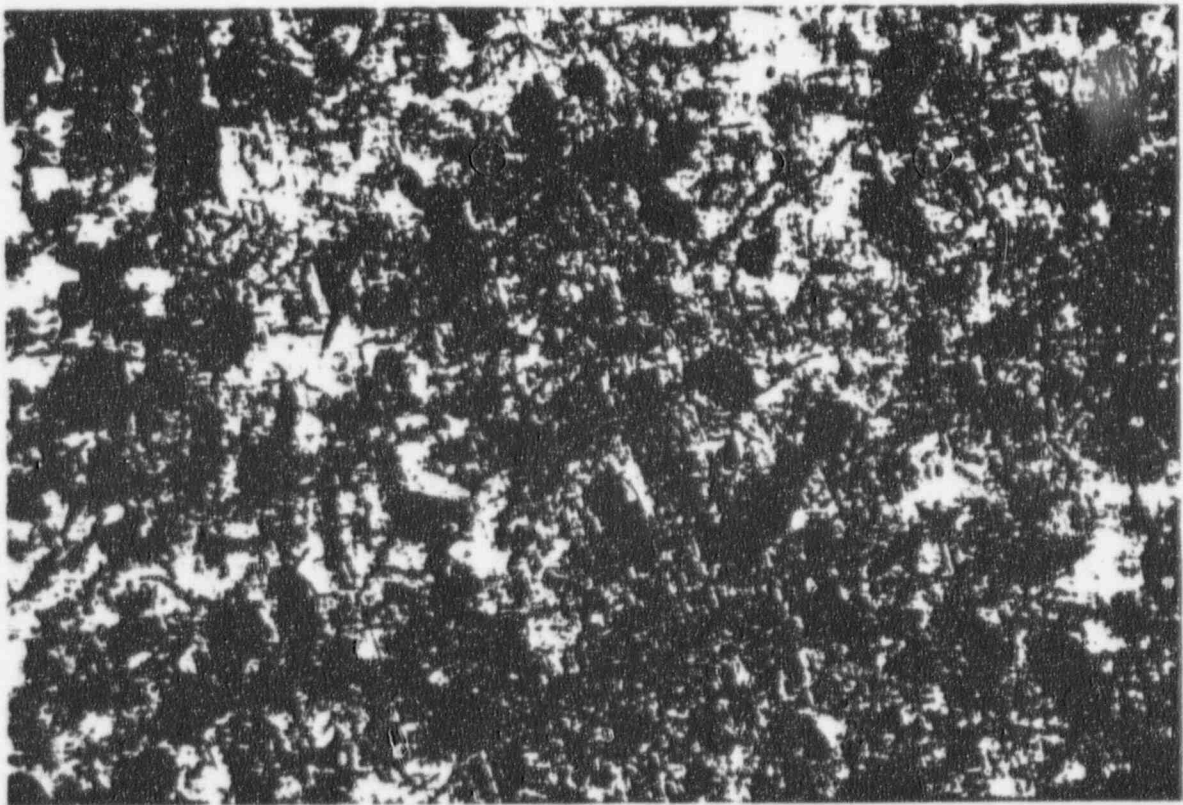
Figure 2. View of the microstructure of the airstart cap 400X
