LICENSEE EVENT REPORT (LER) TEXT CONTINUATION

FACILITY NAME (1) Davis-Besse Unit 1	DOCKET NUMBER (2) 0 5 1 0 0 0 3 1 4 6 8 4	LER NUMBER (6)			PAGE (3)		
		YEAR	SEQUENTIAL NUMBER	REVISION NUMBER			
		8 4	- 0 1 5	-	0 2	OF	0 6

Report No: NP-33-84-16

LER No. 84-015
Davis-Besse Nuclear Power Station Unit 1
Date of Occurrence: October 25, 1984

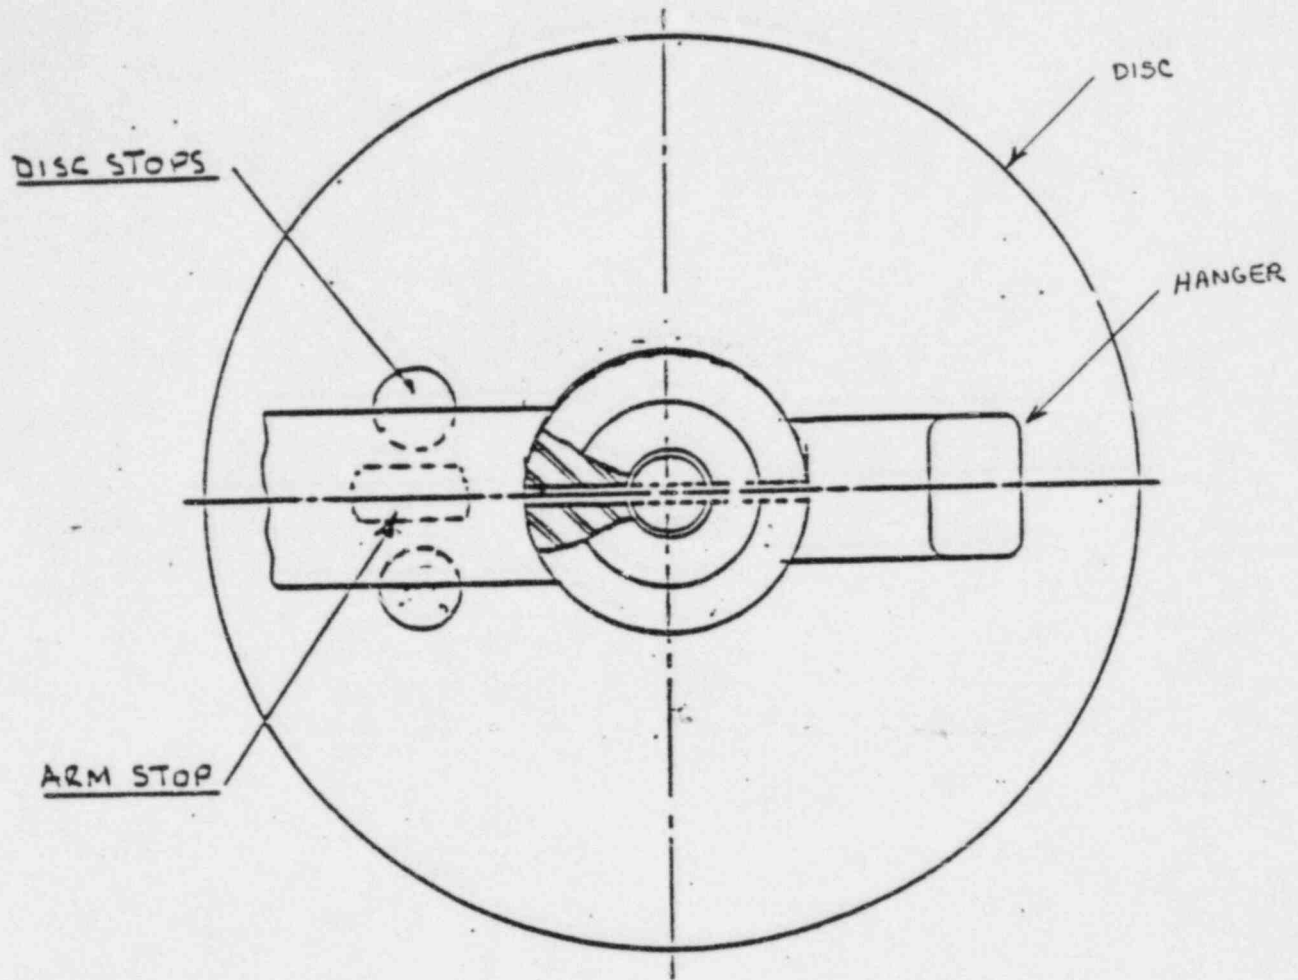
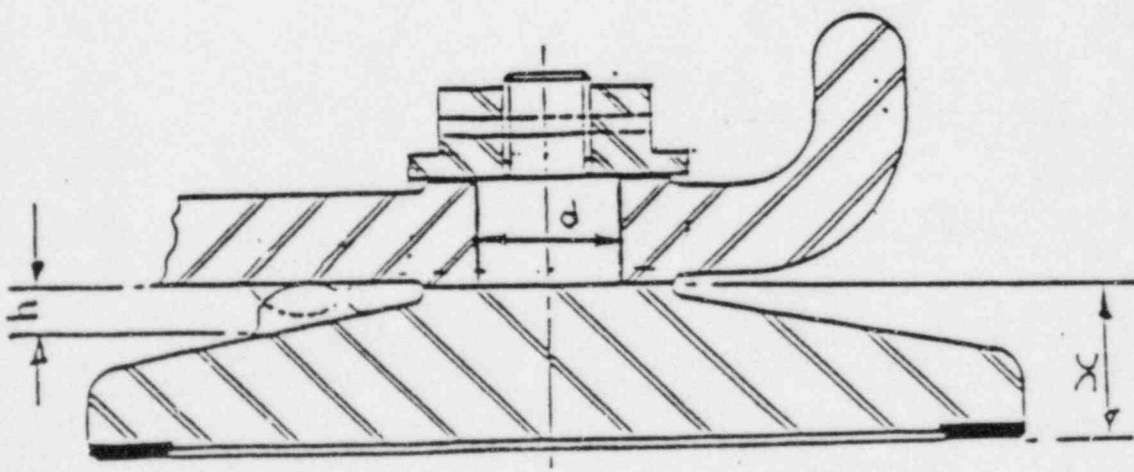
FIG 1

On October 25, 1984, Valve HP 59 was disassembled and inspected. The disc in HP 59 was found to be seated properly. However, it was discovered that the disc could be rotated with sufficient force by hand to cause the anti rotation stop on the disc to ride up on the hanger arm stop(See Figure 1). If the disc was to rotate into this position during normal operation, the valve disc should be prevented from properly aligning with the valve seat and some back leakage could occur.

The valve identified with this deficiency is a Velan Model B9-3114B-13WS Serial No. 285, 2½" swing check valve.

Designation of Apparent Cause of Occurrence: The apparent cause of the anti-rotation stop jamming is due to the design of the anti rotation stops. The four HP swing check valve discs were manufactured by casting. The anti rotation stops on the disc were also part of the casting. As a result, the stop tended to be short and rounded. The resulting dimensions of the disc stop allows the disc stop to slide under the hanger arm and to interfere with the hanger stop when flow through the valve causes the disc to rotate. This contact between the disc stop and hanger stop causes wearing of the stop surfaces. After significant wear of the stop surfaces has occurred, the disc stop can be jammed up onto the hanger stop and lock in this position, basically "cocking" the disc. The disc is then unable to seat properly, allowing reverse flow past the valve to occur.
