November 26, 1984

Docket Nos. 50-348
50-364

Joseph M. Farley Nuclear Plant - Units 1 and 2
IE Bulletin No. 84-03, Refueling Cavity Water Seal

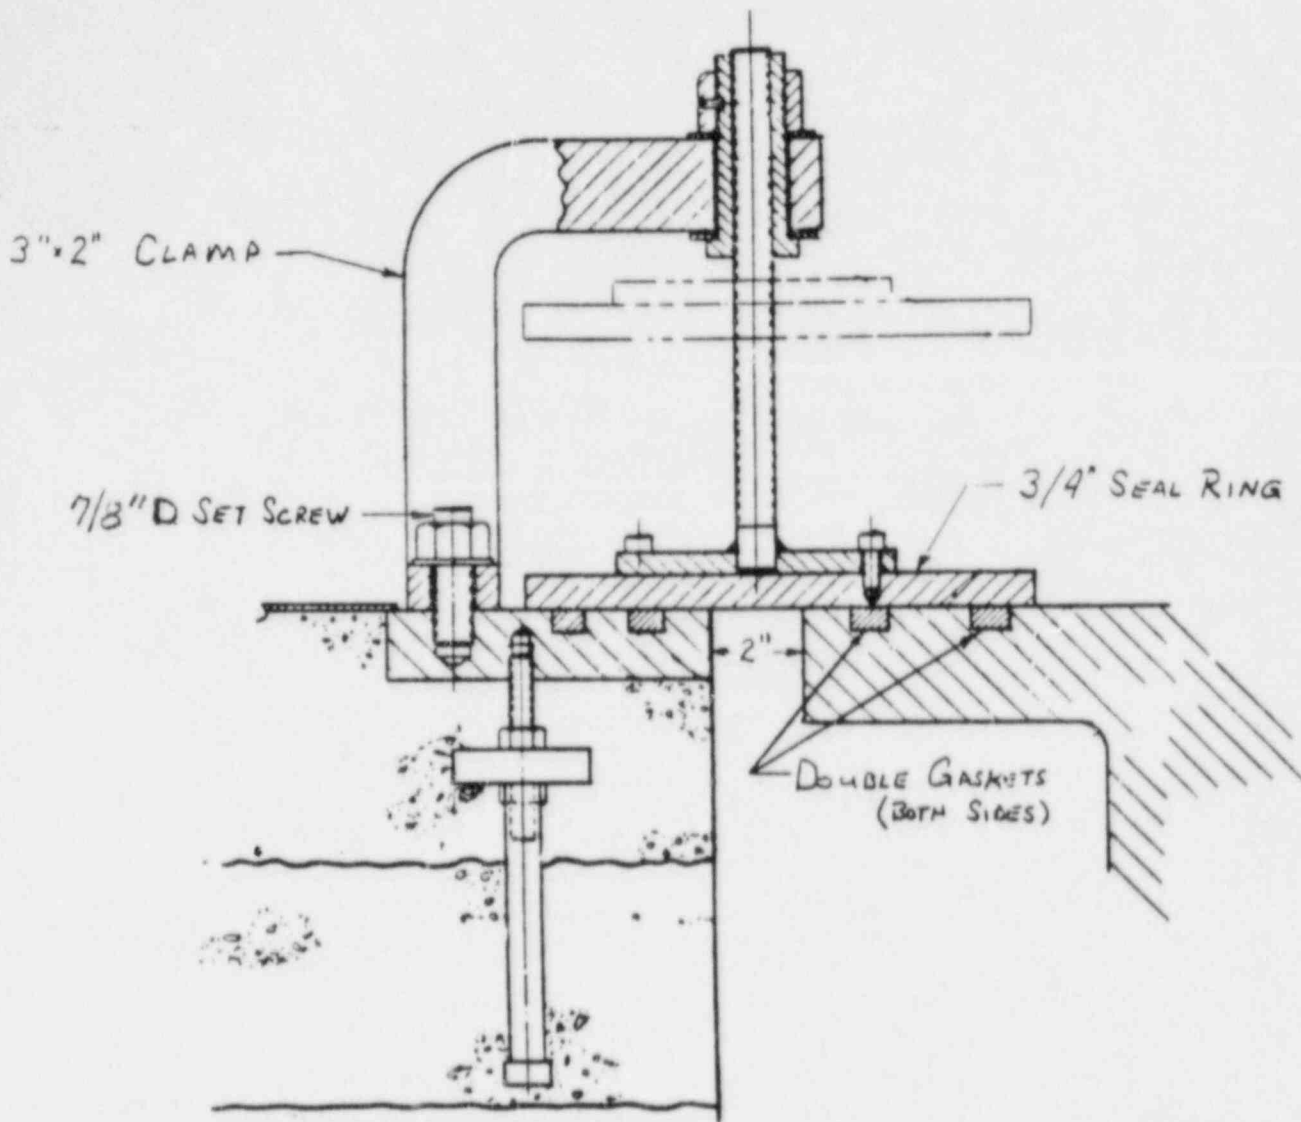
FIGURE 1

A comparison of the refueling cavity water seal in use at Farley Nuclear Plant (Figure 1) and the seal that failed at Haddam Neck Nuclear Plant reveals that the two seals have no design similarities. The Farley seal consists of a 3/4 inch stainless steel ring, 11 inches wide and approximately 17 feet in diameter, spanning a two inch gap between the vessel flange and the seal support ring. This steel ring rests on four elastomer O-Ring seals (double gaskets): two on the vessel flange and two on the seal support ring. The seals are in grooves to prevent their moving out of place and are compressed by 18 holddown clamps acting on the seal ring, only nine of which are required by design. Each clamp is made of a 3 inch by 2 inch steel bar which is anchored to the seal support ring by two 7/8 inch set screws. There are no active

components and the weight of water above the 11 inch ring is approximately 37 tons which acts to make the seal tighter (not to displace the seal as in the Haddam Neck design). In addition, the double gaskets on both the reactor flange and the cavity floor provide a means of leak testing the seal configuration prior to the flooding of the refueling cavity. The leak testing procedure provides for pressurizing the area between the seals to detect leakage. Observation of the ability of the seal to maintain air pressure provides the required assurance that no leakage will be experienced after flooding.

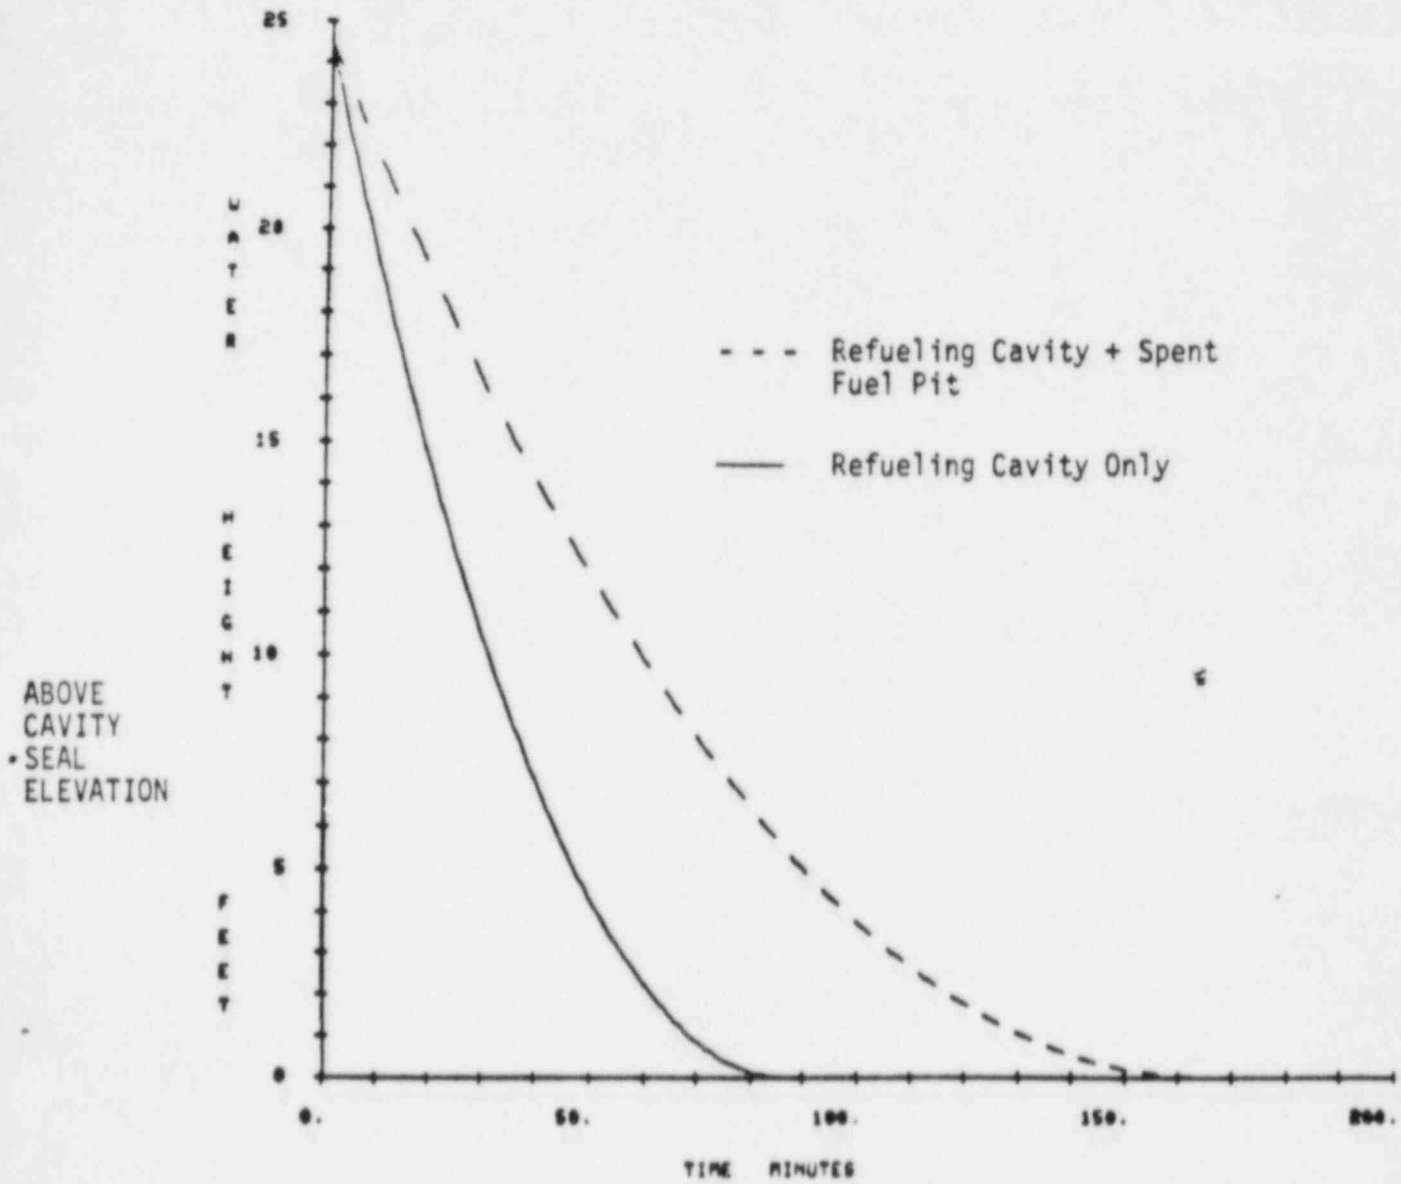
FIGURE 2

For such a hypothetical event where seal deformation could be experienced, a sixty (60) mil gap has been postulated between the seal ring and the reactor vessel flange/refueling cavity floor assuming that the double gaskets were not in place. In addition, the gap was conservatively assumed to be on both the inside (reactor vessel flange side) and the outside (refueling cavity side) of the seal ring. Figure

2 shows the reduction in water level with respect to time, with and without communication between the spent fuel pit and the refueling cavity. Even though this postulated sixty (60) mil leak is extremely unlikely, Figure 2 indicates that eighty-six (86) minutes is required to drain the refueling cavity to the level of the seal ring with the spent fuel pit isolated and one hundred sixty-four (164) minutes to drain to the same level with the transfer canal open. Figure 3 illustrates the leakage rate over time with and without communication between the spent fuel pit and the refueling cavity. Figure 3 also shows that the maximum leak rate is 5500 gpm when the refueling cavity is filled. As the level decreases, the leak rate will also decrease because of a decrease in hydrostatic pressure exerted by the water column above the seal ring.
