POWER REACTOR EVENTS

United States Nuclear Regulatory Commission

Date Published: February 1985

Period Covered: July-August 1984

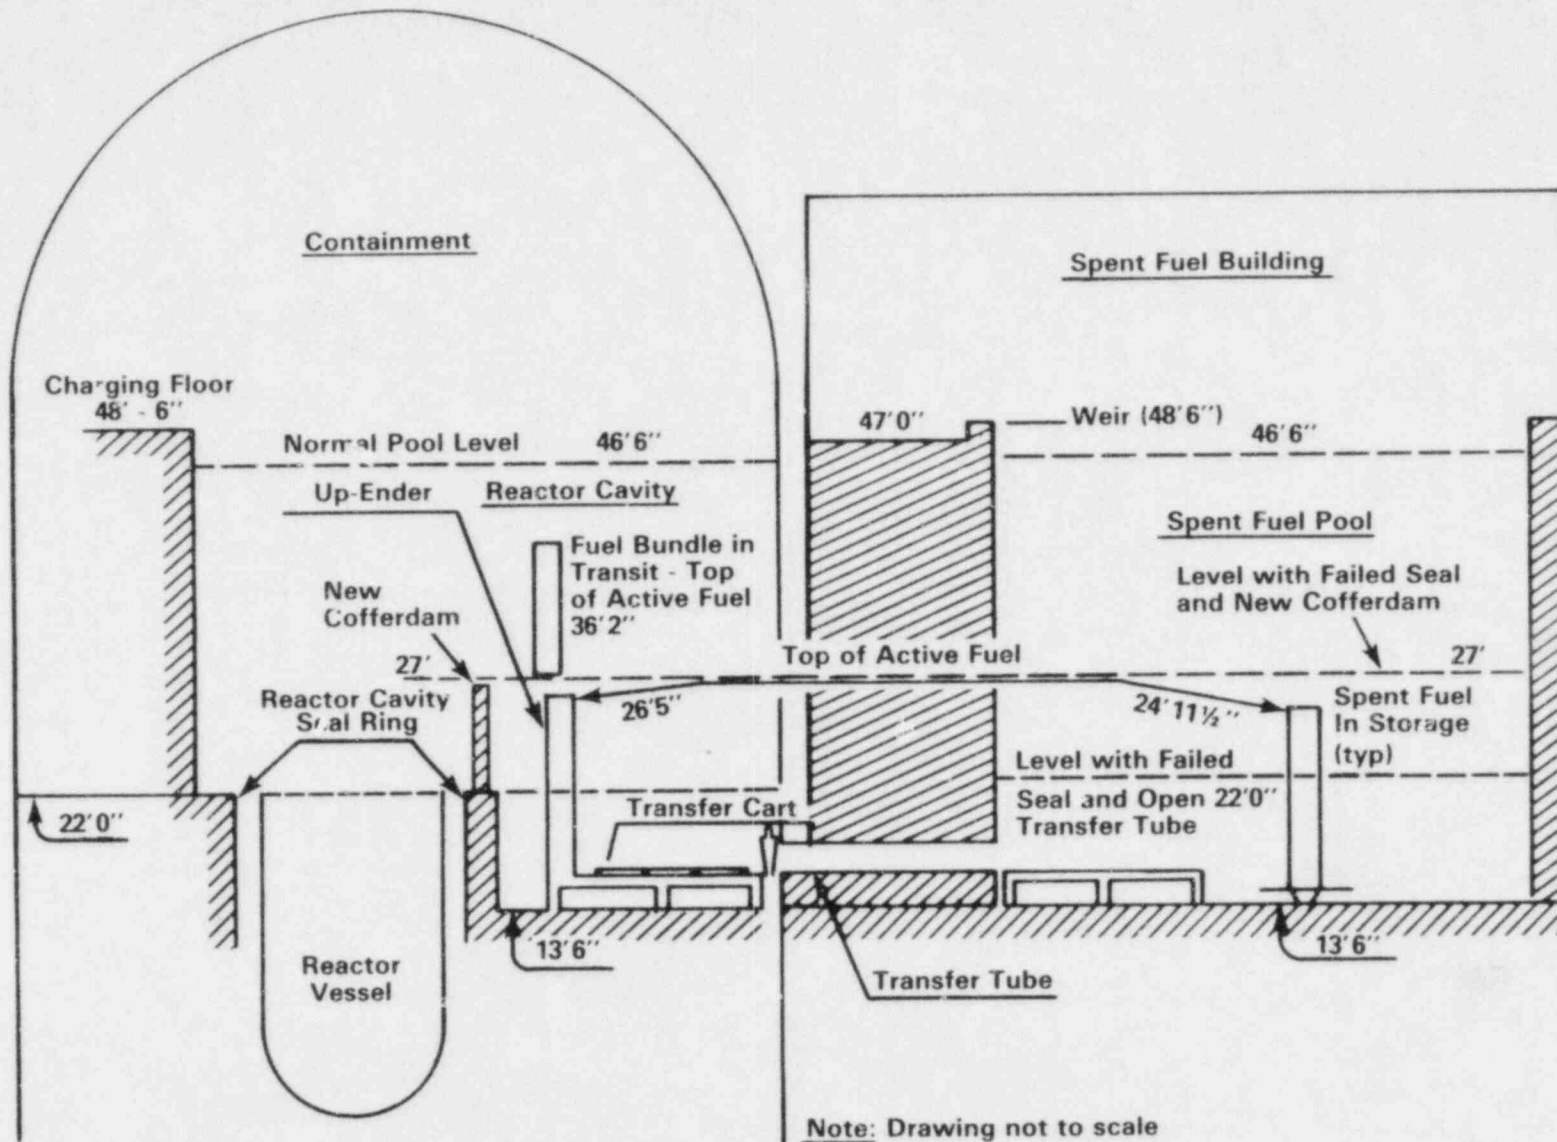
Figure 1. Schematic of Reactor Cavity Pool Seal Failure With Transfer Tube Open

The event was caused by inadequate design of the replacement pneumatic seals used in the cavity seal assembly. The top of the reactor vessel is at the bottom of the refueling cavity, with a 28-inch annulus between the vessel and the bottom of the cavity. (See Figure 1.) This annulus is sealed using a 2-foot-wide stiffened annular plate with inflatable rubber pneumatic seals around the inside and outside diameters.

As stated previously, the licensee's failure analysis identified that there had been insufficient design margin to prevent the pneumatic seals in the seal assembly from extruding through the 2-inch gap in the seal structure. To correct this design error, the licensee reinforced the upper portion (solid rubber) of the pneumatic seals by pressing 3/16-inch steel pins through the elastomer at 3-inch intervals around the circumference of the seals. Subsequent testing confirmed that a safety factor of 4 with respect to extrusion of the pneumatic seal had been established by this modification.

In addition, the licensee installed a leak-limiting back-up cavity seal and a 5-foot-high cofferdam at the mouth of the refueling transfer canal. In the event of another failure of the pneumatic seal, the back-up seal limits the leak rate such that operators have enough time to recognize and react to the event and return spent fuel in the reactor cavity to a safe position prior to uncovering any fuel. The back-up seal also provides a measure of impact protection to the primary rubber seals. The cofferdam prevents uncovering fuel in the spent fuel pool for any future reactor cavity seal problem.

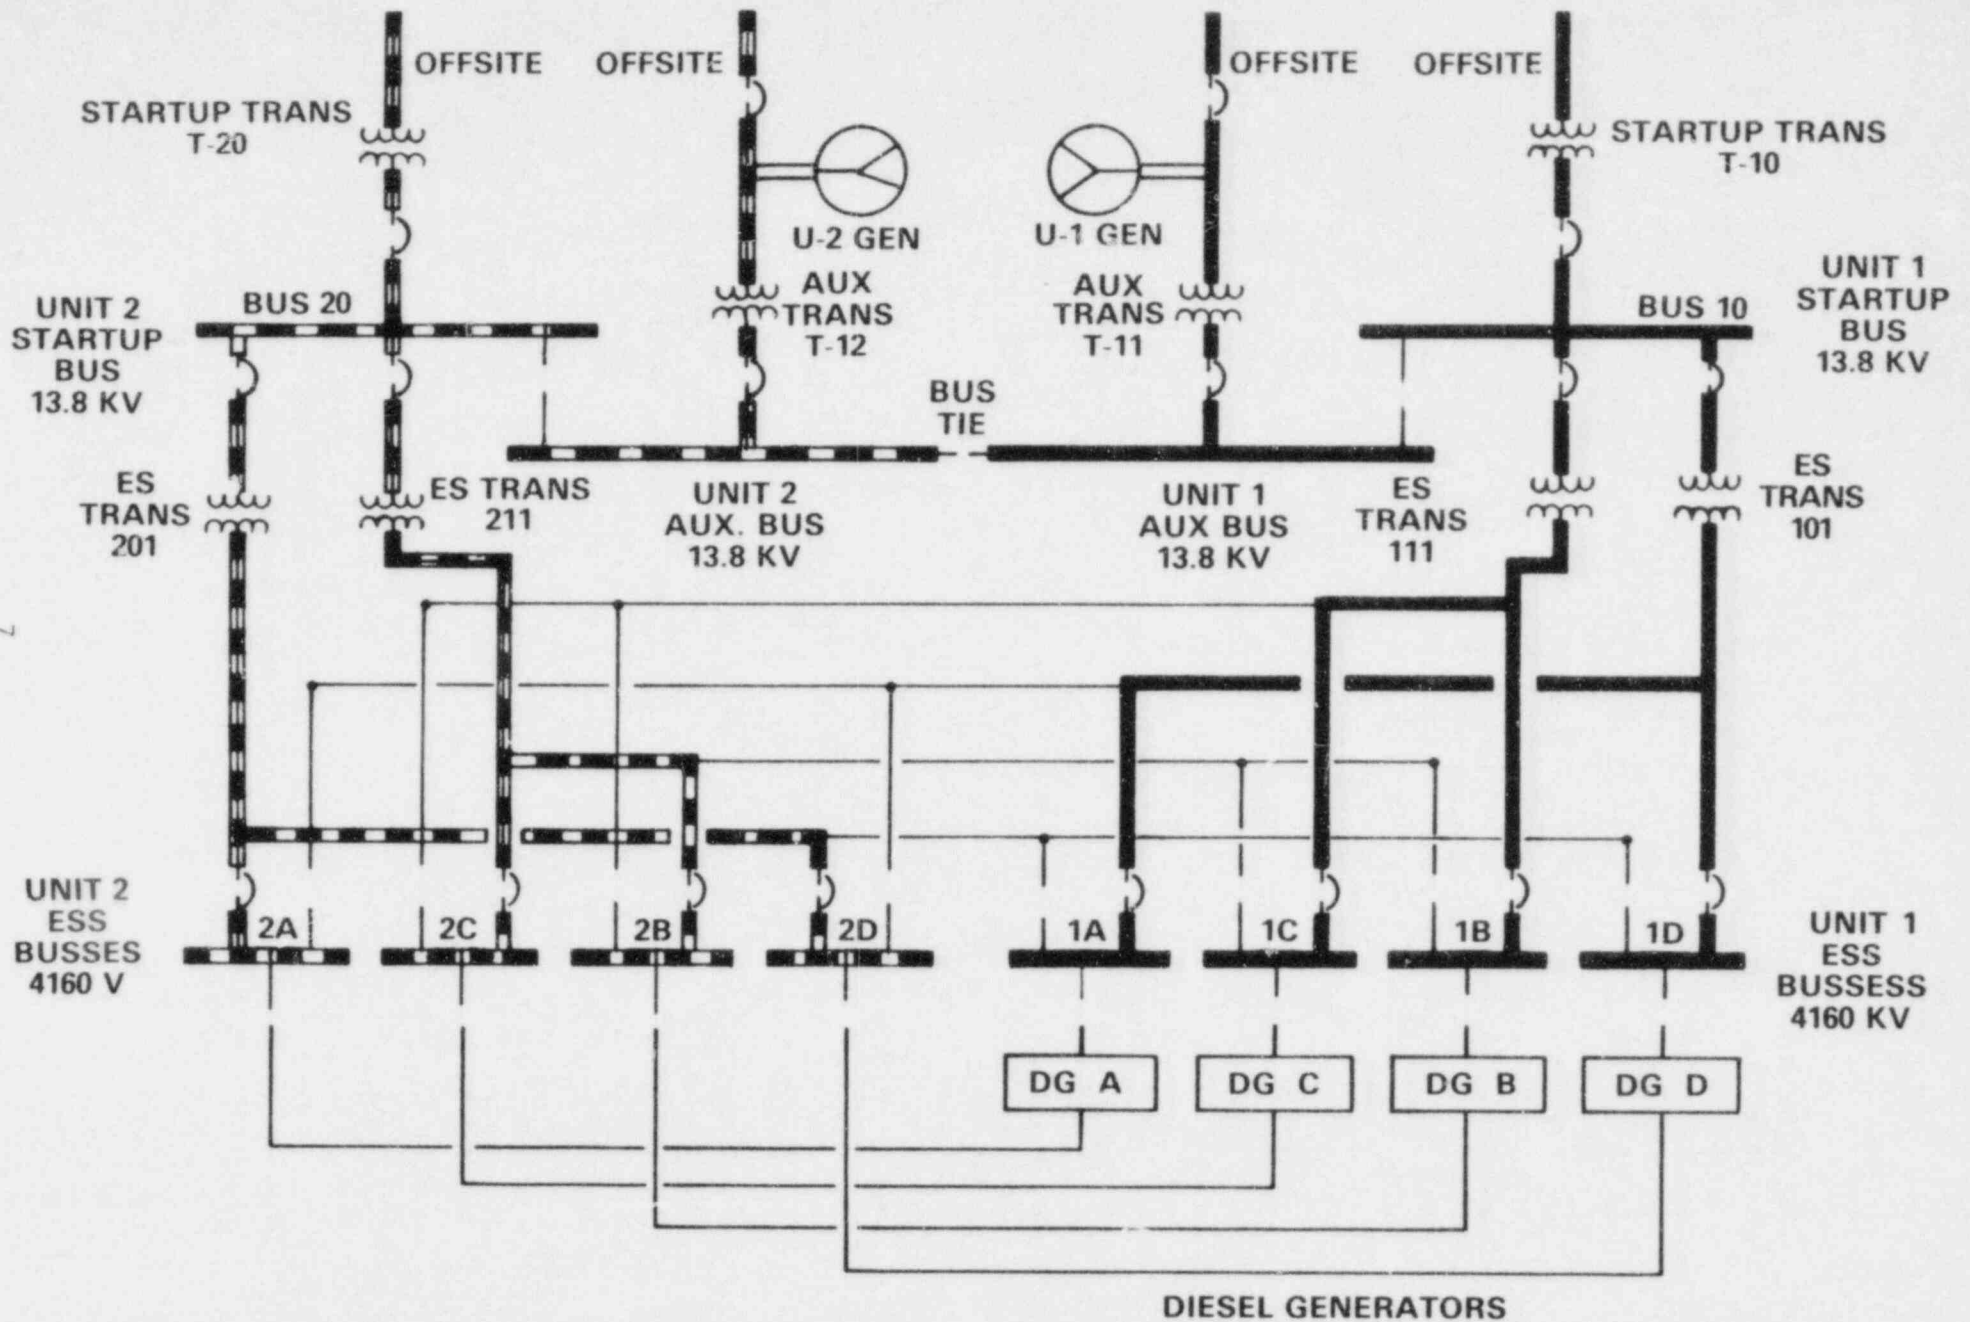
FIGURE 2. INITIAL TEST CONDITIONS

The startup test was initiated at 1:37 a.m. by opening the Unit 2 main generator output breakers and the Unit 2 startup transformer feeder breaker to the Unit 2 startup bus. This resulted in a reactor scram due to turbine control valve fast closure on the simulated load reject, deenergization of the 13.8 kV busses and deenergization of the four Unit 2 4160 V ESS busses. The turbine bypass valves properly opened automatically to limit the initial pressure transient, and the loss of power to the RPS motor generator sets properly initiated primary and secondary containment isolations. The above sequence was as expected; however, the operator at the electrical distribution panel noted that none of the four EDGs started and that the feeder breakers from the two Unit 2 ESS transformers to the four 4160 V ESS busses remained closed. These breakers should have automatically opened and the diesels should have started upon ESS bus deenergization due to the deenergized startup transformer. As a result of the diesels not starting, and providing emergency ac power, all ac power for Unit 2 was lost.

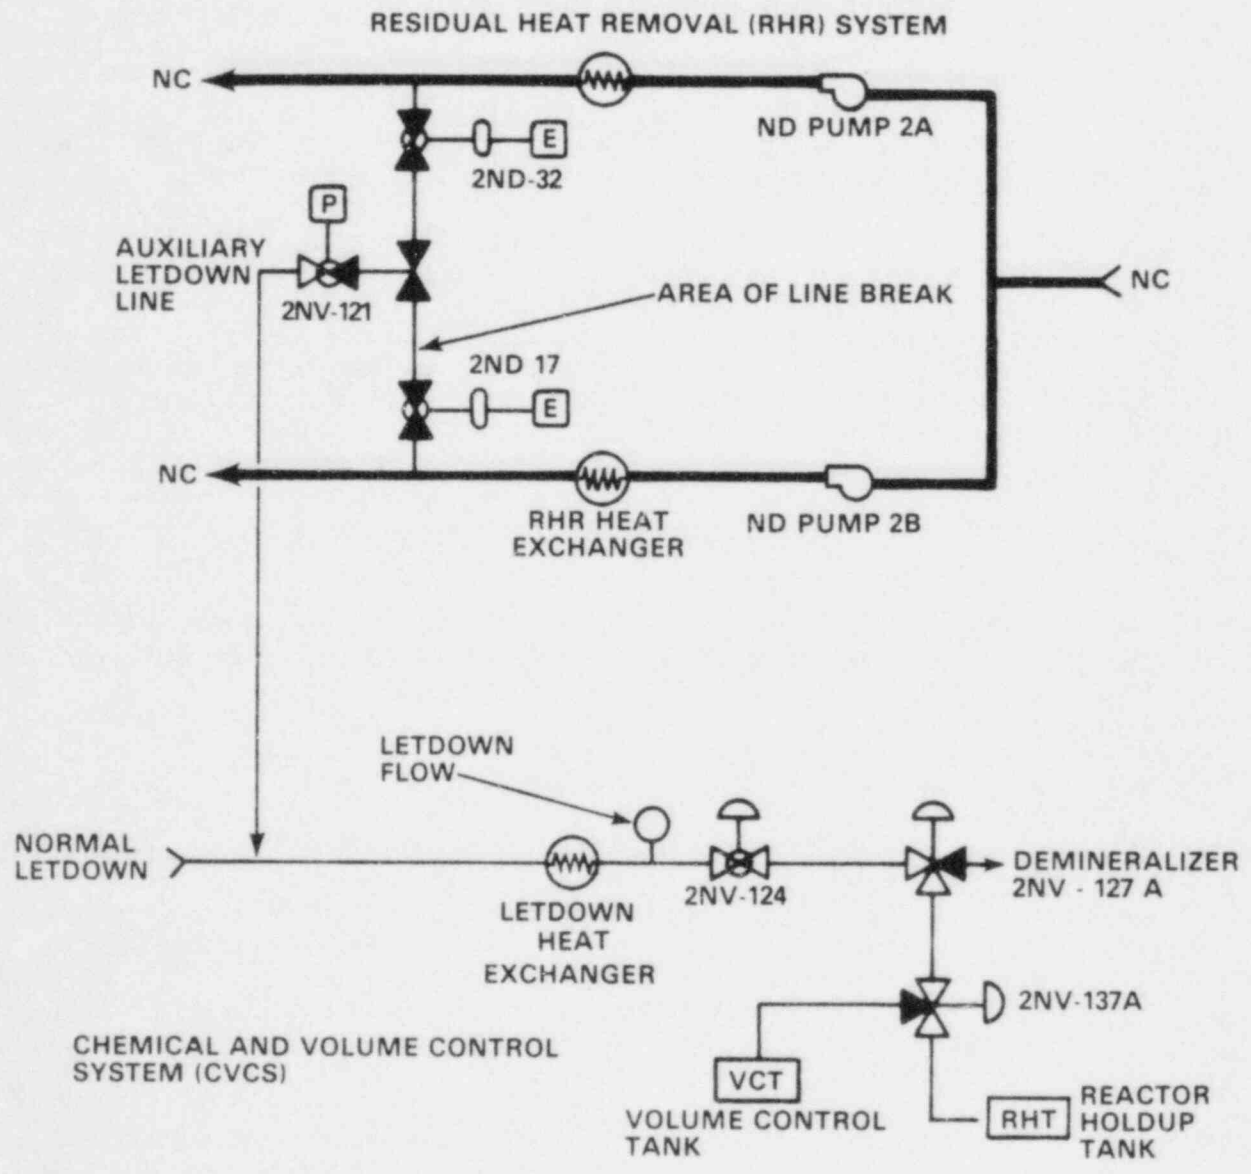
**FIGURE 3
SIMPLIFIED DRAWING
OF
AUXILIARY LETDOWN LINE
AT McQUIRE UNIT 2**

The auxiliary RHR to CVCS letdown path connects the two RHR headers (see Figure 3) to the normal CVCS letdown line. The path is isolated from each header by motor-operated Kerotest valves 2ND-17 and 2ND-32. Flow to the letdown line is controlled by piston operated, Fisher regulating valve 2NV-121. The weld that was broken was immediately downstream of 2ND-17. The pipe was completely separated at the break location. Maintenance personnel also found that the packing assembly on 2NV-121 had moved away from the valve body, along the valve stem. The two nuts that secure the packing flange were completely off of the studs, and were later found on the floor of the RHR heat exchanger room. Both of the studs were undamaged, indicating that the flange was forced from the stud during the event. Since the nuts were relatively undamaged, the packing flange must have been loose prior to the event.

The licensee determined that the forces causing the damage were the result of a water hammer. Work activity had been performed on August 4, 1984, which could have introduced air into the letdown piping downstream of 2NV-121. Limit switches on divert valve 2NV-137A were being adjusted and the valve was open to the recycle holdup tank (RHT) for about 2 hours. During this time, a drain path existed from 2NV-121, which is located near elevation 750, to the RHT, which is located on the 716 elevation. The vent for this draining operation would have been through the loose packing on 2NV-121. The RHT pressure was maintained near atmospheric during this time, which would not have prevented draining. In this configuration, at least some of the water in the line might have been replaced with air.

The morning of the event was the first time the auxiliary letdown line was used after the air was drawn into the line. Valve 2NV-121 was leaking through the seat extensively, as shown by the letdown flow rate observed by the operators when the line was put in service. This prevented the operators from gradually increasing flow in the line. Isolation valve 2ND-32 (Figure 3) is an open/shut valve with seal-in circuits and a relatively quick opening Kerotest body. When the operators opened 2ND-32, flow increased rapidly in the auxiliary letdown line. The rapidly increasing flow combined with the air pocket resulted in the severe water hammer.

All S/Rs, piping, and valves damaged during the event have been repaired. Extensive radiographic and/or dye-penetrant testing was performed on RHR system welds to verify that no cracks existed. Evaluations have been performed which verify the suitability of existing bolt holes in concrete walls for reinstalling S/Rs.

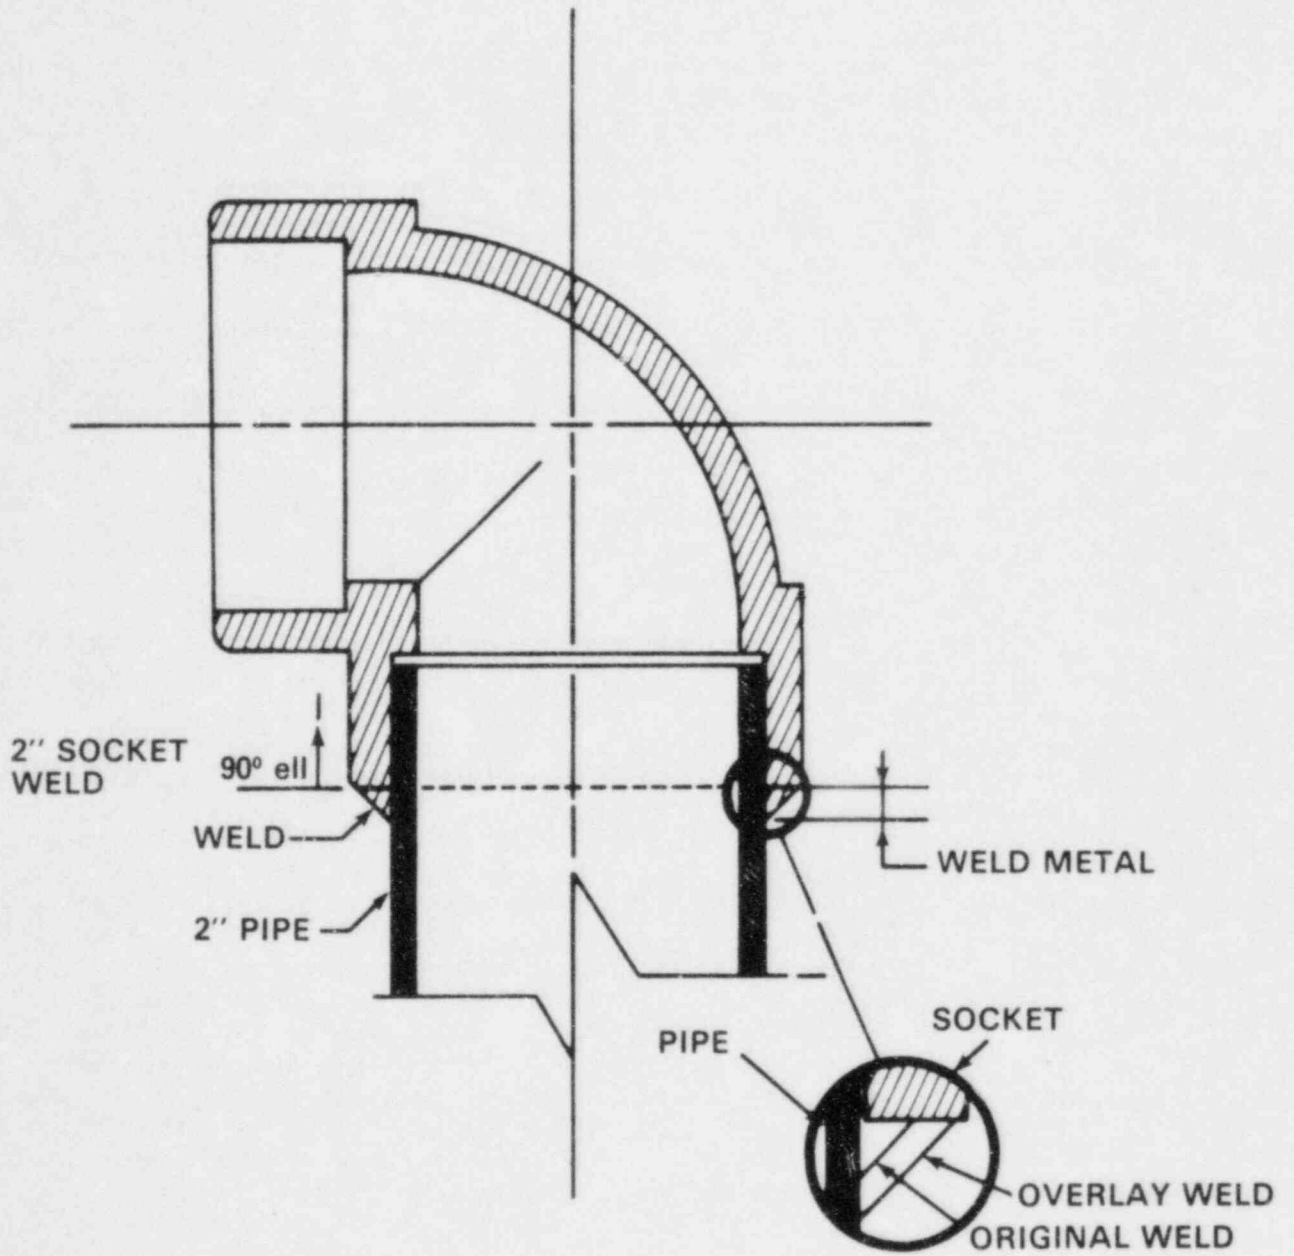
FIGURE 4.
SOCKET
WELD
(NO SCALE)

The broken weld was a 2-inch socket weld (see Figure 4). It had been properly installed and tested using dye penetrant. Proper gap had been maintained between the end of the pipe and the socket during the fitup. Although there was some lack of penetration of the weld metal, this had been minimal and not unusual for this type of weld. Following the event, the weld was inspected at McGuire, using a glove box and unmagnified observation. It was then further decontaminated and sent to a research laboratory for more detailed examination. A preliminary report showed the weld broke in a ductile fashion, probably due to one high stress event; however, it was also found that a majority of the weld break area had been fatigued. A crack had started on the inside diameter of the weld and progressed radially outward. Although the crack appeared to have included 360° of the weld, it had not penetrated the outer surface of the weld at any point. Therefore, the welded area was not leaking prior to the failure.

A vibration measurement program was conducted to determine the cause of the fatigue damage found on the broken weld. The problem was found to be caused by backflow through the Kerotest valves when operators pressurized idle RHR trains from operating trains. The RHR system startup procedure was changed to use the 8-inch crossover line including the A and B RHR heat exchanger bypass valves. Vibration of the RHR and auxiliary letdown system will be monitored during the next unit cooldown. (Refs. 11 and 12.)
