INDIANA & MICHIGAN ELECTRIC COMPANY

AEP:NRC:0898

Donald C. Cook Nuclear Plant Unit Nos. 1 and 2
Docket Nos. 50-315 and 50-316
License Nos. DPR-58 and DPR-74
REFUELING CAVITY WATER SEAL
(IE BULLETIN 84-03)

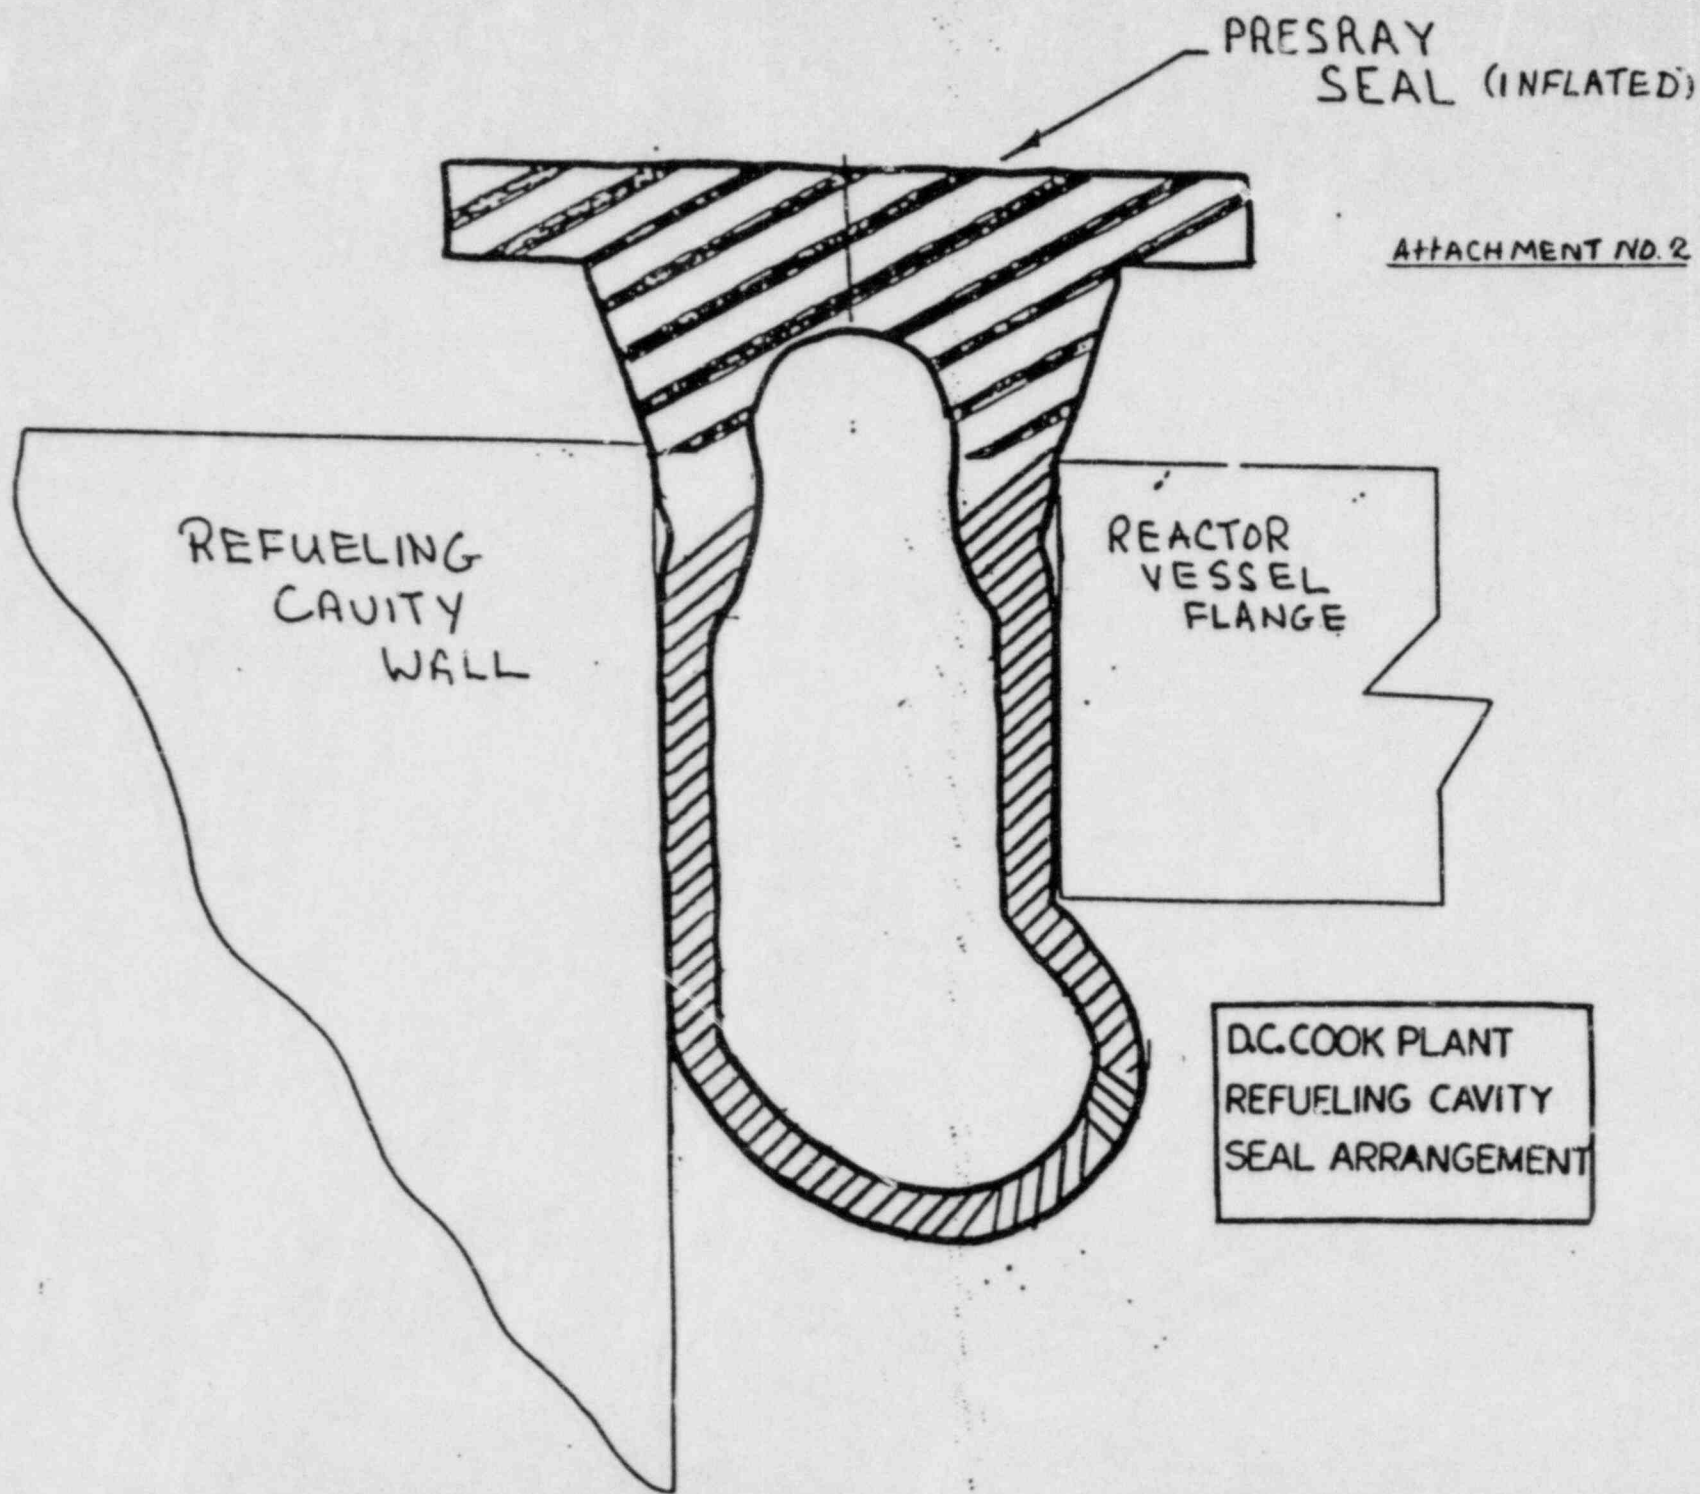
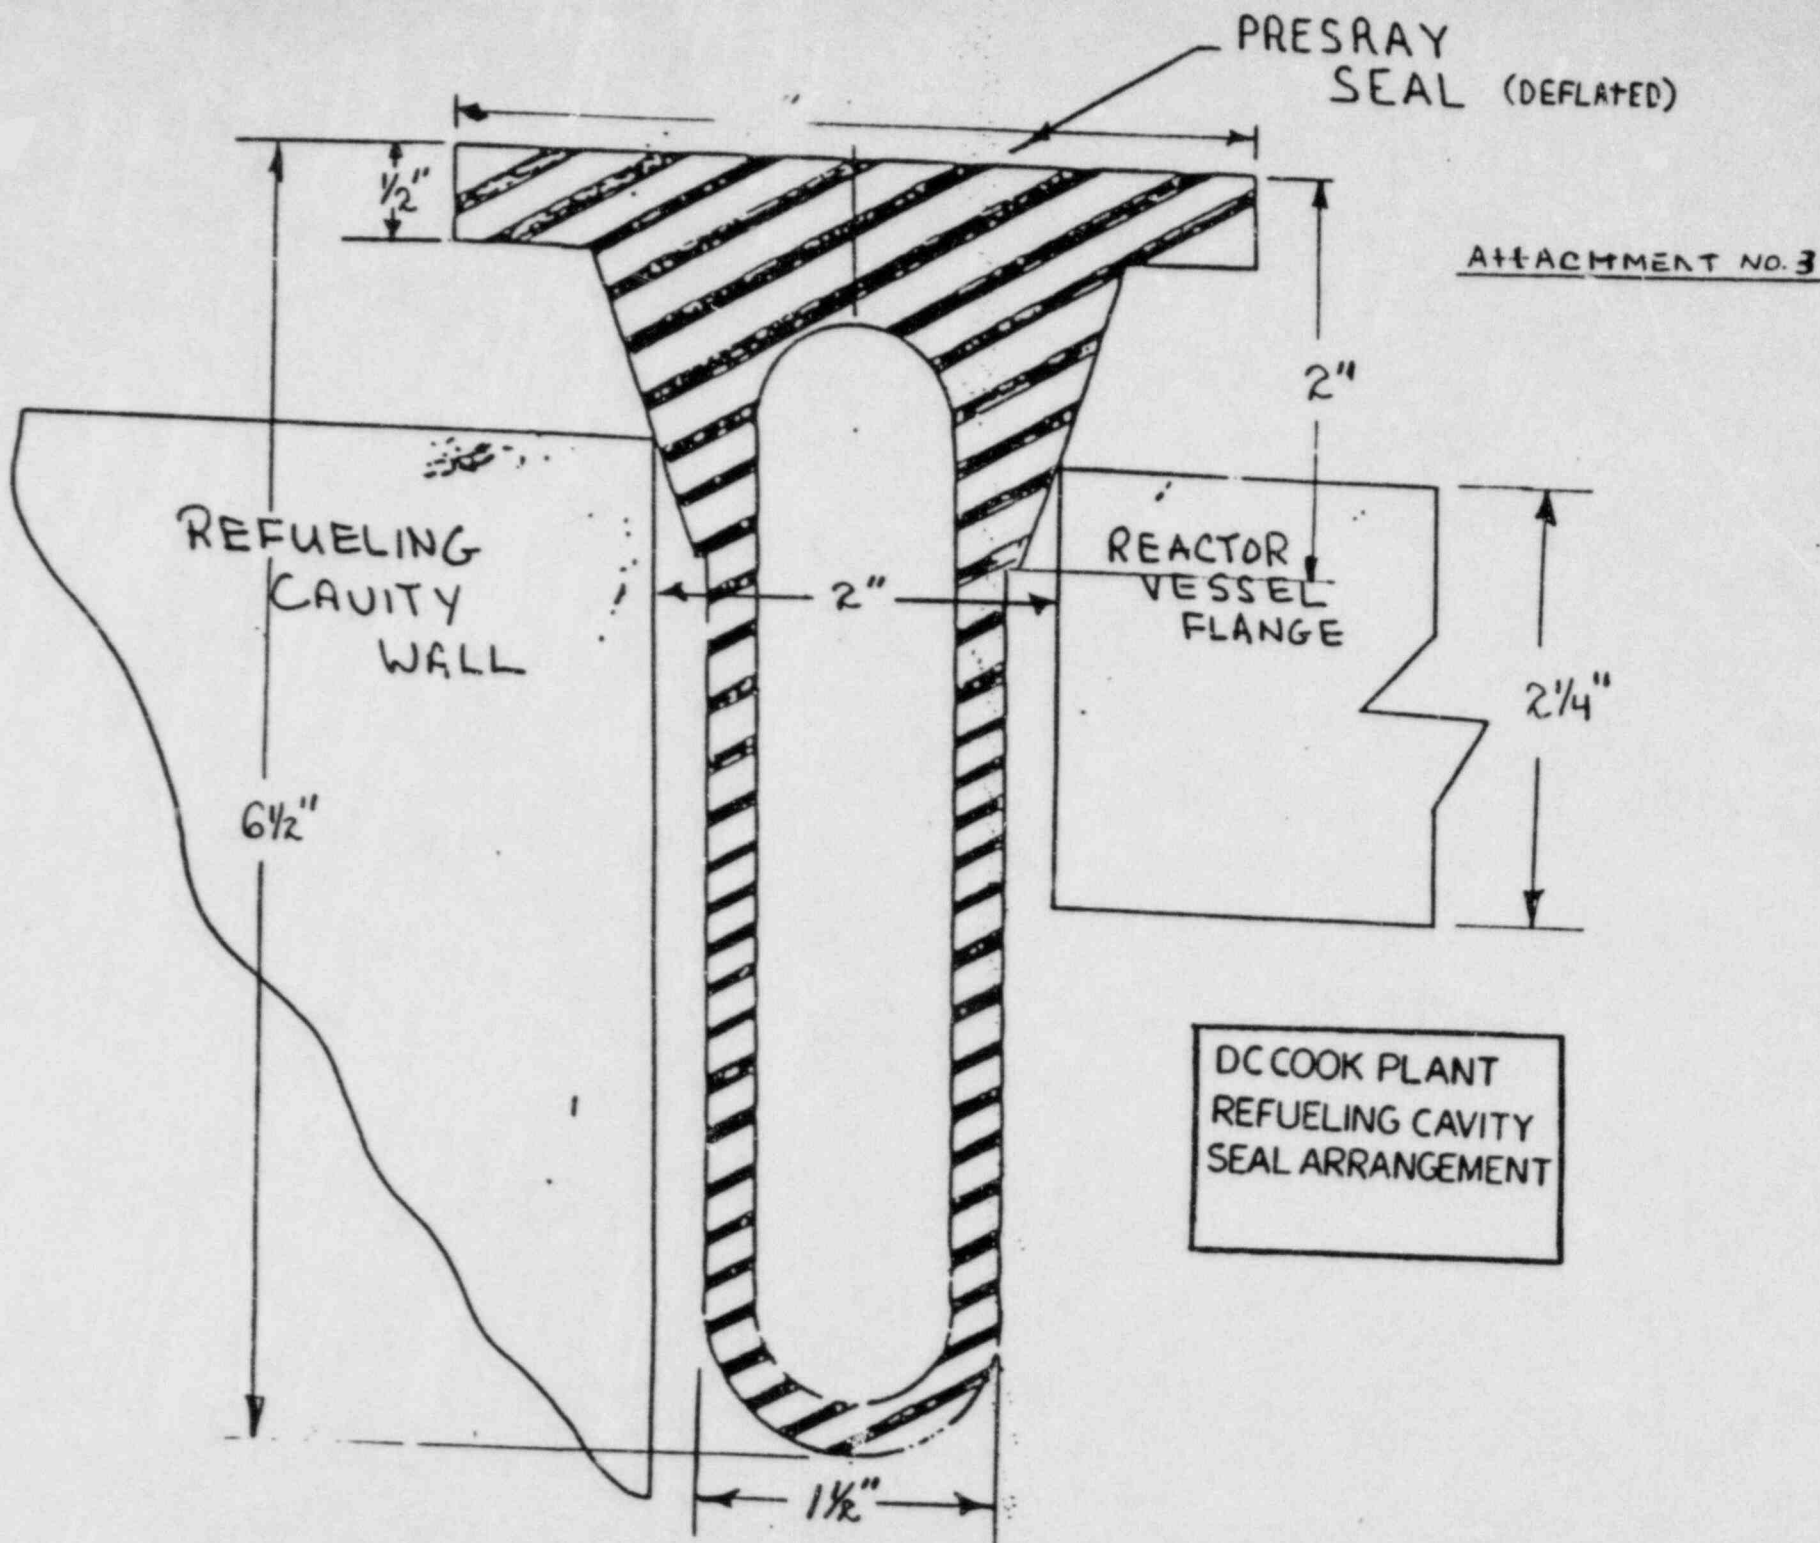
The refueling cavity seal arrangement at the Donald C. Cook Nuclear Plant is a one piece seal inserted in a nominal two inch annular opening between the reactor vessel flange and the refueling cavity wall. This arrangement is different than that depicted in Figure 1 of NRC IE Bulletin 84-03 (Attachments 1, 2, and 3).

Inflation of the seal at normal pressure (15-30 psig) results in a slight downward force on the seal which tends to draw it into the annulus. Overpressurization would have a tendency to increase this downward force, but the rigid annulus configuration at Cook, and the rigidity of the seal rubber, prevent the 4 inch section of the seal from being pulled through the 2 inch annulus opening. In addition, the annulus configuration offers more surface contact with the cavity wall than the Haddam Neck design. In discussions with the Presray Corporation, manufacturer of both the Cook and Haddam Neck refueling cavity seals, it was determined that the upper section of the Cook seal is wider than the type used at the Haddam Neck plant. Also, the seal used at Cook has a greater rubber hardness, a 60 durometer, versus Haddam Necks 40 durometer, seal.

Based on the above review, we conclude that failure of the active seal component (i.e., the inflated lower portion of the rubber seal) will not result in a gross seal failure or gross leakage because of the passive seal component (i.e., the solid wedge-shaped upper portion of the rubber seal), and we believe the gross failure of the refueling cavity seal in a manner cited in IE Bulletin No. 84-03 to be highly improbable.
