AEOD ENGINEERING EVALUATION REPORT\*

UNITS: Dresden 2  
Quad Cities  
DOCKET NOS.: 50-237  
50-254  
LICENSEES: Commonwealth Edison  
NSSS/AE: GE/Sargent & Lundy  
SUBJECT: MOTOR OPERATED VALVE FAILURES DUE TO HAMMERING PROBLEM.  
REFERENCES: 1. Commonwealth Edison, LER 84-003 Rev. 1,  
Docket, No. 50-237, dated September 19, 1984.  
2. Commonwealth Edison, LER 84-014.  
Docket No. 50-254, dated August 14, 1984.  
3. IE Information Notice No. 82-10:  
"Following Up Symptomatic Repairs to  
Assure Resolution of Problem."

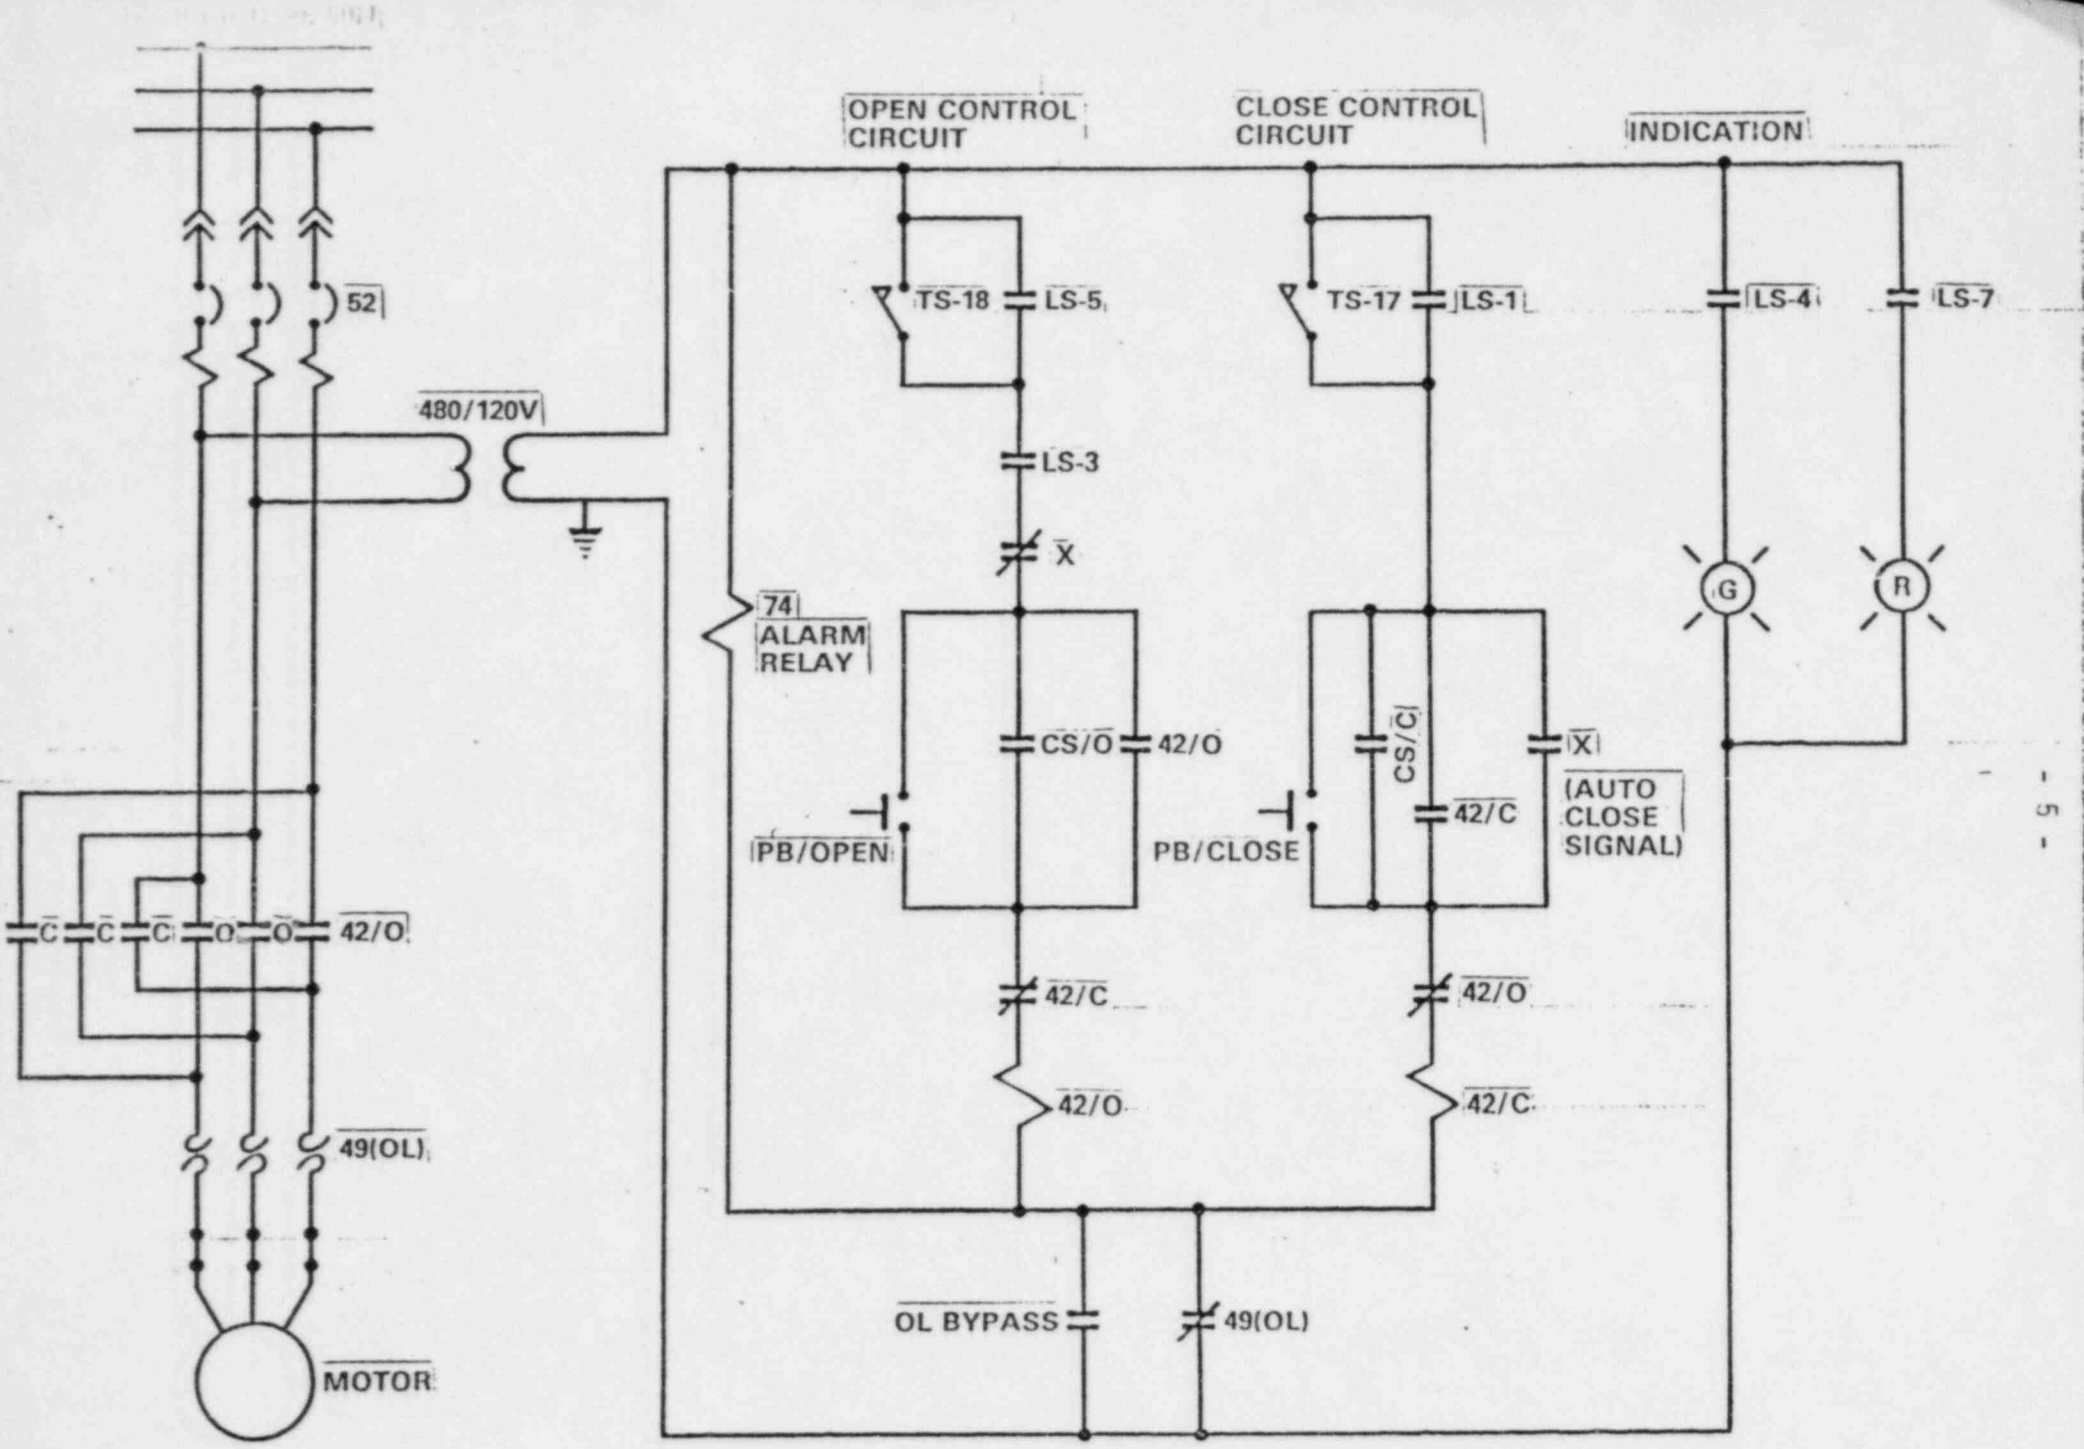
FIGURE 1  
ELEMENTARY DIAGRAM FOR MOTOR OPERATED VALVE

The problem encountered at the Quad Cities and Dresden units is directly attributed to the operation of the close control circuit of the valve operator. As shown in Figure 1, the close control circuit has limit switch LS-1 in parallel with torque switch TS-17 in series with a parallel combination of control switch and PB close contacts, a seal-in 42/C contact and the auto-close signal X contact. (Examples of auto-close signal are: containment isolation, feed water system isolation, steam line rupture isolation, safety features actuation, loop selection logic actuation, high reactor pressure interlock, etc. In many cases these signals persist even after the valves have closed.) This combination of series-parallel contacts is connected to the closing contactor coil 42/C through a 42/O interlock contact (the 42/O interlock is provided to prevent the closing contactor coil being energized while the opening contactor coil is energized). The closing control circuit is completed through the thermal overload contact to the control transformer grounded lead. Consider this circuit with the valve fully open. LS-1 is closed since the valve is open and TS-17 is closed since there is no torque on the valve. When a valve closing signal is given either by the closure of the control switch CS/C or PB/close contacts or by closure of auto-close X contact, the closing circuit contactor 42/C is energized and seals in through 42/C contact in parallel with CS/C contact. The 42/C contactor will close its main

contacts in the 3 phase motor circuit and will energize the motor operator to drive the valve towards the closed position. Initially, the motor will apply a high breakaway torque to the valve to drive it off the open position. This will cause TS-17 to open, however, LS-1 in parallel will keep circuit continuity. Once the valve comes off the open position, TS-17 will reset and LS-1 will open. Contactor coil 42/C remains energized till the valve operator experiences a high closing torque again. This would normally occur when the valve is fully seated (closed). When the high torque set point is reached, TS-17 will open, interrupting the close control circuit, deenergizing the contactor coil 42/C, and stopping the drive motor. When the motor stops, the torque on the drive shaft will relax and TS-17 will reset. If at this point the closing signal is still present, i.e., if CS/C, PB/close or X contact is still closed, then 42/C will once again energize and the motor operator will attempt to close the valve still further. High torque will again interrupt the circuit by opening TS-17. This cyclic operation will continue until the close signal is removed. Continued attempts to close an already closed valve resulted in the hammering effect experienced by the valves at Quad Cities 1 and Dresden 2.

The open control circuit operates in a similar manner with the exception that the circuit is interrupted by the limit switch LS-3 with the torque switch TS-18 providing valve protection from an overtorque condition. With this circuit configuration, a cyclic operation is not possible since LS-3 remains open once the valve is fully open.
