# Closeout of IE Bulletin 80-07: BWR Jet Pump Assembly Failure

Prepared by R. S. Dean, W. R. Mills, W. J. Foley, A. Hennick

PARAMETER, Inc.

Prepared for  
U.S. Nuclear Regulatory  
Commission

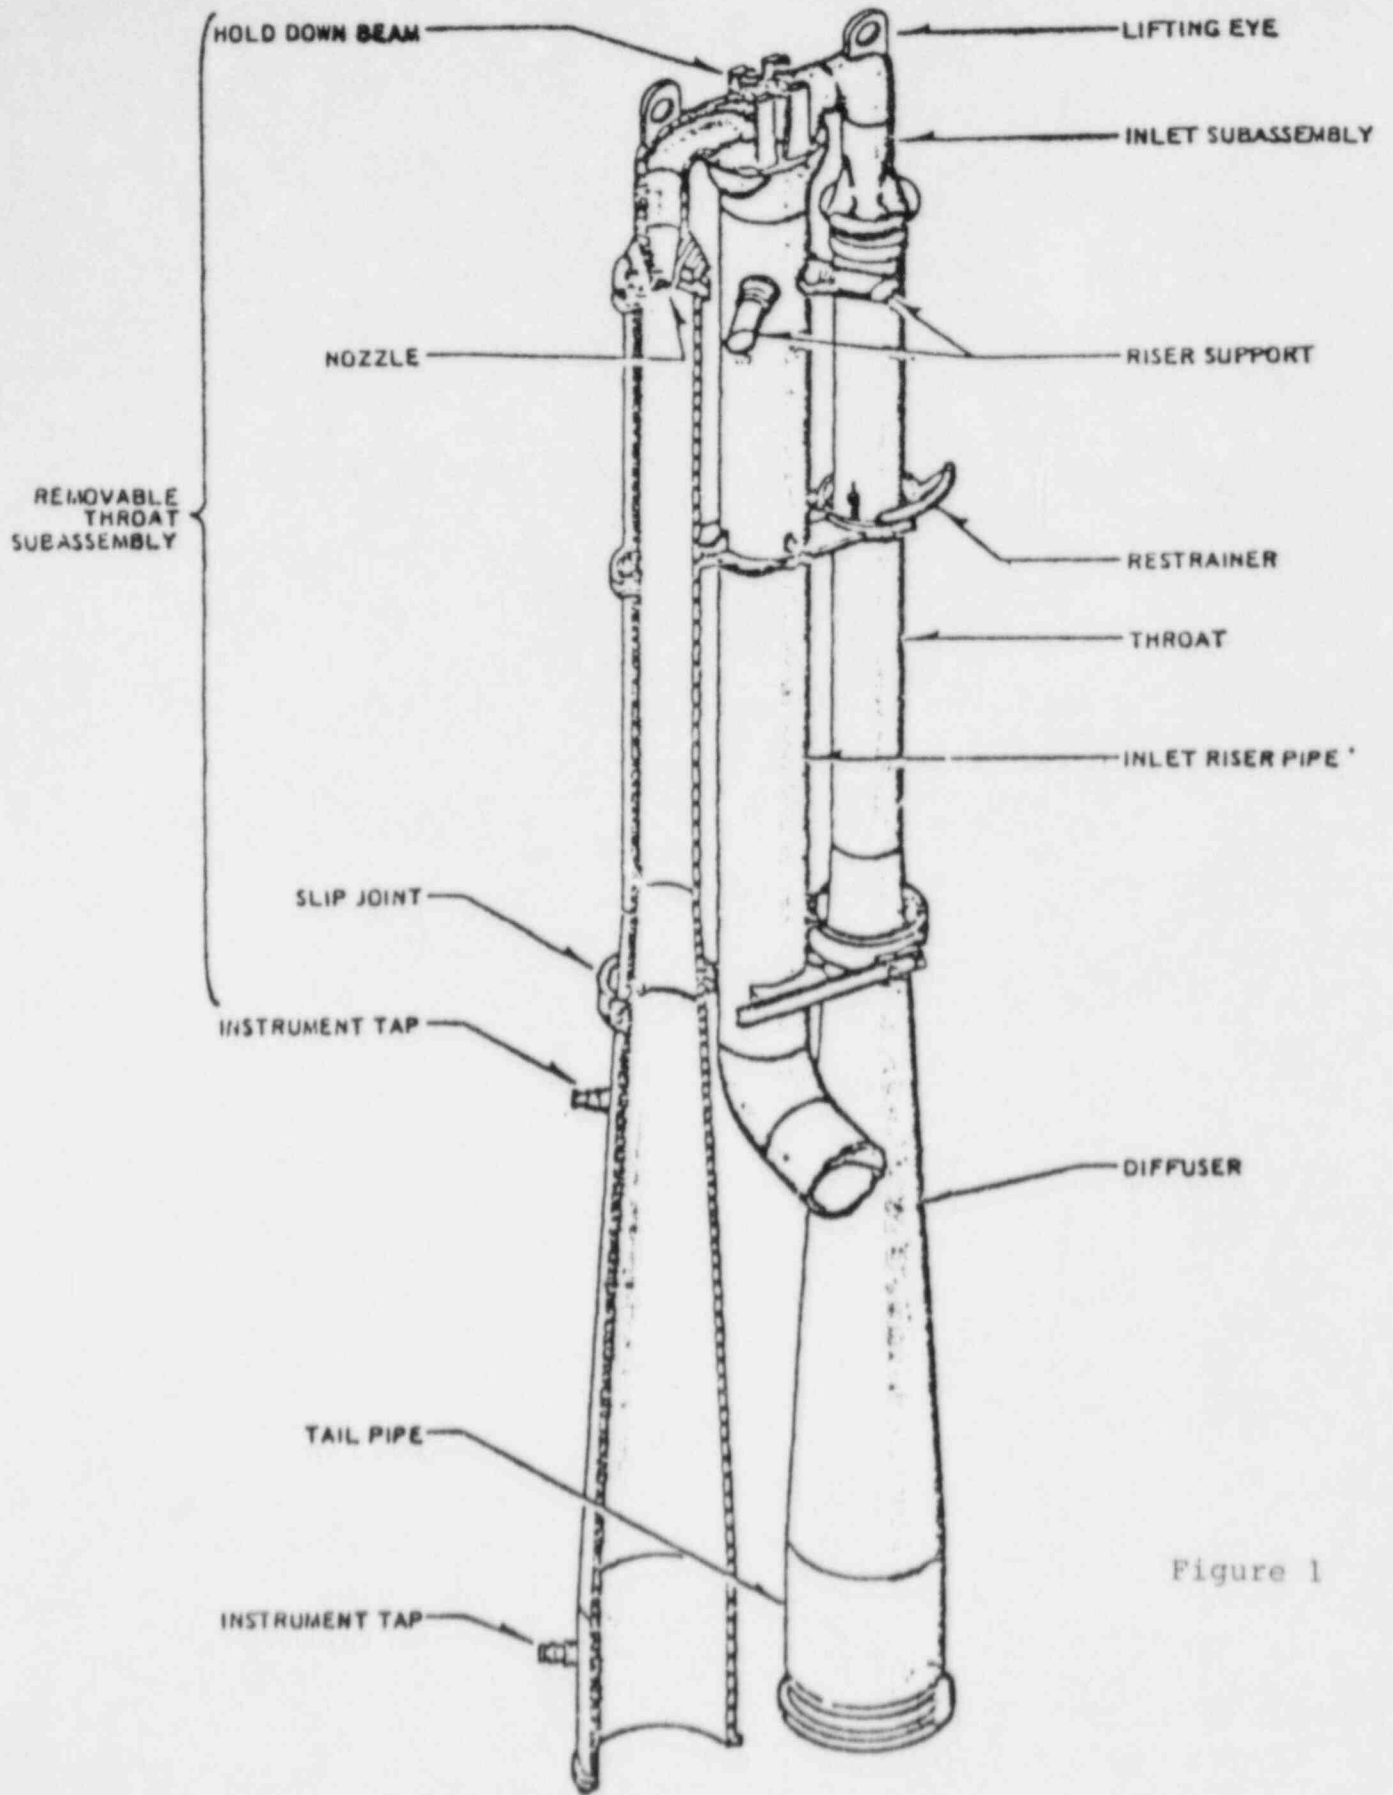
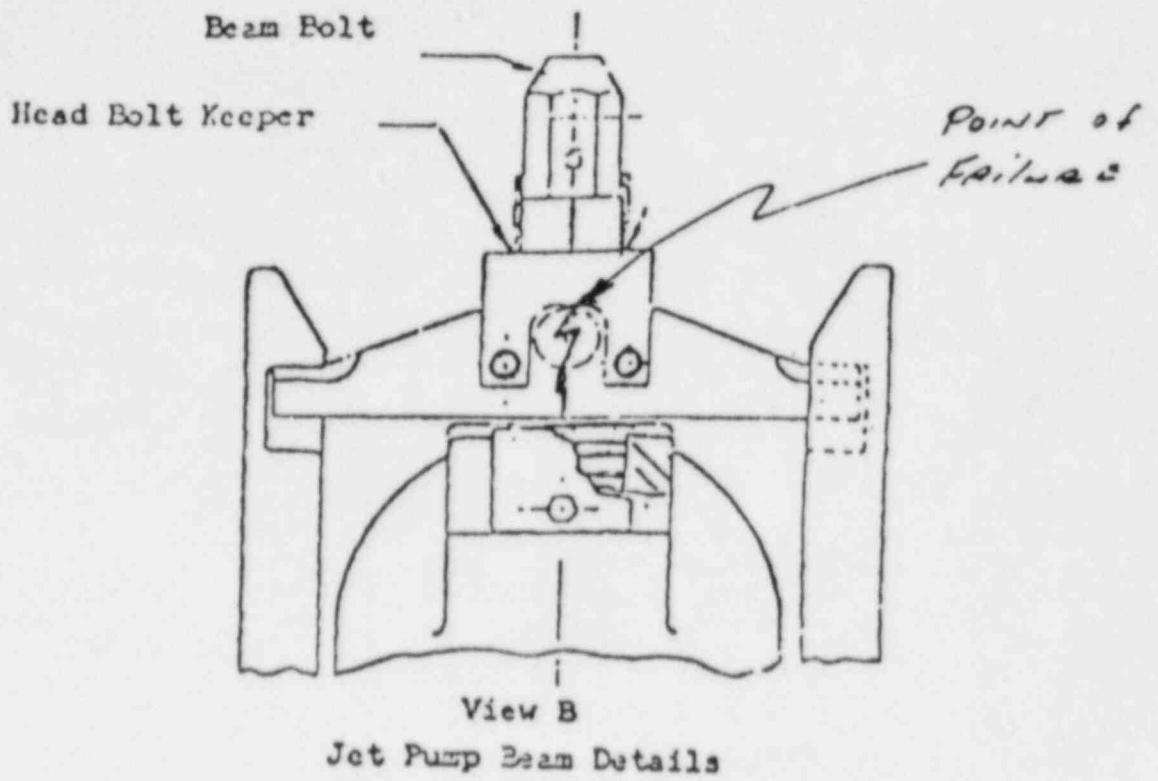
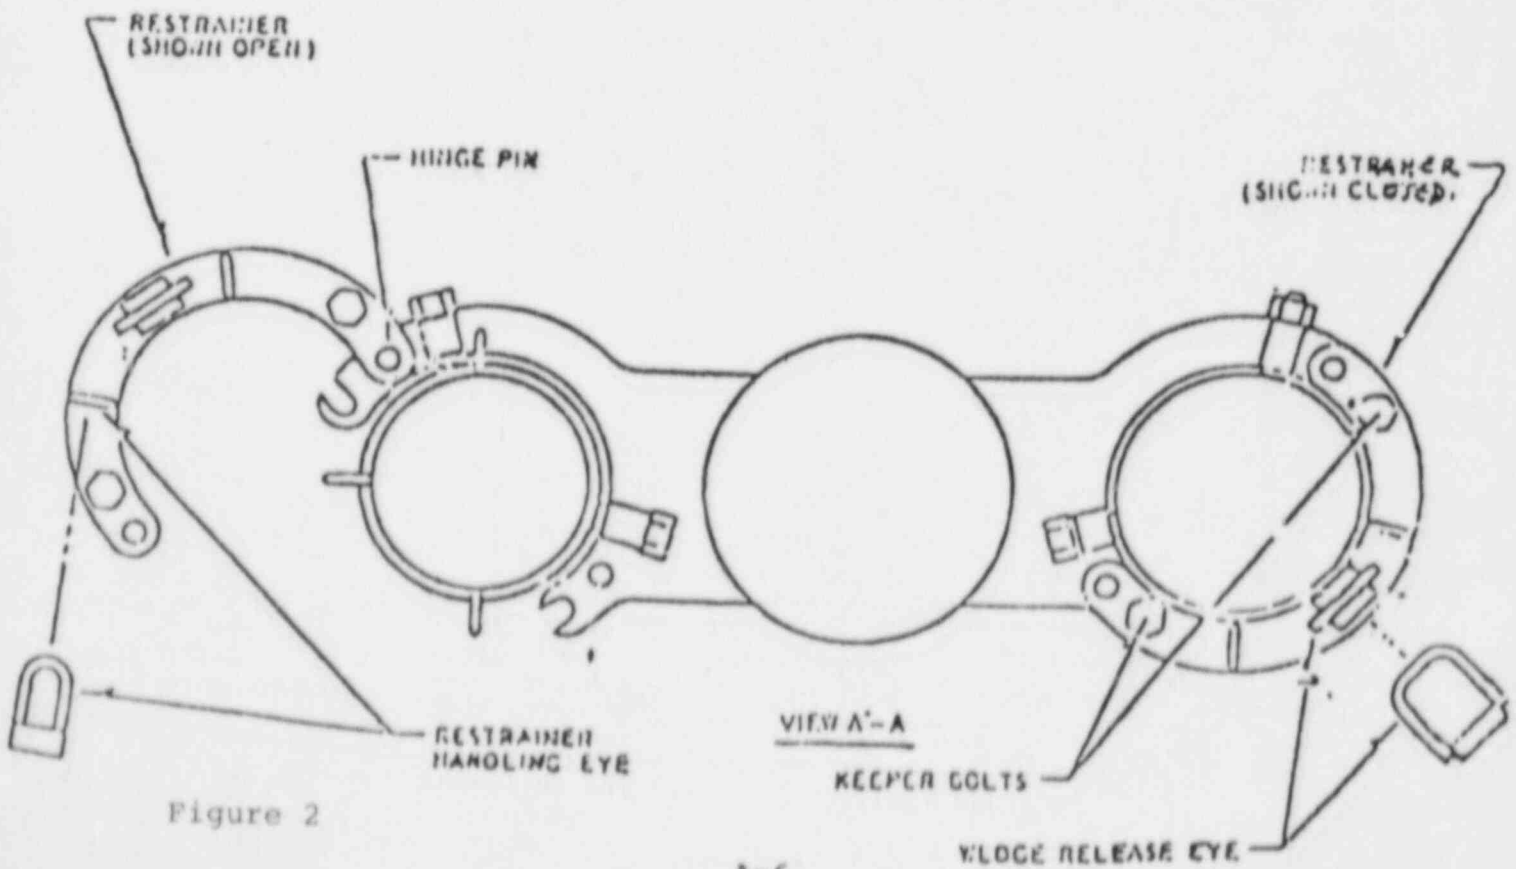
Figures 1 and 2

Following vessel head removal and defueling, TV camera and visual inspections of the jet pumps and vessel annulus revealed the hold-down beam assembly of the suspect jet pump had broken across its ligament sections at the mean diameter of the bolt thread area. Failure of the beam assembly resulted in pump decoupling at the diffuser connection. Subsequent insitu ultrasonic examination of all other jet pump hold-down beams, using a special UT technique developed by General Electric revealed ultrasonic indications of cracking at the same location in 6 of the remaining 19 beams examined. Initial estimates of crack depth ranged from 6 to 20 mils. A sketch of the typical jet pump assembly is shown in figures 1 and 2.

In February 1980 a jet pump hold-down beam failed at Dresden 3 resulting in jet pump disassembly which caused an orderly plant shutdown. Subsequent visual inspection by TV camera and ultrasonic examination, conducted at the direction of General Electric, disclosed that hold-down beams on other jet pumps at Dresden 3, Quad Cities 2 and Pilgrim contained cracks in the ligament zone at the center of the beams. Investigation determined that these cracks were caused by intergranular stress corrosion, which in the case of these jet pump beams, progressed very slowly over a period of years.

NOTE: Replacement of all original hold-down beams with new BWR/4-6 beams with revised heat treatment and reduced preload is the most satisfactory corrective action.
