TECHNICAL DATA REPORTTDR NO. 666REVISION NO. 0BUDGET
ACTIVITY NO. 123125PAGE 1 OF 18**PROJECT:**

TMI-1 OTSG REPAIRS

DOCUMENT TITLE: Adequacy of TMI-1 OTSG Return to Service Safety Assessment
After 1984 Technical Specification ECT Examination

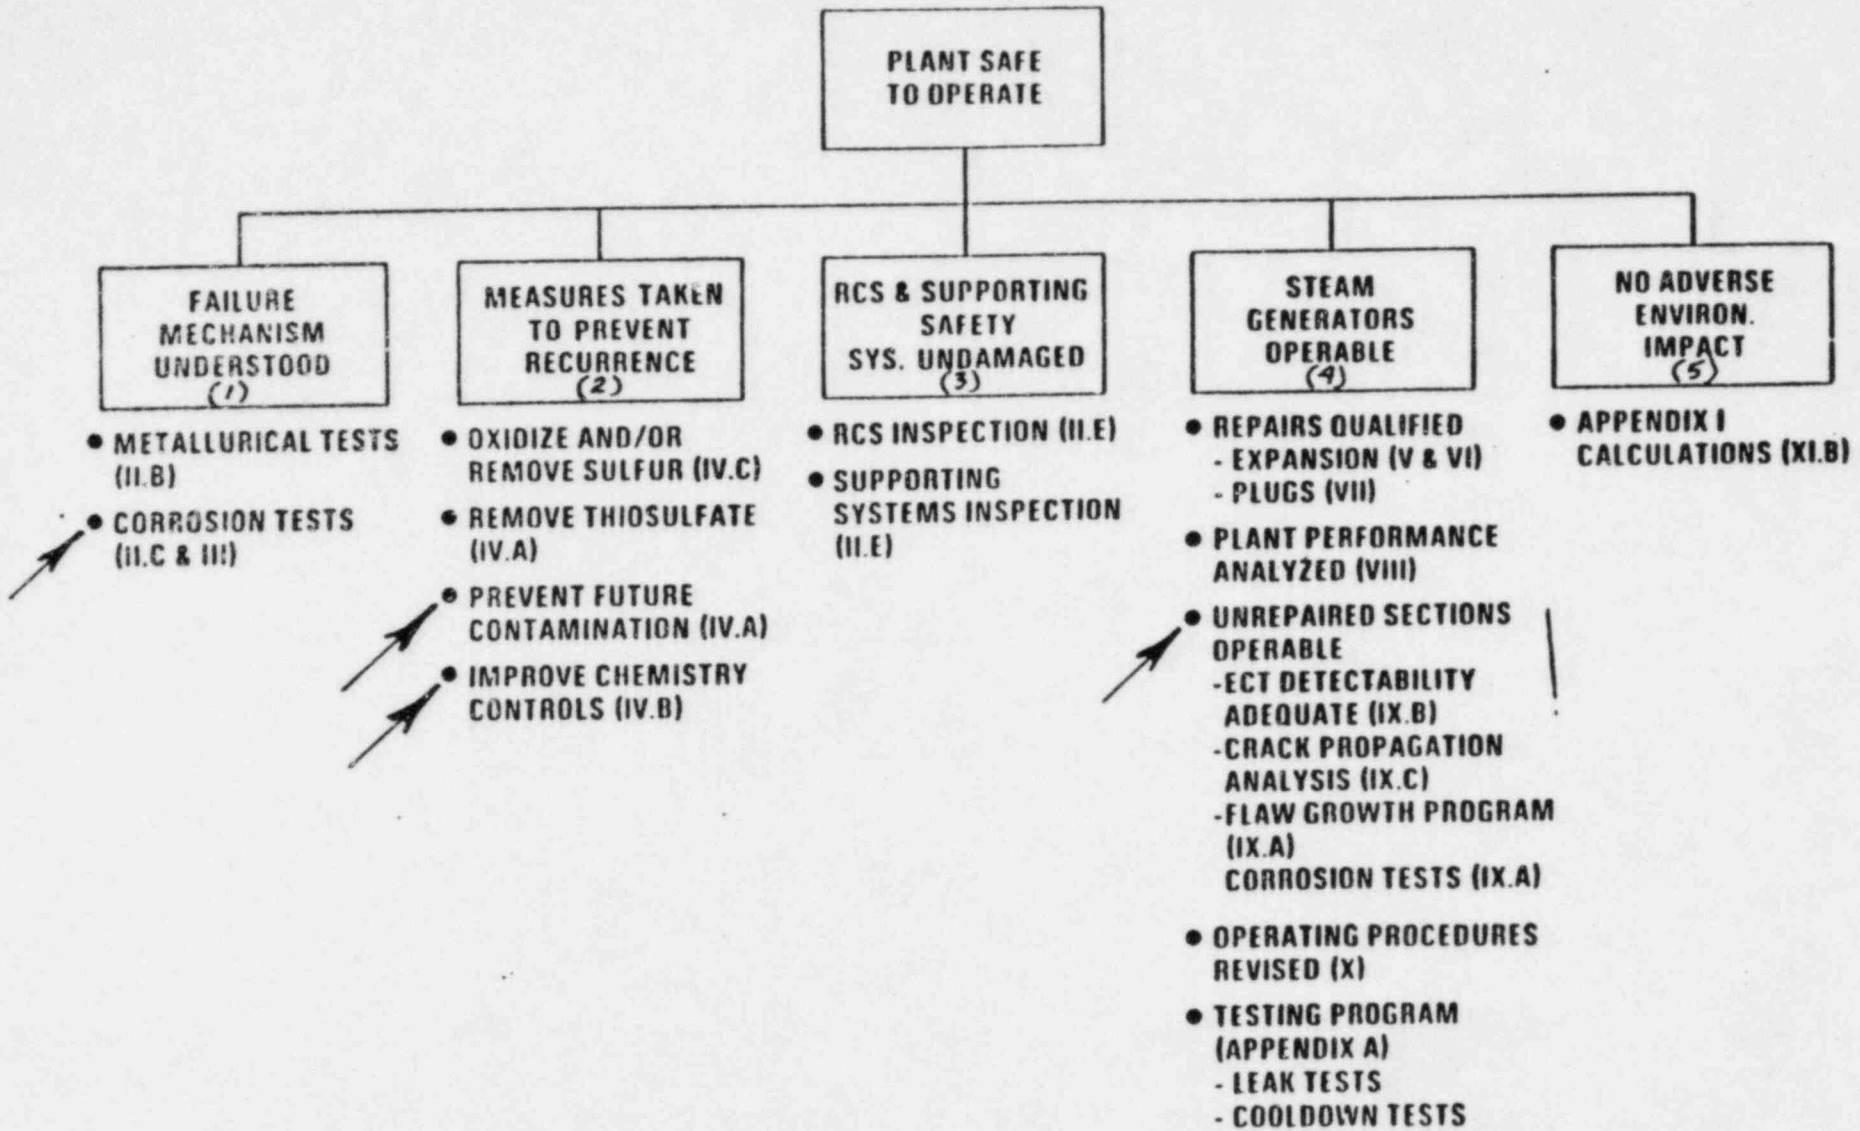
FIGURE I-7

The logic of the safety evaluation done in TR-008 is set forth in Section ID and describes the points to be demonstrated and assured by the repair program to allow OTSG return to service. This logic is graphically captured in Figure 1-7 (attached) and stated in ID (1) through (5) as follows (Ref. 1, Section ID, page 3):

1. The failure mechanism is understood well enough to define the root cause of the steam generator damage;
2. Other components in the RCS and supporting safety systems were not visibly damaged by the failure mechanism;
3. The plant can be operated such that this failure mechanism is arrested and will not recur;
4. The Steam Generators can be repaired and operated within the design basis;
5. The plant can be operated with some tube leakage without adversely impacting the environment."

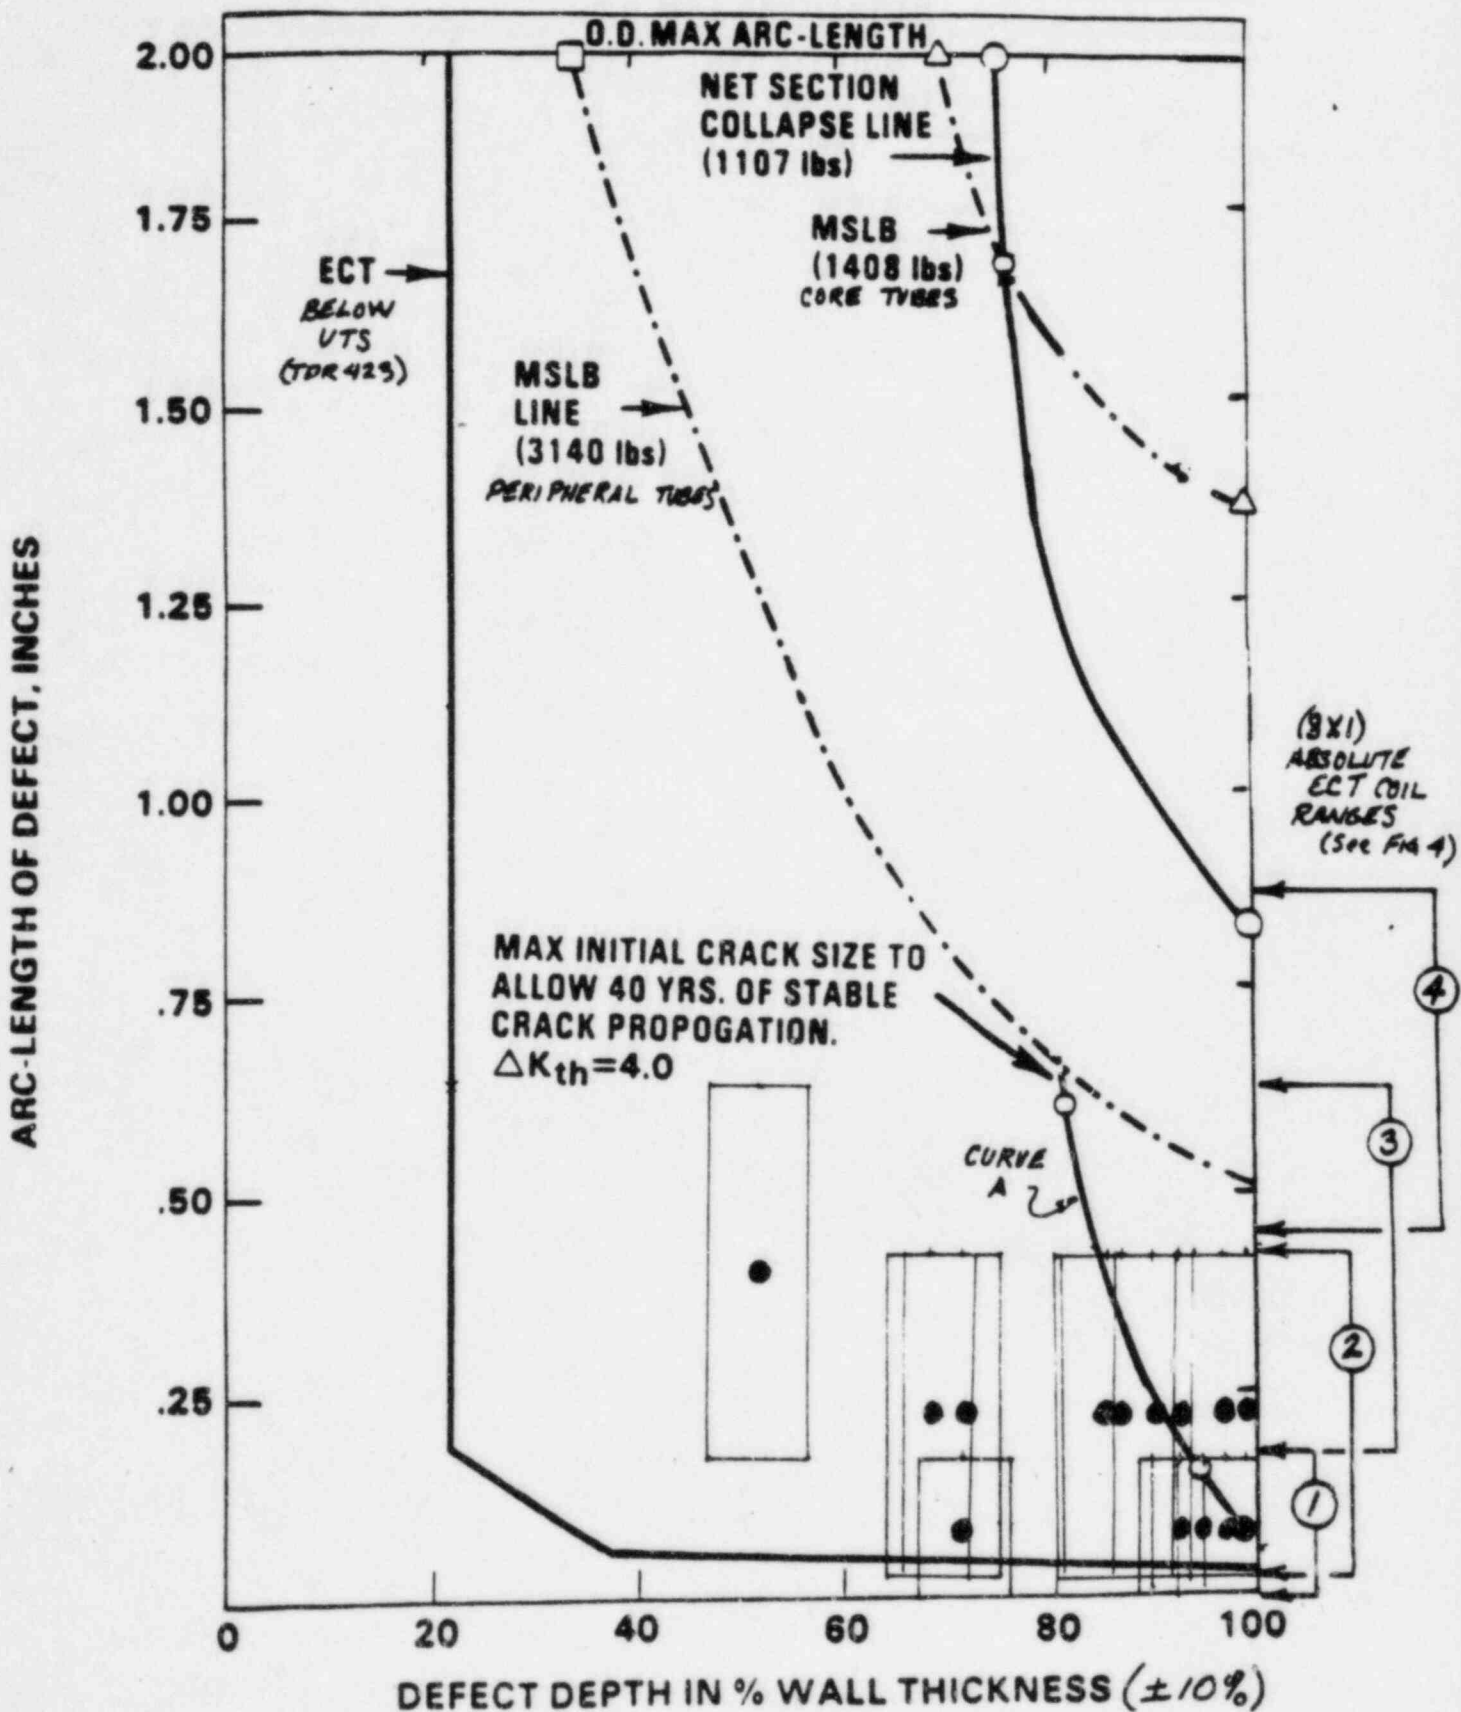
MAJOR INDICATIONS BELOW THE UTS LOWER FACE ($\pm 1''$)

rather than a point. The indications plotted in Figure 1 (a thru c) include all the worst combinations of through-wall penetration and circumferential extent for single defects (See Table 1). These tubes have all been removed from service in 1985. Three tubes exhibited defects of large circumferential extent but lesser penetration: 3 coil signals coupled with 20-50% through-wall penetration, with one showing 76% through-wall but located within the upper tubesheet. These extreme cases are also plotted and they nonetheless did not approach the MSLB line for peripheral tubes. It should be noted that, minority extremes aside, the great majority of all 1984 ECT indications fall below or in the immediate vicinity of the limits of ECT detectability (See Figure 2).

It can be seen from Figure 1a-c that the maximum possible size characterization of several indications both extend above the ECT detectability curve and include areas above curve A. Areas above curve A represent crack sizes which will propagate through-wall in service. Nonetheless, assuming the worst confluence of events (1- the indication is truly at the maximum extent of its characterization range, and 2- the defect is a crack and not an IGA pit) there is still no unanticipated hazard. Degradation in this range will be by through-wall penetration before tube rupture (Leak Before Break) and OTSG leak detection systems and procedures will enable operators to deal with the leaking tubes safely.

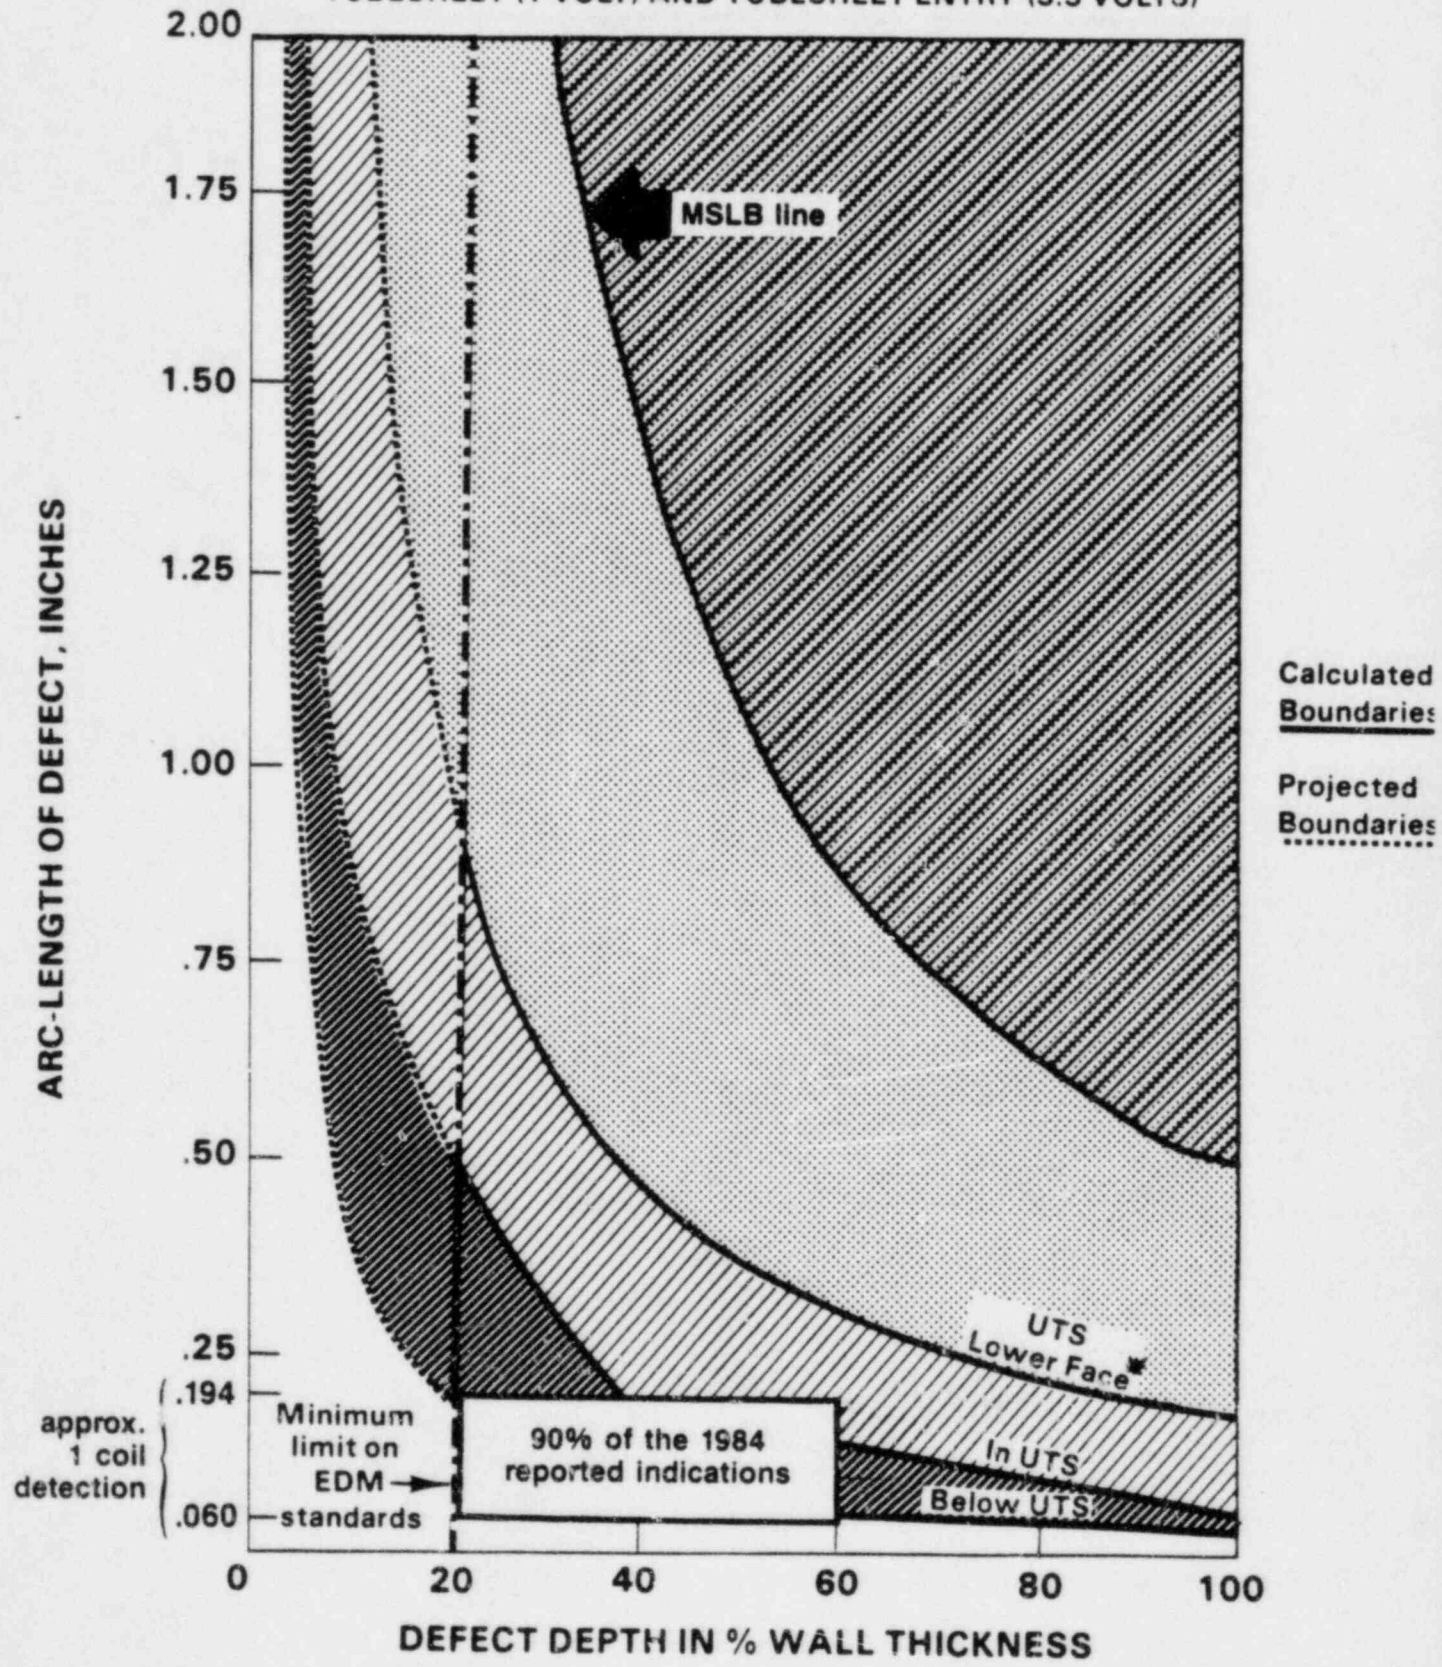
FIGURE 2
(WAS FIGURE 6 OF TDR 652)

ESTABLISHED MINIMUM SENSITIVITY FOR THE HIGH GAIN .540 S.D. EXAMINATIONS
BELOW UPPER TUBESHEET (300 MV) WITHIN UPPER
TUBESHEET (1 VOLT) AND TUBESHEET ENTRY (3.3 VOLTS)

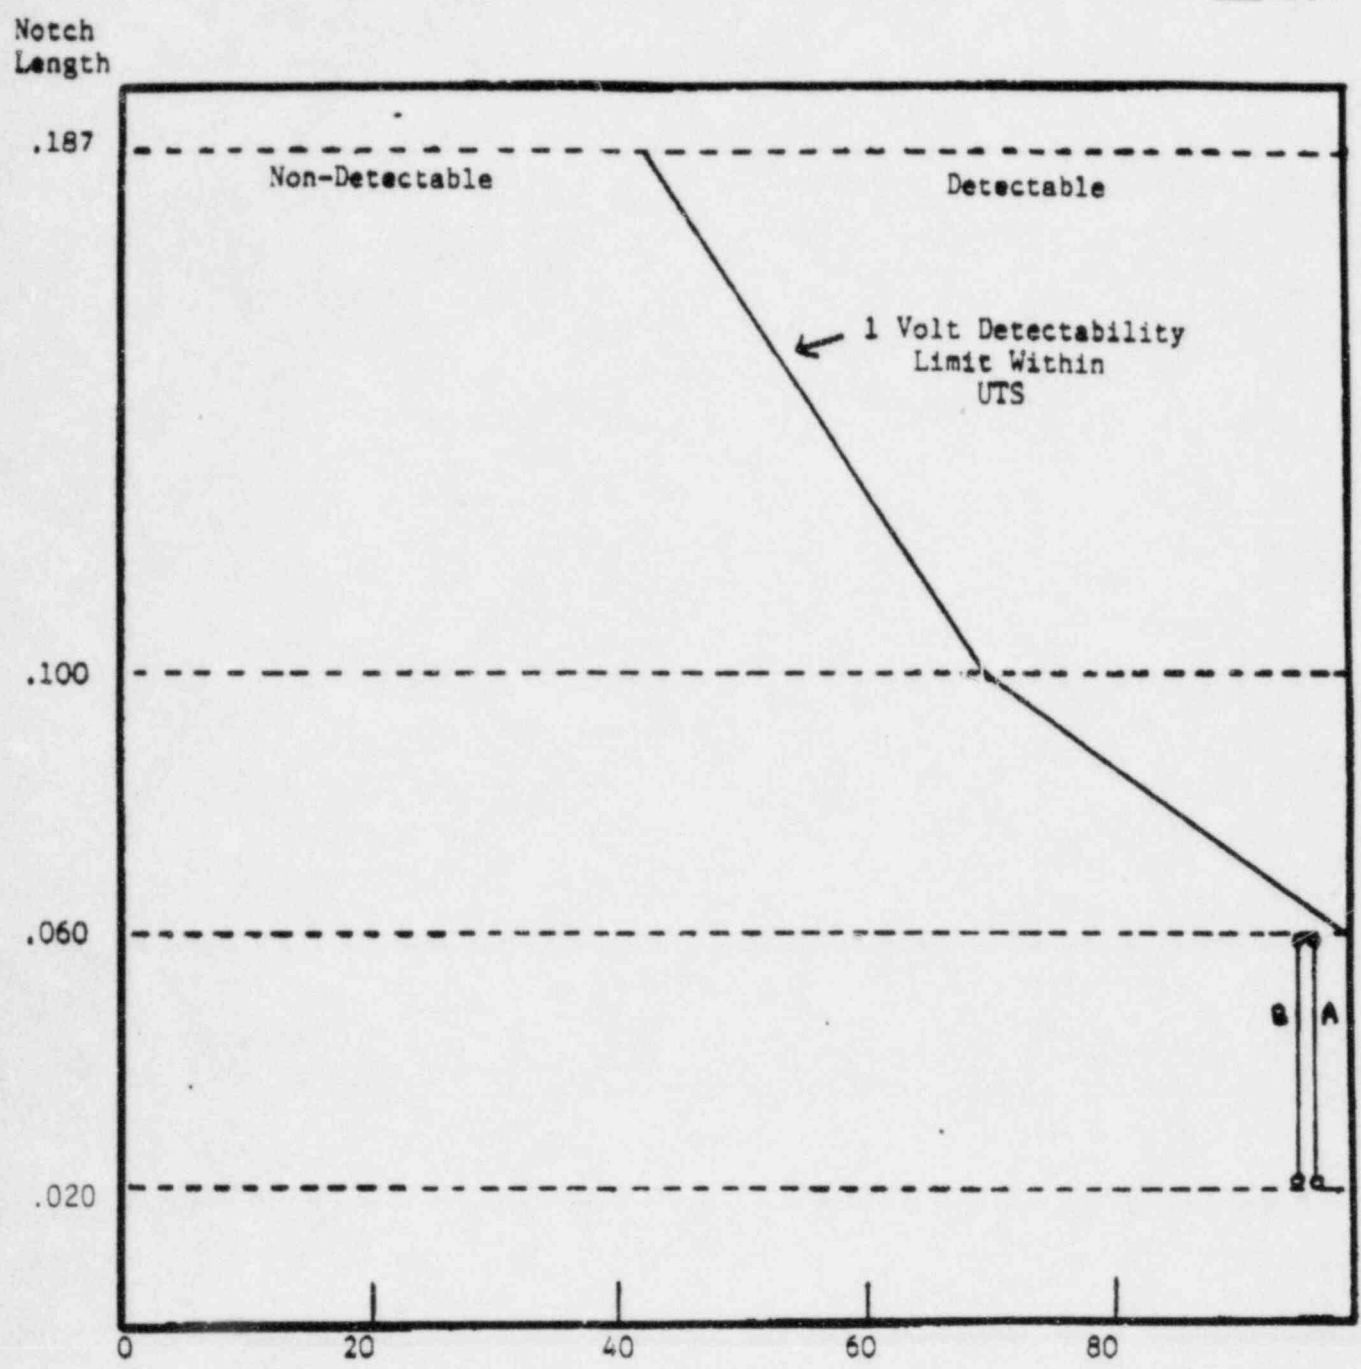
Figure 3a - Within - Tubesheet
 Fiberscope Indications
 Compared to Detectability Limit

Subsequent to the release of TR-008 the observations obtained from the outcome of the Long Term Corrosion Tests and failure analysis are now seen to support the presence of local IGA which may not be visible to the standard .540 differential probe but have the potential to be exercised into visibility by mechanical loadings (Ref. 2, pg. 22). This presence is further suggested by the distribution of new indications (in tubes of higher mechanical loading) and the results of fiberscope observations in OTSG tubes in which rounded dark areas consistent with IGA in appearance were seen at locations where ECT reported indications (See Figures 3a and 3b).

- A A-89-124
- B A-76-119

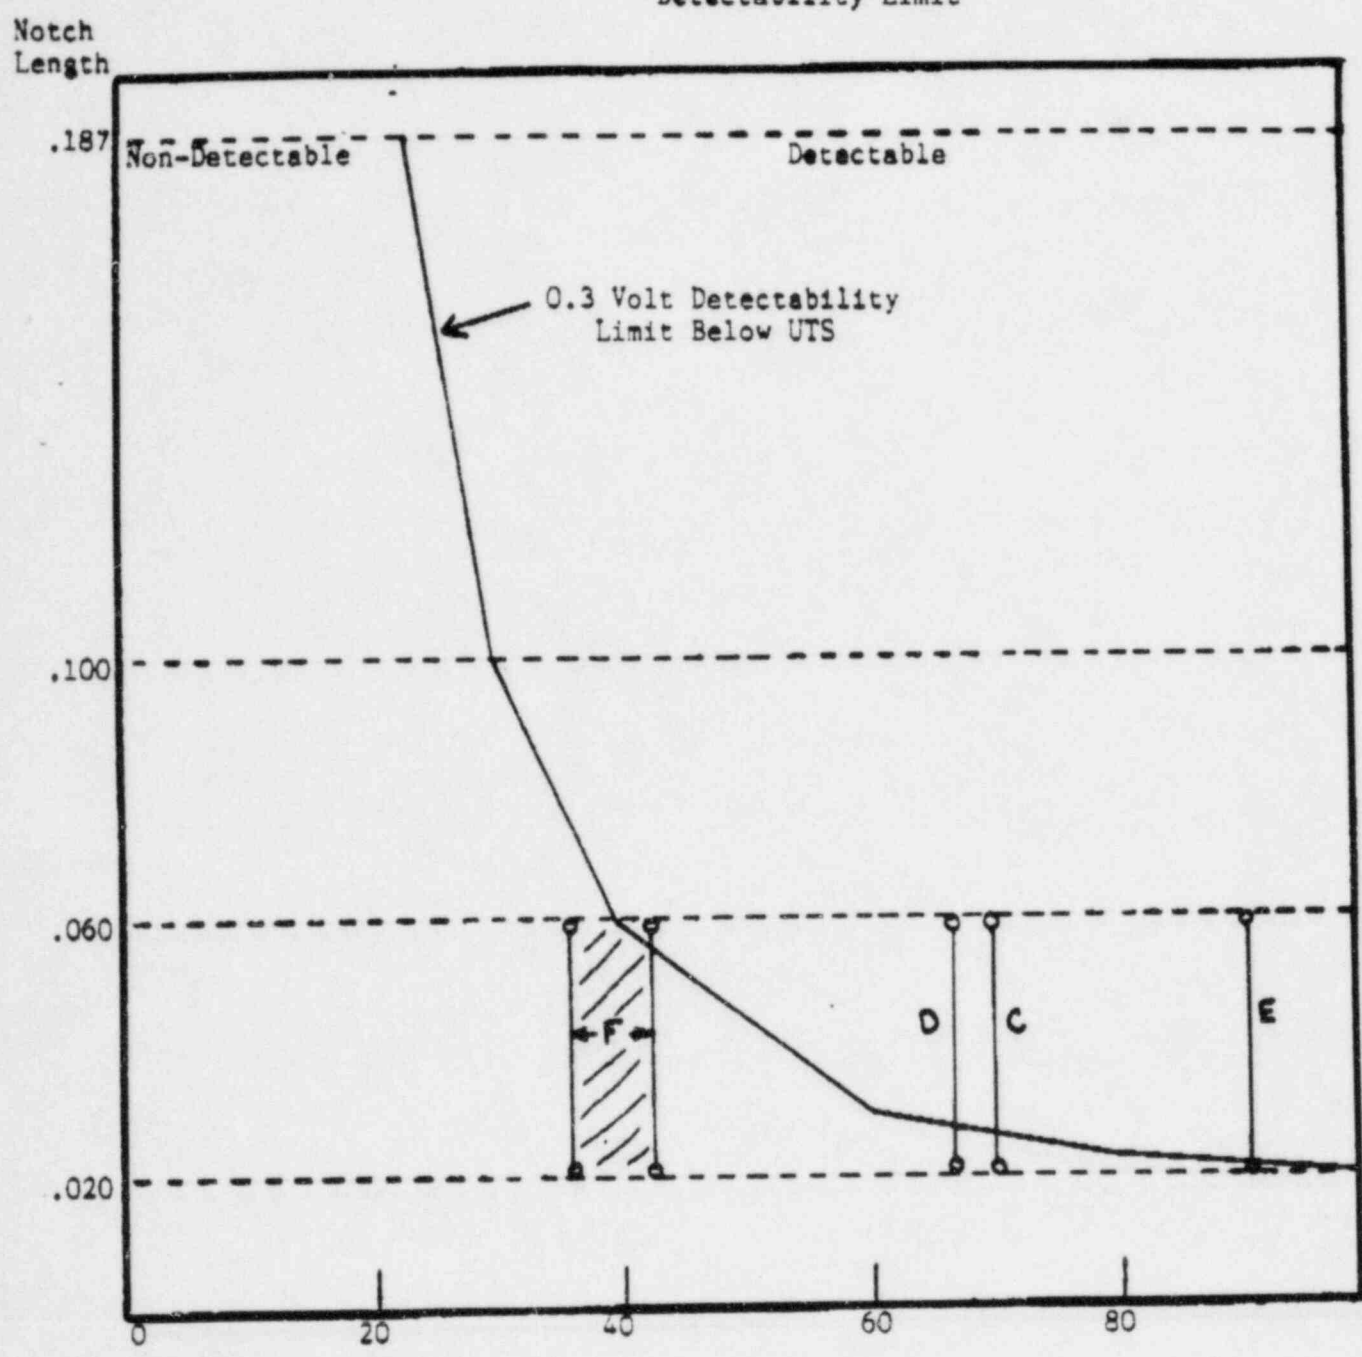
Figure 3b - Below - Tubesheet Fiberscope
 Indications Compared to
 Detectability Limit

- C A-66-129
- D A-61-123
- E A-57-128
- F A-60-126

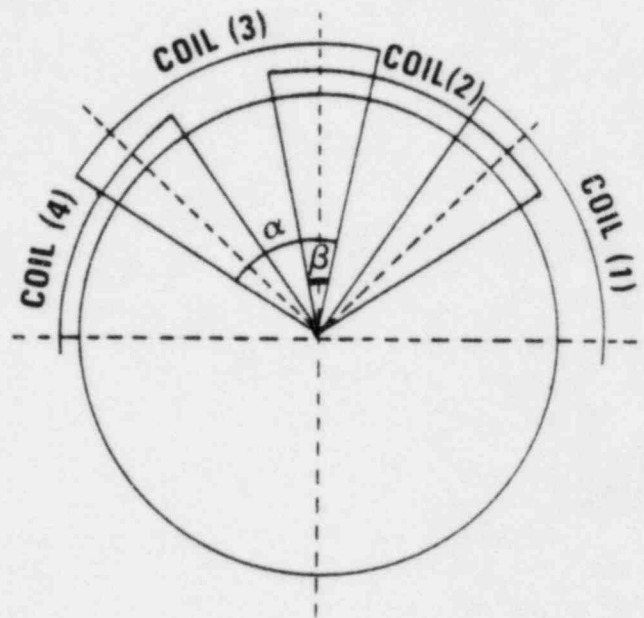
FIGURE 4
 (WAS Figure B-1)

Many of these defects were nonetheless used as justification for removal of a tube from service. This arose from considering these pits as behaving like cracks and therefore capable of propagative interaction. Additionally, circumferential extent was characterized solely by the maximum number of ECT probe coils signalling; no credit was taken for the overlap of coils (See Figure 1a thru c) whereby a defect only slightly larger than one-half of one-coil sensitivity would register as a two-coil defect. These are inherent conservatisms which should not be used to mask the actual appreciation of the comparatively benign nature of these defects.
