U. S. NUCLEAR REGULATORY COMMISSION

Report No. 50-456/84-21(DRP); 50-457/84-20(DRP)

Facility Name: Braidwood Nuclear Power Station, Units 1 and 2

Inspection Conducted: September 4 through October 5, 1984

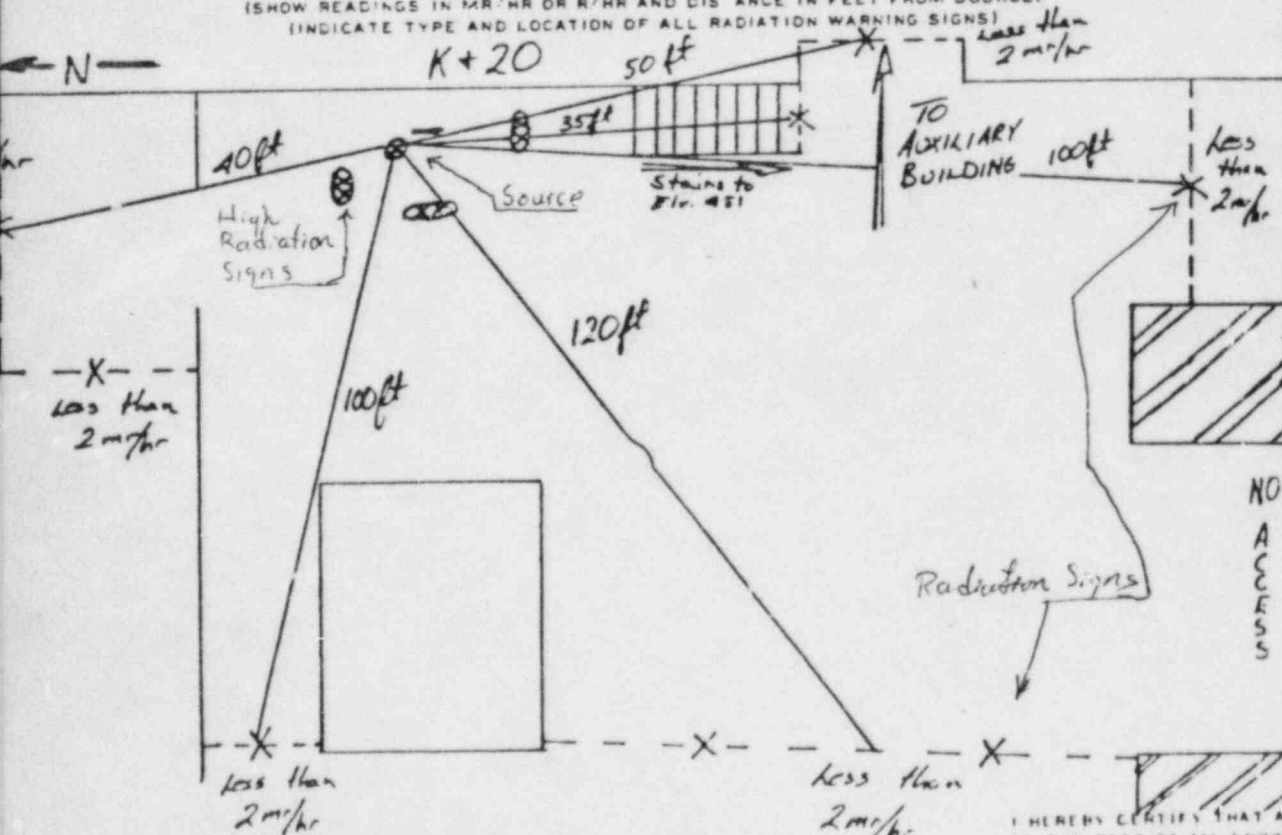
SURVEYS & SKETCH OF RESTRICTED AREA:

On September 10, 1984, between the hours of 6:30 a.m. and 7:00 a.m., three Commonwealth Edison Rad-Chem Technicians violated a posted radiation area by passing through the personnel barriers which encompassed the area in which radiography was being performed. The outer perimeter of the radiation area was roped off and displayed the necessary radiation signs (see attachment 1) at all eight points of entry. The "radiation area" signs are constructed as described in 10 CFR 20.203 and were labeled with bold printing stating: CAUTION RESTRICTED, KEEP OUT RADIATION AREA. Within the radiation area and on the three accessible sides to the radiographers source, high radiation signs were conspicuously placed, (see attachment 1). When the individuals came across the restricted area, they continued through the barrier and on to the Health Physics Office. They returned to the restricted area, again disregarded the radiation barrier, but were challenged and stopped by the radiographers. When questioned as to why they violated a posted restricted area, they questioned the authenticity of the signs because they were not held in place by yellow and magenta rope. A radiation survey was immediately taken of the area where the men had traversed and a maximum reading of 3 mr/hr was obtained. The stay time in this area, which was shortened by the actions of the radiographer was approximately 15 seconds.

Commonwealth Edison has requested Pittsburgh Testing Laboratory (contractor responsible for NDE testing) to use yellow and magenta rope to suspend their radiation signs when establishing restricted areas. This action will be consistent with material familiar to all Commonwealth Edison/Braidwood Station Employees. The NRC inspector requested Commonwealth Edison to inform their training department to explain the minimum intent of Federal Regulation 10 CFR 20.203 and 10 CFR 34.42 and that the regulations do not require a specific kind or color of material to support radiation exclusion signs or specify the type of material to be used to establish an exclusion perimeter.
