Pennsylvania Power & Light Company

SUSQUEHANNA STEAM ELECTRIC STATION  
T-ASCO SCRAM PILOT SOLENOID VALVES  
ER 100450/100508 FILE 841-4  
PLA-2361

Subject: Preliminary Evaluation of Failed Scram Pilot Solenoid Valve

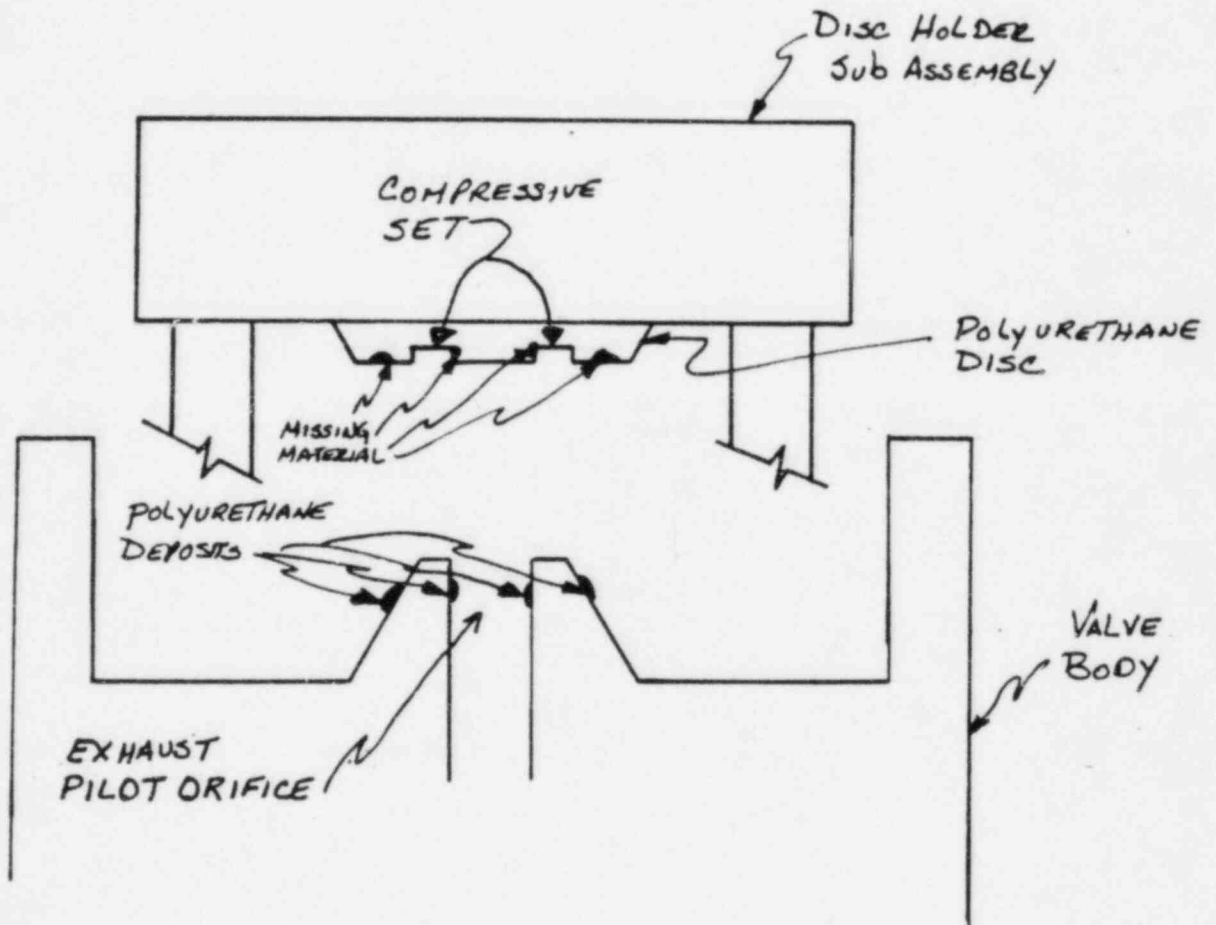
SKETCH OF DISC HOLDER SUBASSEMBLY AND EXHAUST PILOT ORIFICE

The polyurethane discs were examined under a microscope along with their mating pilot orifices from the valve body. Although there was some evidence of material transfer from the core disc to the brass pilot orifice on the valve body, the deposits were limited and only discernible under the microscope. The disc holder subassembly had a substantial amount of the polyurethane material in a roughened state with sufficient irregularities to indicate that some of the material had torn away from the seat. Microscopic examination of the exhaust pilot orifice in the valve body revealed pieces of the seat material had adhered to the area surrounding the pilot orifice. As depicted in Figure 1, the seat material had not adhered at the initial point of contact with the pilot orifice, but rather around the edges. This indicates that the bonding of the disc holder subassembly to the pilot orifice occurs only after either a compressive set or significant softening of the seat has occurred.

The preliminary cause of the failures in service appear to be a result of the disc holder sub-assembly adhering to the exhaust pilot.

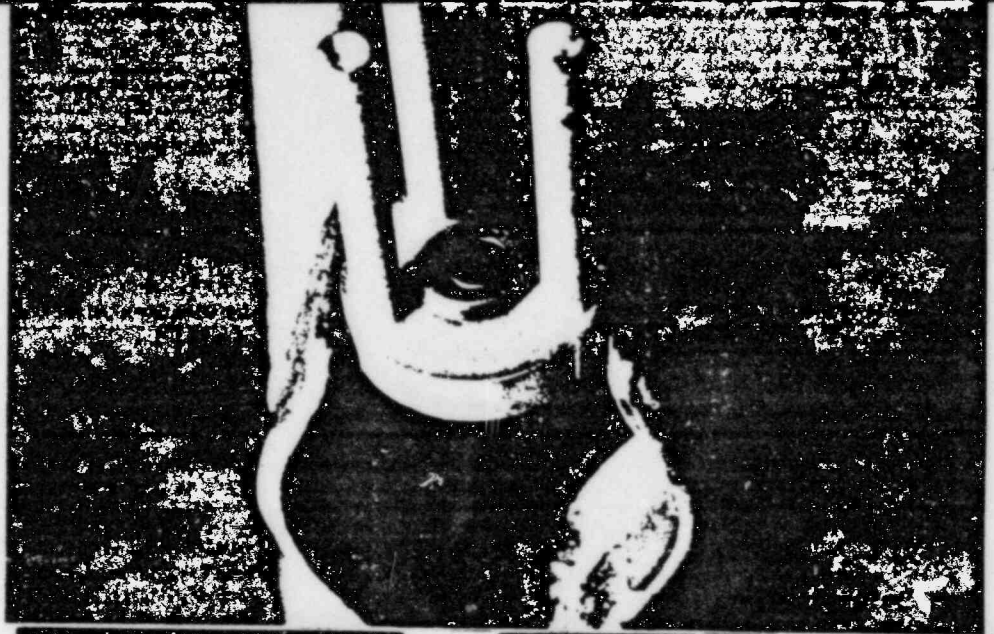
FIG. 2

FRC has included three color photographs of the solenoid valve internals marked as Figures 2, 3, and 4. All three photographs are of components from the solenoid valve that had failed in service. Figure 2 is a photograph of the disc holder subassembly with its polyurethane seat. The compressive set and the roughness outside the diameter of the compressive set should be noted. The roughness is a result of tearing of the polyurethane seat due to adhesion to the exhaust pilot orifice. Matching patterns of polyurethane were found adhered to the exhaust pilot orifice. Figure 3 is a photograph of the core disc seat with a similar compressive set evident. The black ring at the mating surface may be the result of either heat or contaminants in the air supply and further testing would be required for a determination. Figure 4 shows the stem and disc holder subassembly. Although it may not be evident in the photograph, the disc holder subassembly is being supported by the stem. The stem had firmly adhered to the polyurethane at the base of the disc holder subassembly. The photographs depict the as-found condition of these components.
