NED-84-605

December 10, 1984

NRC DOCKET 50-321
OPERATING LICENSE DPR-57
EDWIN I. HATCH NUCLEAR PLANT UNIT 1
INSERVICE INSPECTION OF STAINLESS STEEL PIPING -
1984 REFUELING OUTAGE

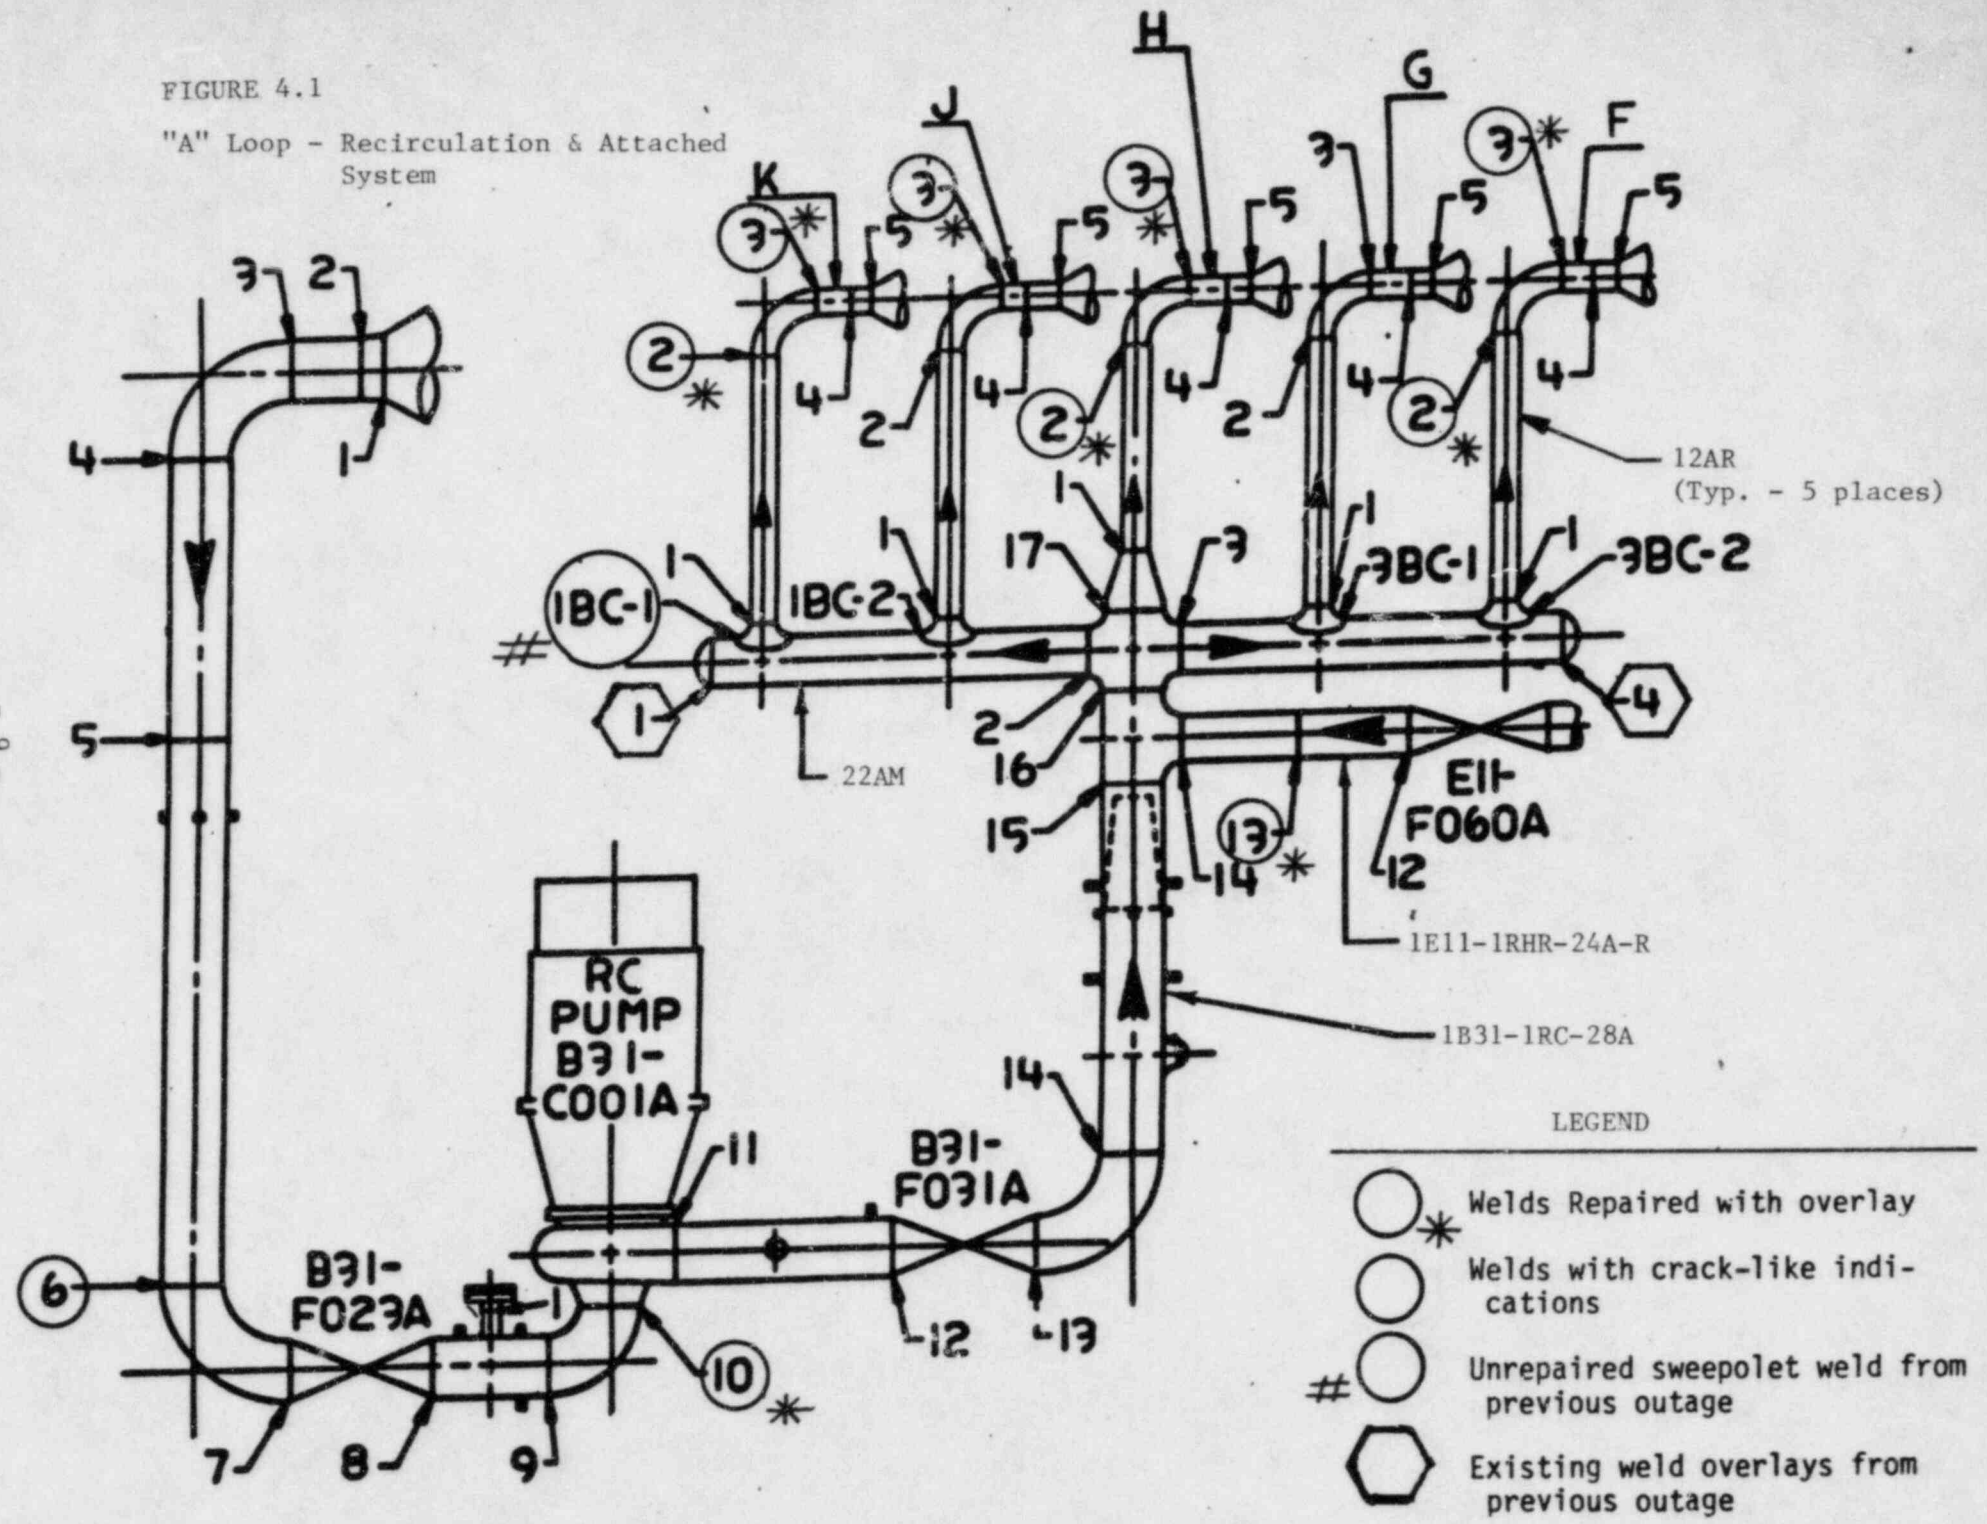
FIGURE 4.1
"A" Loop - Recirculation & Attached System

Of the 136 circumferential and branch connection (sweepolets, etc.) welds examined, 21 welds (19 circumferential and 2 branch connection) were found to have reportable, crack-like indications. These welds and their results are tabulated in Table 4.1.

As noted in Section 4.0, 21 piping welds in the Recirculation and RHR systems were found to have reportable, crack-like indications. Analyses performed by NUTECH have demonstrated the need to repair 17 welds at this time in the form of a weld overlay. The welds requiring repair at this time are:

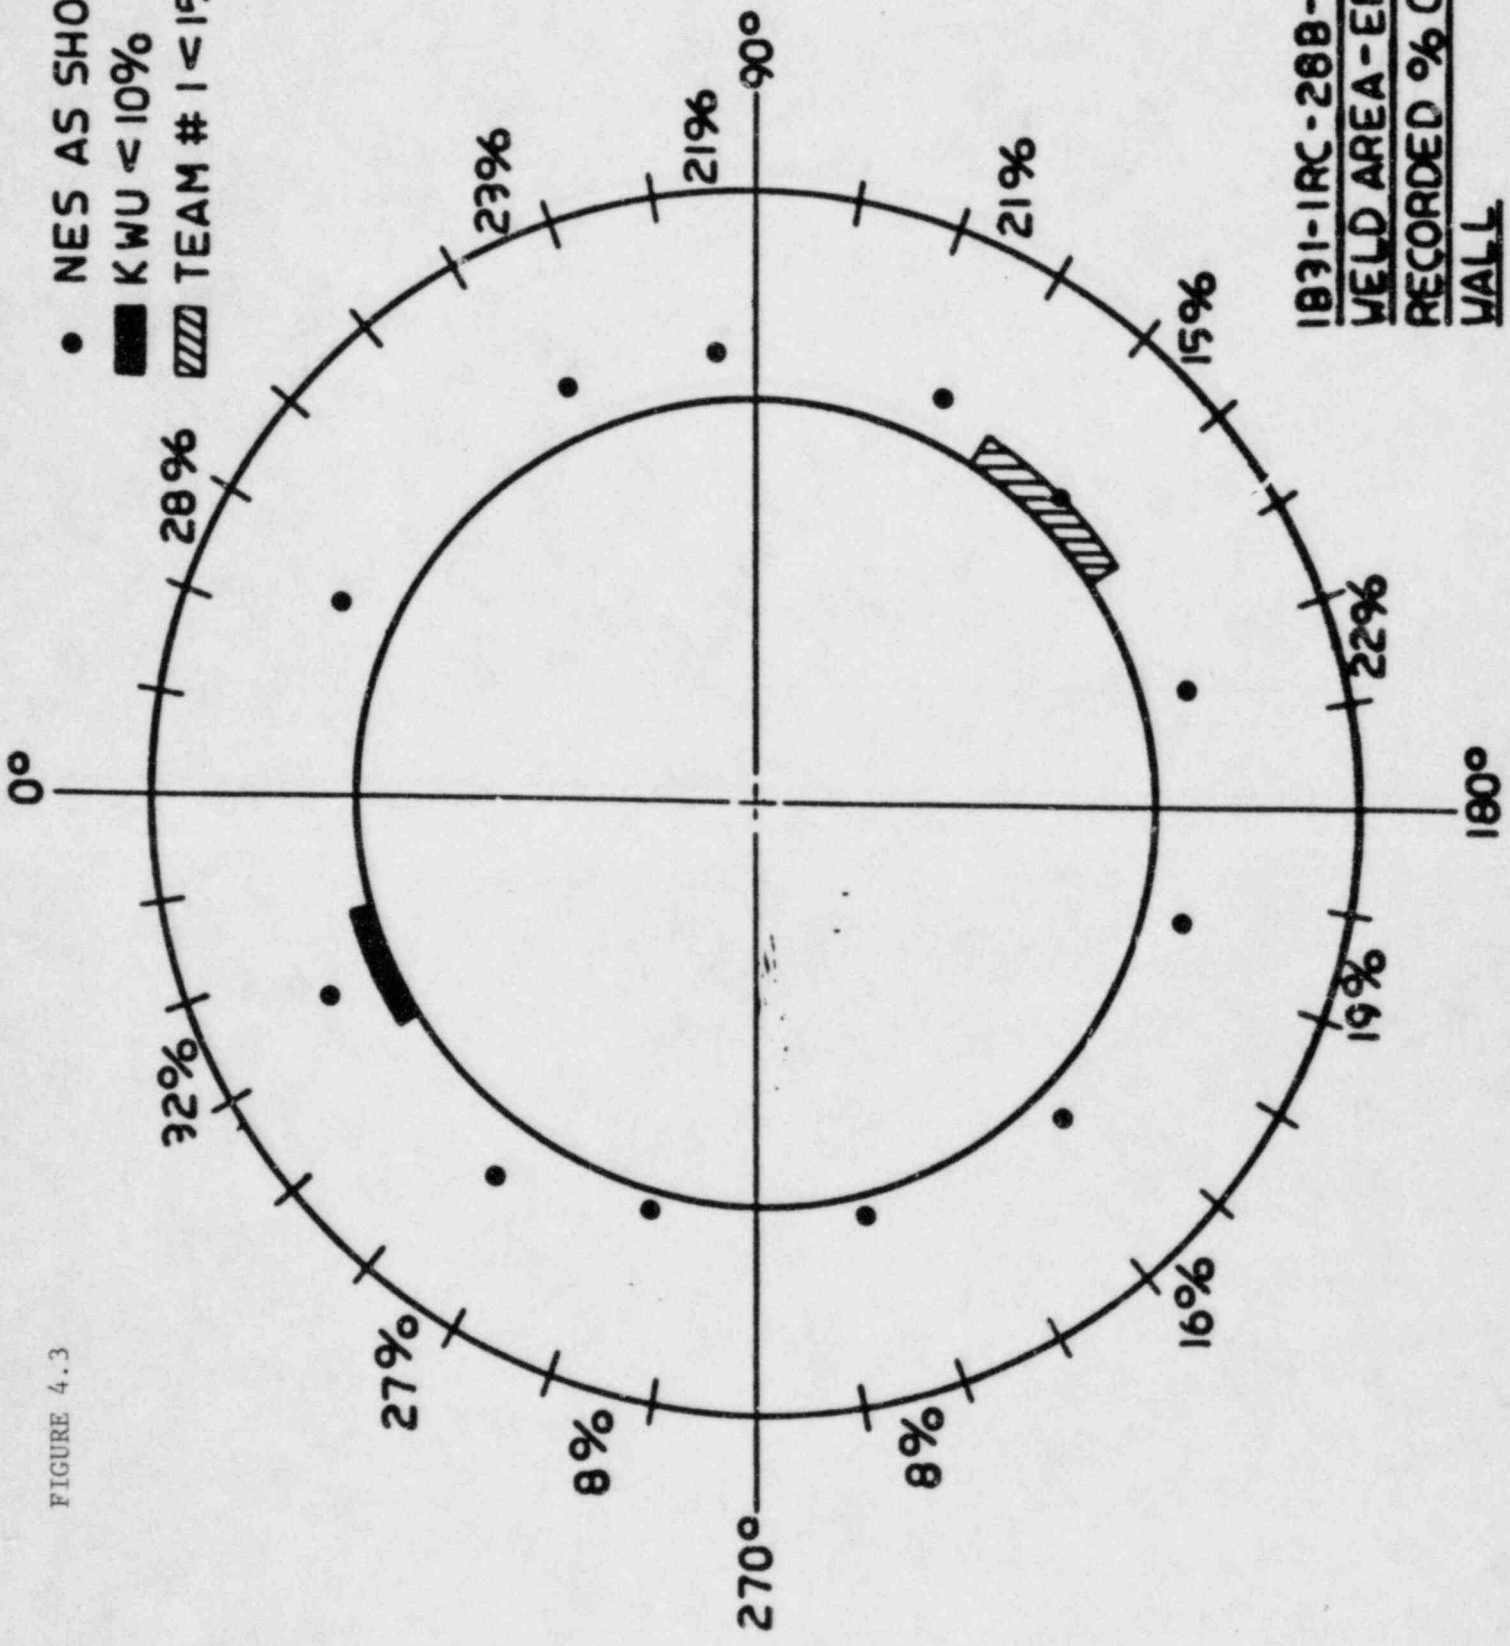
FIGURE 4.3

indications. However, final evaluation and disposition of sizing results was made by SCS and/or NES. The most conservative estimate was reported to GPC by SCS and was used in analysis for decisions concerning repairs. It should be noted that this was not a research effort but a means to show that results were conservative. Some examples of the third-party review results are shown in Figures 4.3 and 4.4.

1831-IRC-288-3
WELD AREA - END VIEW
RECORDED % OF THRU
WALL

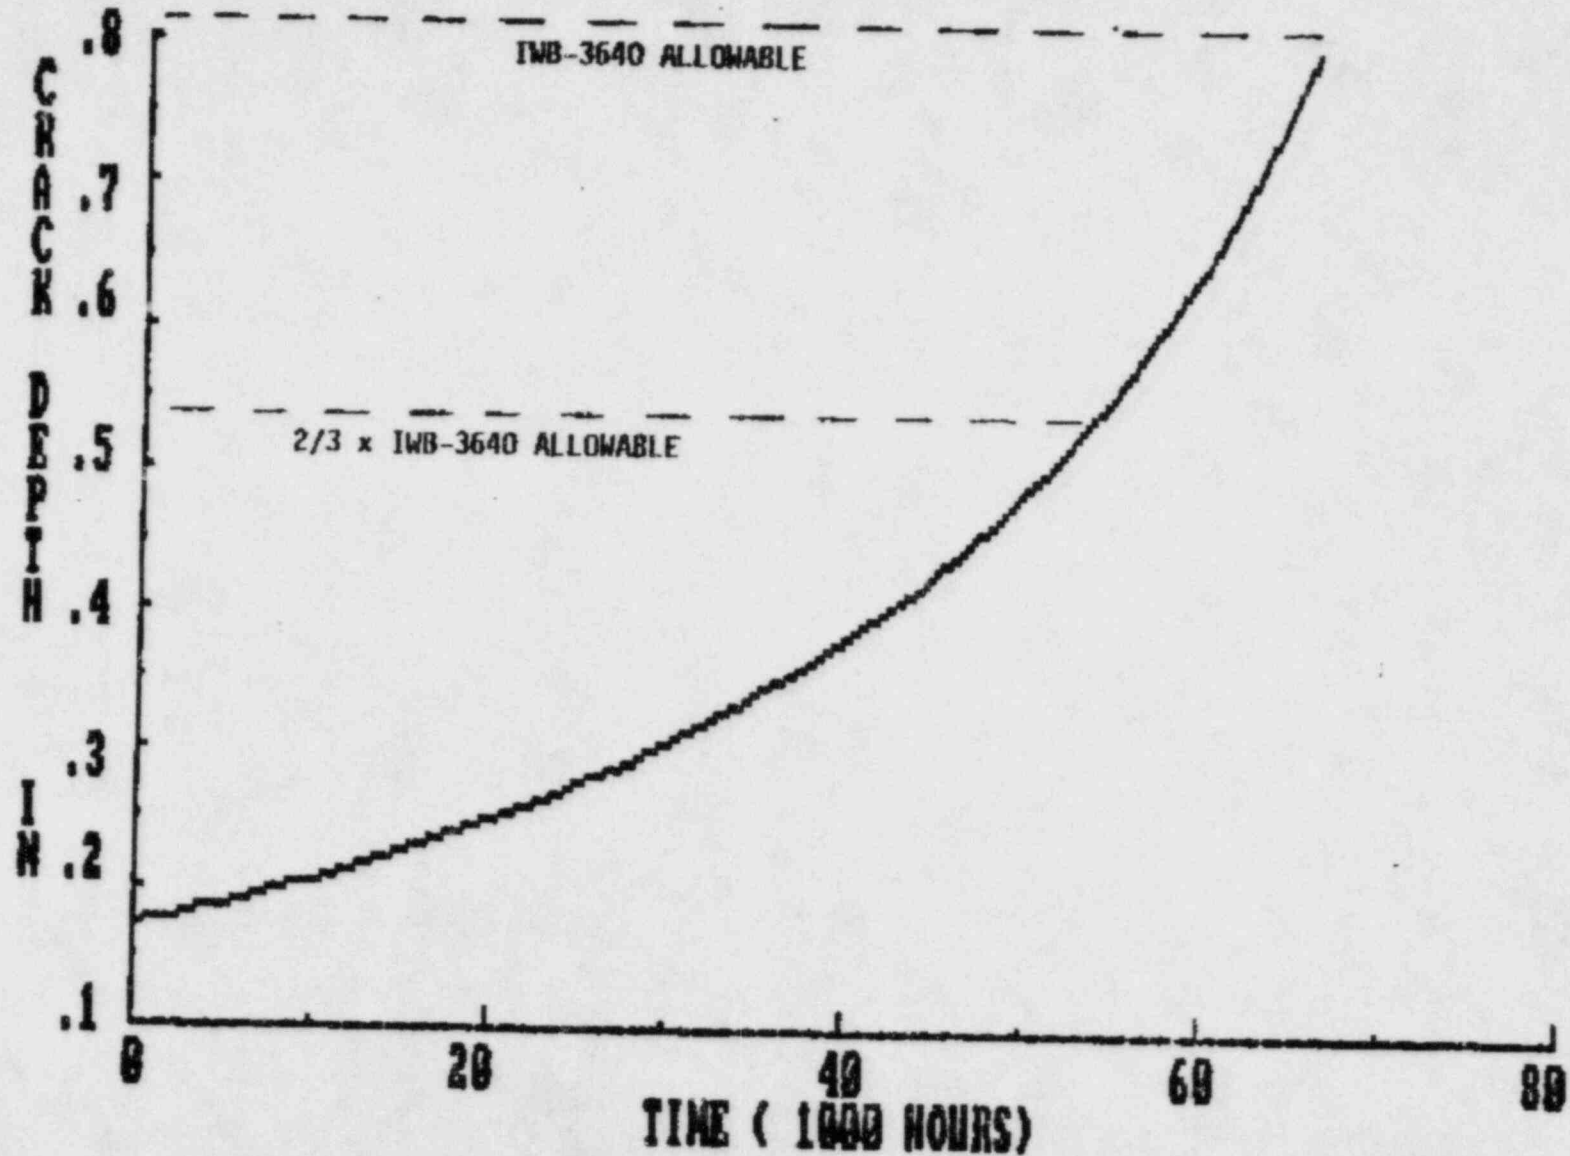
FIGURE 5.1 Projected Crack Growth Versus Allowable For Weld 2B-A6

The two axial crack-like indications were of a depth so that flaw evaluation was able to demonstrate continued successful operation for at least one additional fuel cycle with these joints unrepaired. The crack growth analysis utilized representative circumferential residual stress data and analysis for this pipe size obtained from EPRI reports (Refs. 2, 3, 4). The analysis technique and results were again compared to the NUTECH Engineers results and agreement was obtained. Crack growth curves versus allowable flaw size for the two joints are presented in Figures 5.1 and 5.2. It is seen that in both cases the indications are acceptable for a period well in excess of one fuel cycle.

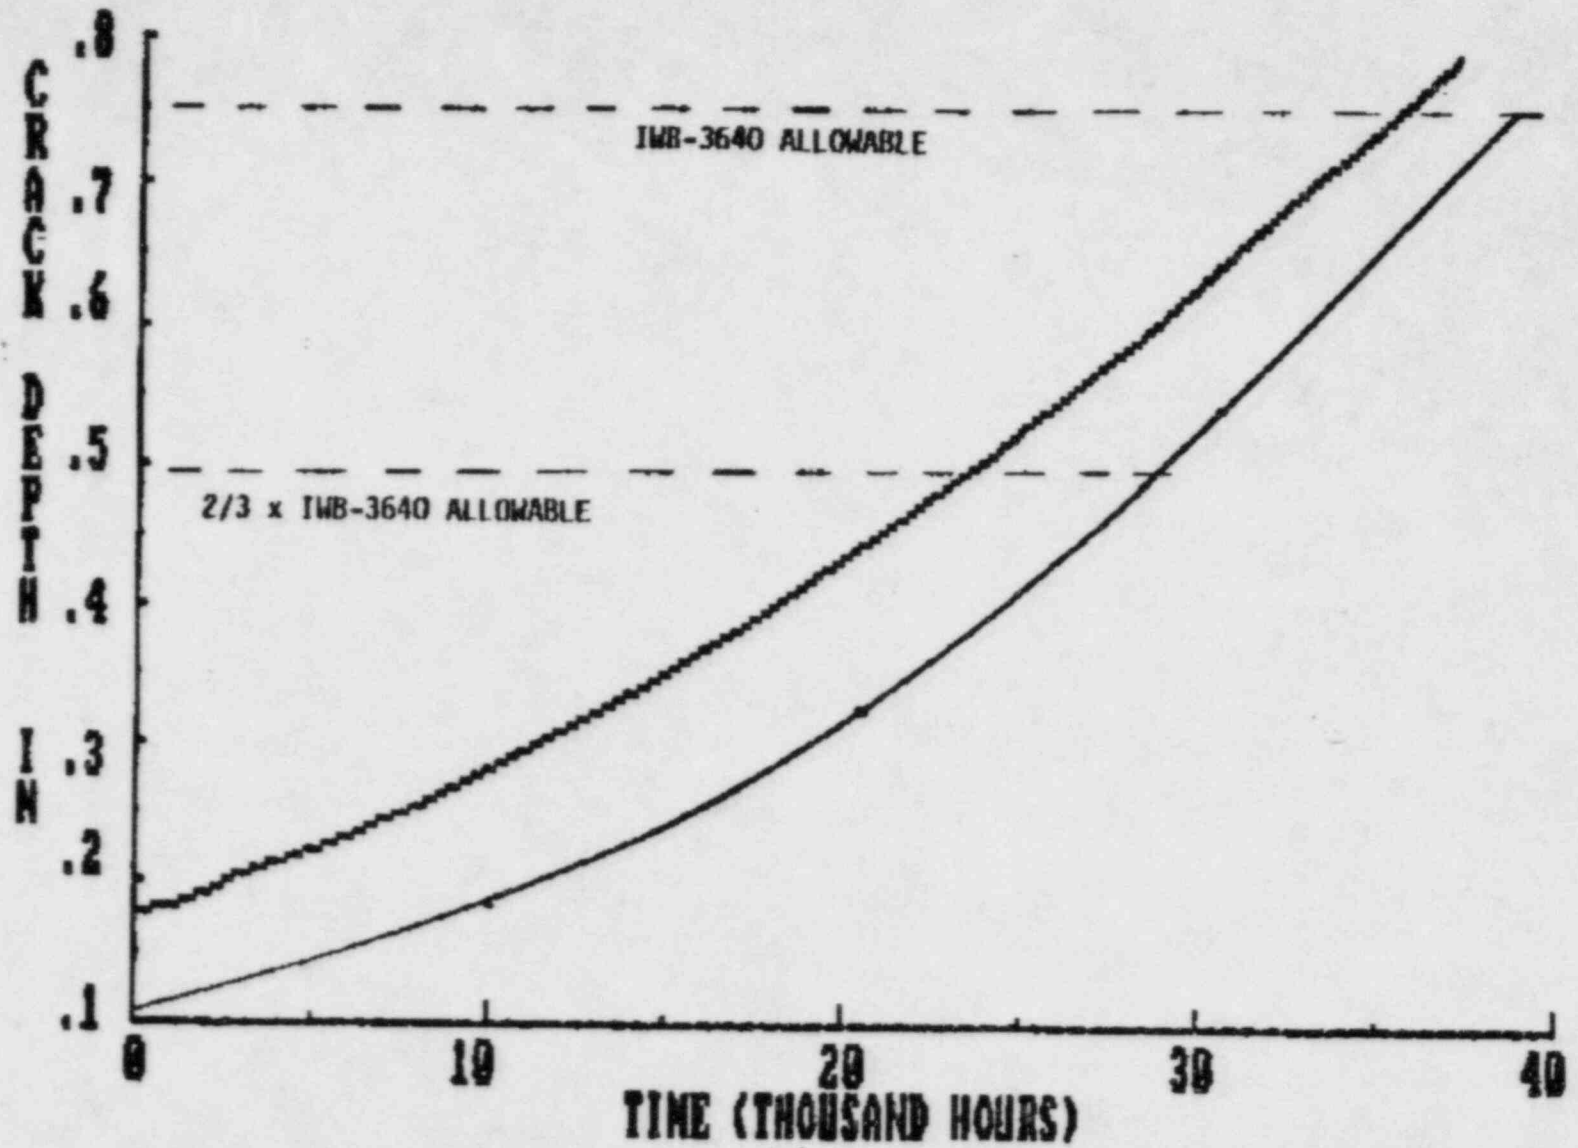
FIGURE 5.3 Projected Crack Growth Versus Allowable For Sweep-o-let Weld 22-1BC1-AM1

With regard to the sweepolet weld, 1B31-1RC-22AM-1BC-1; it was examined during the Fall 1984 maintenance/refueling outage and found to have reportable, crack-like indications other than those observed during the previous outage. The indications observed during the previous outage were shallow, axially oriented, and lay outside of the heat affected zone of the weld. The indications observed during the Fall 1982 maintenance/refueling outage were not observed during the current outage. The area of the indications was reexamined with advanced techniques (e.g., sizing techniques) to try to confirm cracking; however, no cracking was detected and the previous indications were thought to be I.D. roll (noise) rather than IGSCC. The new indications were observed to be two circumferential indications totaling approximately 9 inches in length with a maximum through wall depth of 11%. In addition, several spot indications were observed with the deepest indication being 18% through-wall. Analyses conducted by the primary contractor and a third party indicated that the subject weld could be left unrepaired for a period of at least one fuel cycle based on flaw limits imposed by ASME Section XI Code, Paragraph IWB-3640 and NRC Generic Letter 84-11. Based on these examination results and analyses, it is the intention of GPC to remove the acoustic emissions leakage device installed on this solution annealed sweepolet weld joint during the current outage. While the device was voluntarily installed by GPC and was not a licensing condition, NRC's concurrence with its removal is requested since the device is discussed rather extensively in the Hatch Unit 1 SER issued for the analyses/repairs conducted during the previous outage. It is the opinion of GPC that local leakage detection is no longer required for this weld. The extremely high inherent toughness and ductility of the stainless steel piping material; the tendency of cracks in such piping to grow through-wall and leak before affecting its structural load carrying capacity (i.e., "Leak-before-break" concept); and augmented reactor coolant leakage surveillance requirements currently in effect support our desired removal of the acoustic emissions leakage detection device on the subject weld.

Crack-like circumferential indications were also observed in two of the sweepolet to ring header welds during the inservice inspection of these welds. These crack-like indications were evaluated using the flaw evaluation methodology described above. The weld residual stress used assumed that the sweepolet to header joints had been solution annealed following welding, (a condition which was verified as a result of a review of shop fabrication records) and therefore produced a zero through thickness residual stress state. The flaw evaluation results indicated that all of the flaws would remain within the limits imposed by the ASME Code, Section XI, Paragraph IWB-3640 and NRC Generic letter 84-11 for a period of at least one fuel cycle (see Figures 5.3 and 5.4). These results were compared to those developed by NUTECH Engineers and were essentially in agreement.
